139 George Street, Avalon

Geotechnical Comments for Section 4.55

GEOTECHNICAL INVESTIGATION:

Alterations and Additions at **139 George Street, Avalon**

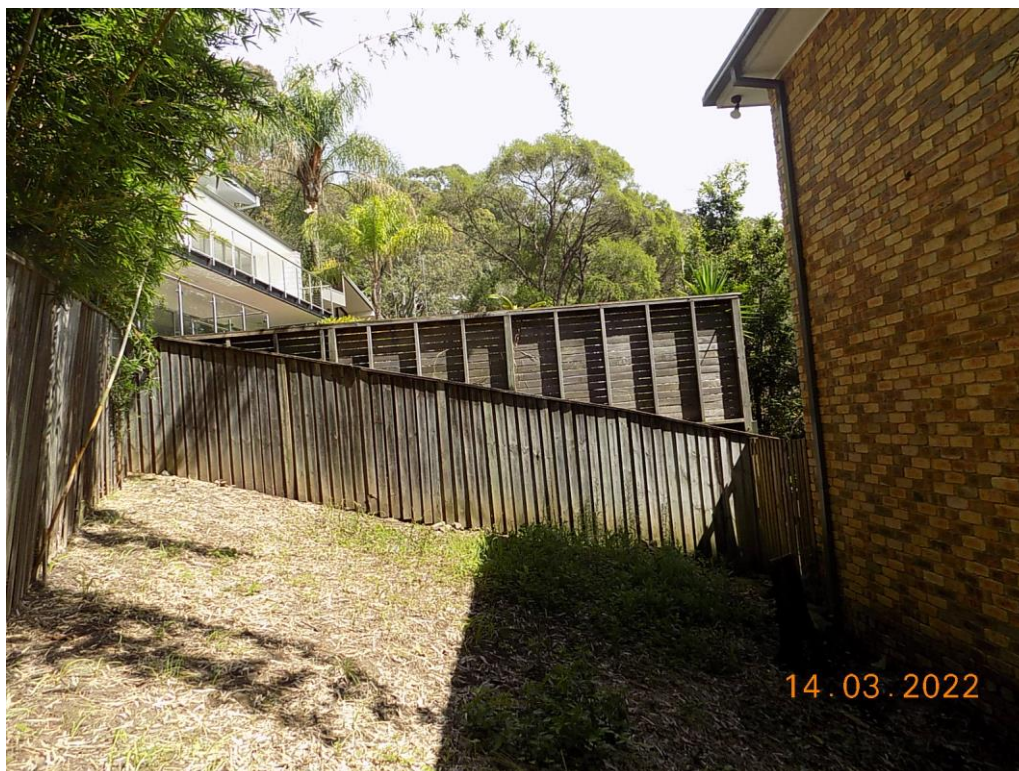
Photo 7

timber log retaining wall supports a fill for the ROW (Photo 2). A second, stable ~1.3m high timber log retaining wall supports a fill for the driveway (Photo 3). The part three-storey brick house is supported on brick walls. The supporting brick walls show no significant signs of movement. A stable ~0.7m high masonry retaining wall supports a cut for a carport attached to the E side of the house (Photo 4). A series of ~1.4m high timber retaining walls terrace the slope on the E side of the property (Photo 5 & 6). One of the supporting soldier posts has separated and the wall has begun to bulge in the middle. See **Section 16** for advice regarding this wall. A moderately sloping lawn extends from the uphill side of the house to the upper common boundary (Photo 7). Several Sandstone boulders can be seen embedded in stable positions in this location (Photo 8).
