9 July 2017

**RE: ENGINEER ASSESSMENT OF FAILED RETAINING WALL  
PEDESTRIAN WALL ON SOUTH SIDE OF WALKWAY  
TREE DAMAGE TO WALL  
15 EAST ESPLANADE MANLY  
FOR SP 6749**

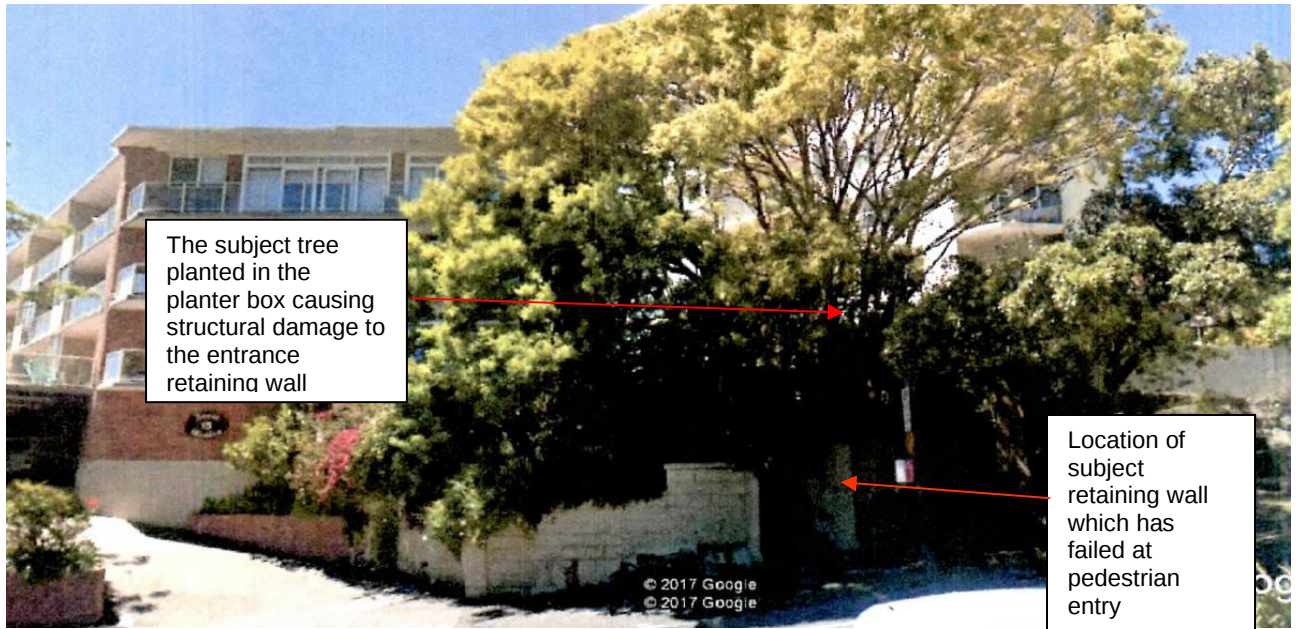
The wall is leaning outwards by approximately 100mm and has sheared at the lower level course.

The subject tree roots are visible from the opened joints in the wall adjacent to a an engaged pier located on the corner of the wall. The tree roots are visible directly up against the wall.

The length of wall failure is approximately 8.5m long. The wall height varies from 800mm to 1800mm in height.

The cause of the damage is in our view as a result of inappropriate tree location to the retaining wall structure and limited space in the planter box. This being that the tree is planted too close to the retaining wall.

The wall is unsafe and it is imminent complete collapse will eventually occur unless the tree is removed and replaced with suitable shrubs.

The section of failed wall will need to be demolished and replaced which is around 8.5 m in length.

The footing for the wall would be part of the concrete steps hence the existing steps would be required to be demolished and replaced incorporating the footing.
