Geotechnical Assessment

Project: Alterations & Additions
12 Capua Place, Avalon Beach NSW

Ref: AG 24301
2 August 2024

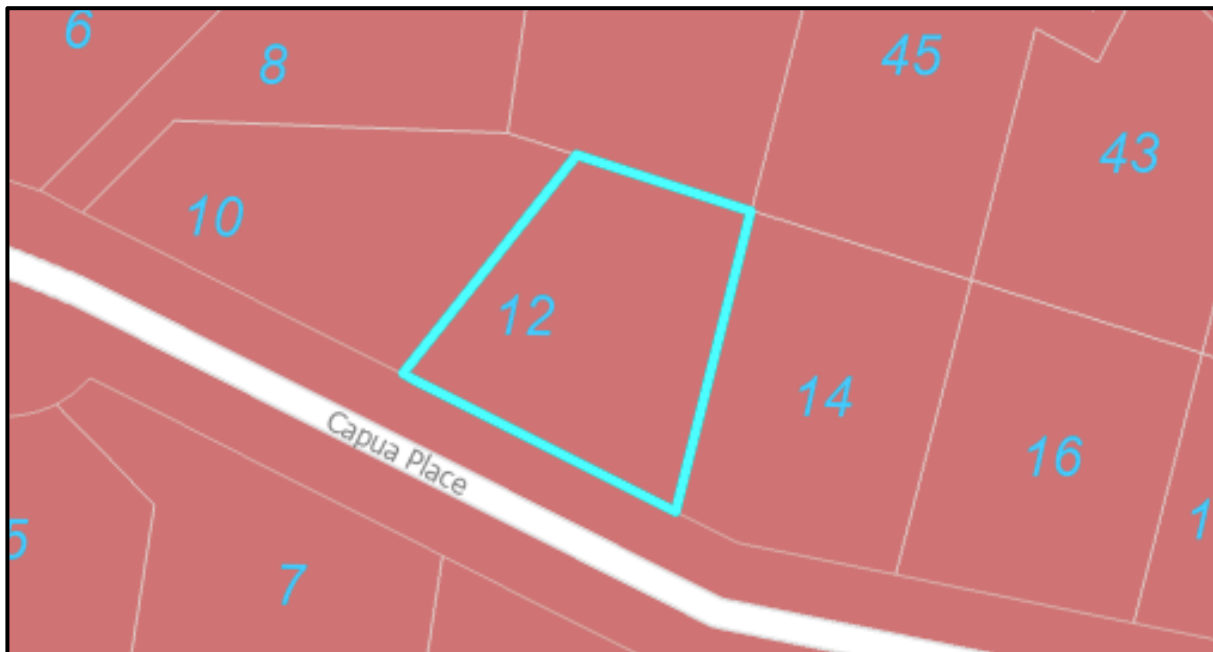
Image 2. PLEP Geotechnical Hazard Map
– 12 Capua Place, Avalon Beach NSW © NBC Maps

- No evidence of significant soil creep, tension cracks or landslip instability were identified across the site or on adjacent properties as viewed from the subject site at the time of our inspection.
- There are heavily weathered sandstone boulders at various locations in the slope across the site. The sandstone boulders may have been originally mobilised by a large-scale historical (>100 years) rockfall/landslip event that no longer poses a stability risk to the site.
- There are no significant stability risk defects within the observable sandstone escarpment along the southern boundary.
- Based on reference to the plan entitled "Geotechnical Hazard Mapping" (Ref. P21DCP-BC-MDCP2002, dated 2007) prepared by GHD LONGMAC on behalf of Northern Beaches Council (Pittwater), the site is mapped in a **Geotechnical Hazard H1** zone.

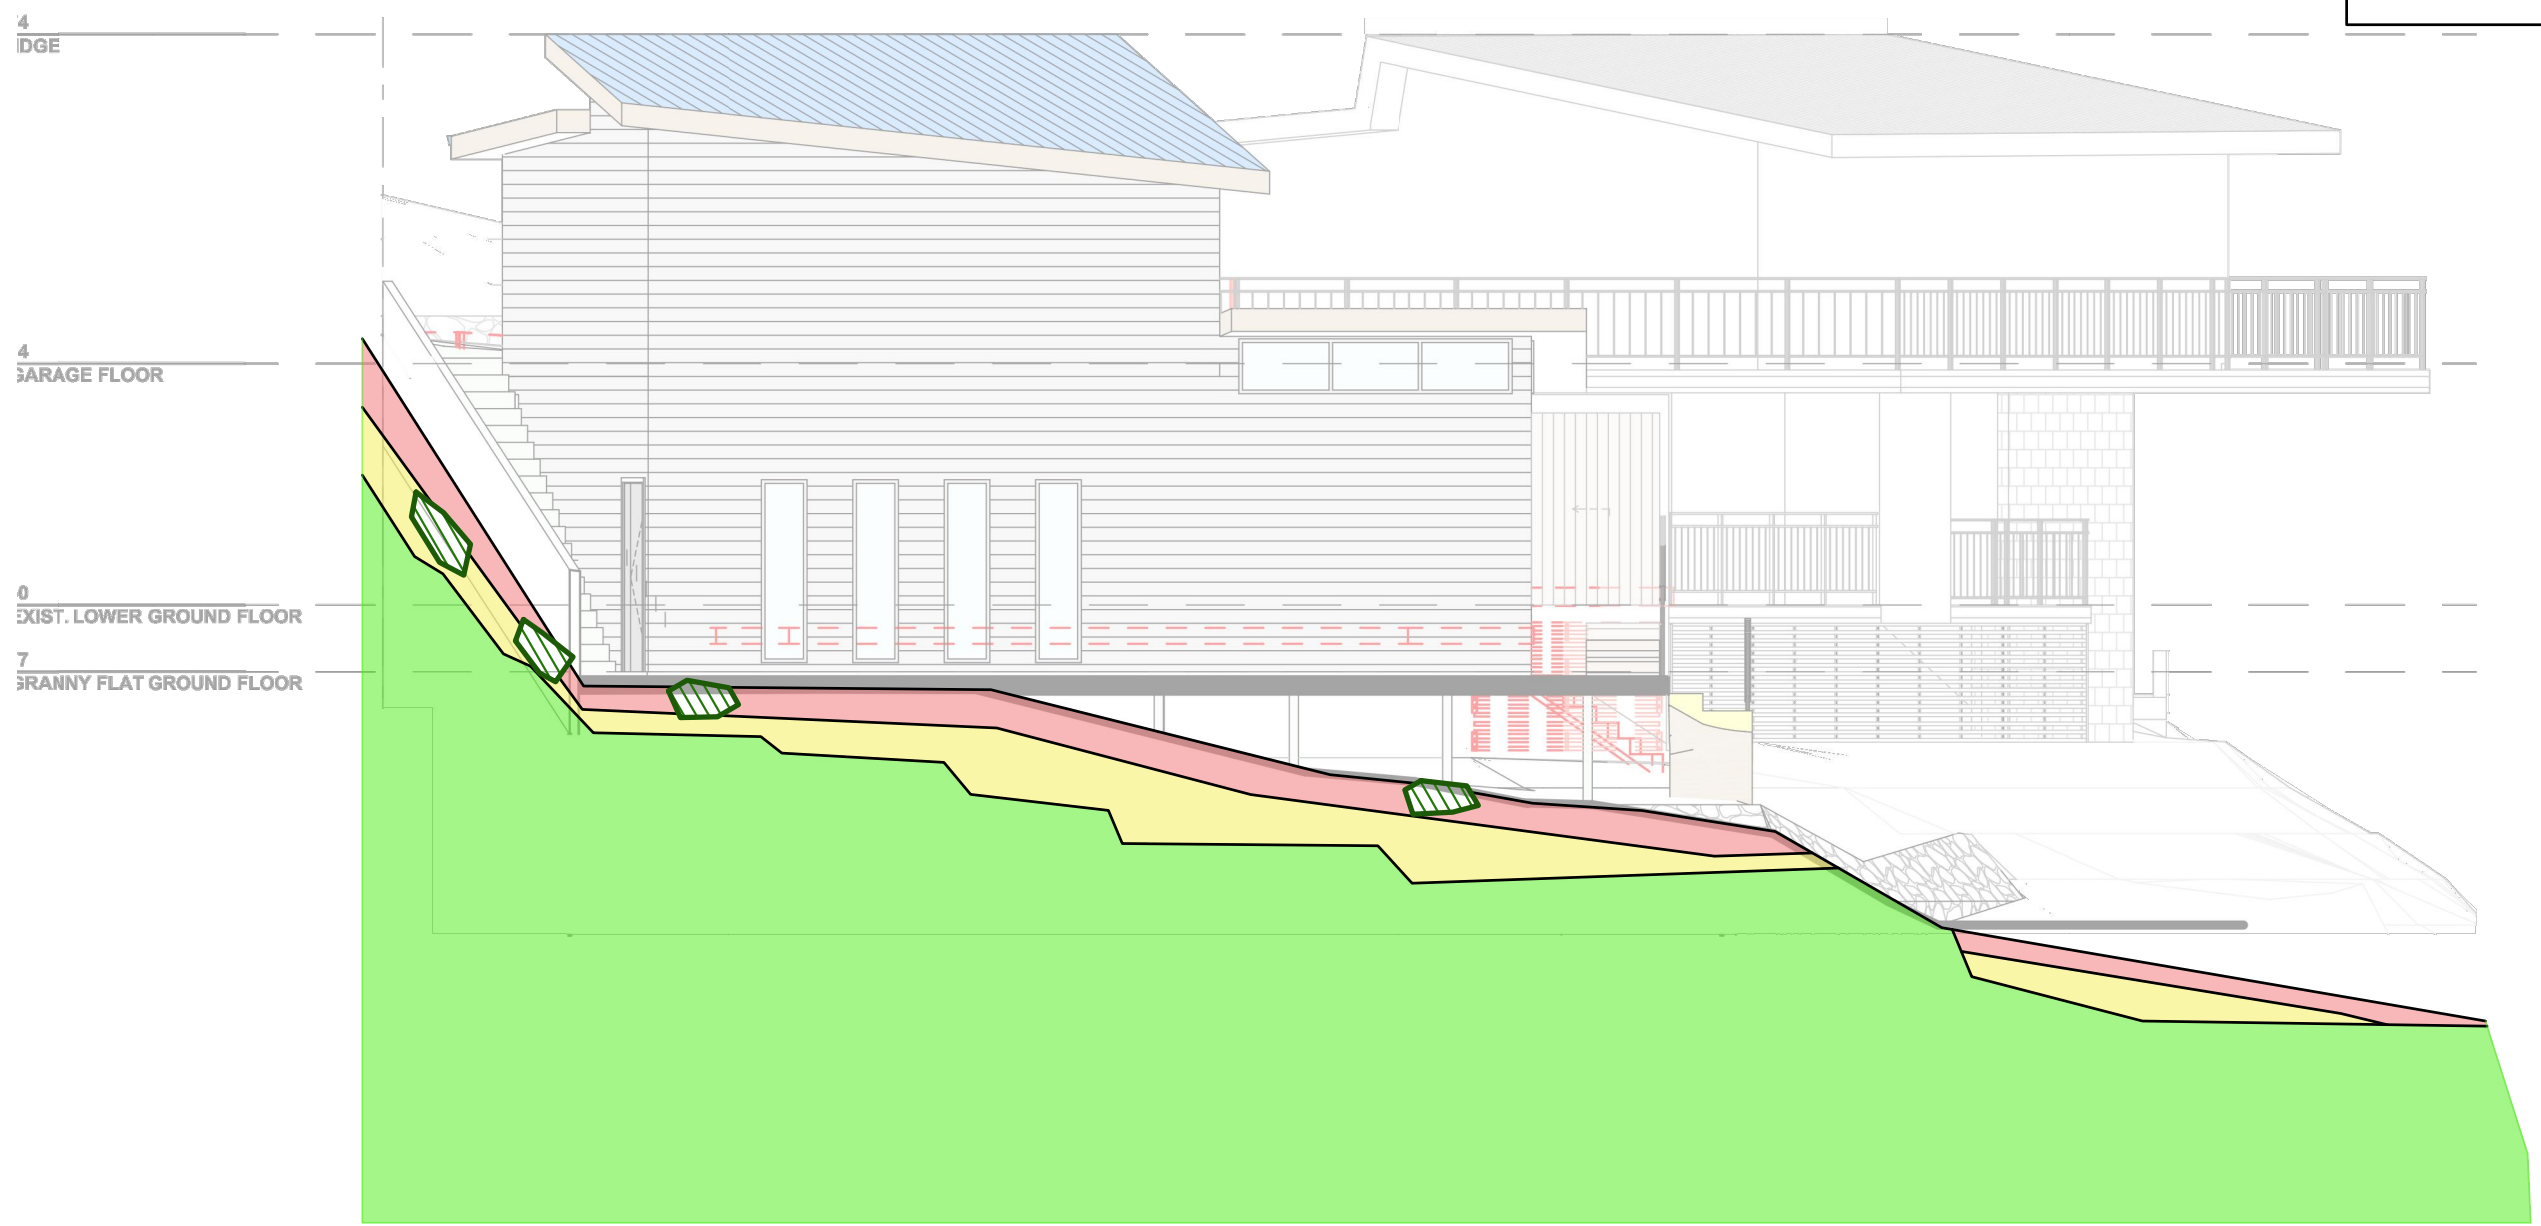
INFERRED GEOLOGICAL SECTION
SCALE NTS

The soil profile consists of shallow uncontrolled silty fill and silty topsoil (O & A Horizons), clayey sand (B Horizon) and low-medium strength sandstone bedrock (C Horizon). There are numerous partially detached and potentially fully detached joint blocks and sandstone boulders in the upper profile at the upslope side of the existing house and in the area of the proposed works. These vary from large (>3m) to small (<1m). Based on our observations and the results of testing on site, we would expect weathered bedrock to be found within 2.0 metres below current surface levels across the area of the proposed works, where not already outcropping and potentially deeper where filling has been carried out.

INTERPRETED SUBSURFACE SECTION ONLY.
ACTUAL GROUND CONDITIONS MAY VARY.

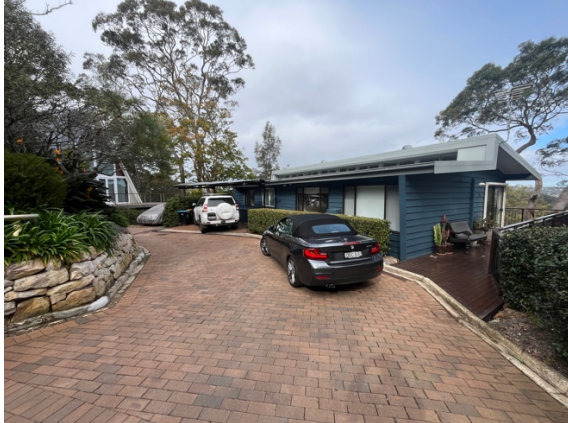
Photo 1: Right of carriageway access and residence frontage

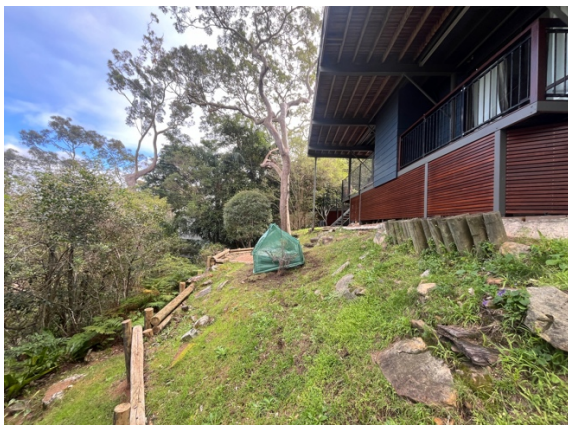
Photo 5: Rear of the residence
