Report Title: Geotechnical Report 81 Hilltop Road, Avalon  
Report Date: 21/5/19  
Author: BEN WHITE  
Author's Company/Organisation: WHITE GEOTECHNICAL GROUP PTY LTD

## **GEOTECHNICAL INVESTIGATION:**

New Carport, Pool, and Alterations and Additions at **81 Hilltop Road, Avalon**

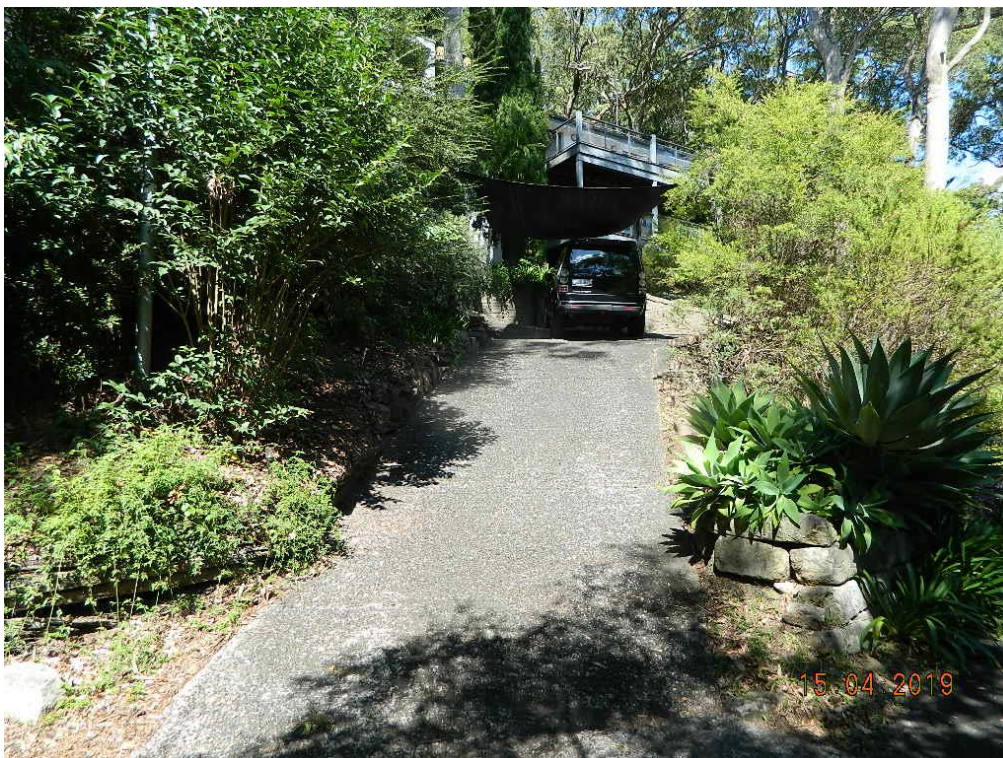
Photo 2

- 2.3** At the road frontage, a concrete Right of Carriageway (ROW) runs across the lower boundary of the property (Photo 1). A concrete driveway extends off the ROW up the slope to a concrete parking area on the downhill side of the property (Photo 2). A ~0.5m stable dimensioned sandstone block retaining wall and an old timber retaining wall support a cut for the ROW (Photos 3 & 4). The old timber
