GEOTECHNICAL INVESTIGATION:

Proposed Pool and Alterations and Additions at **3 Capua Place, Avalon**

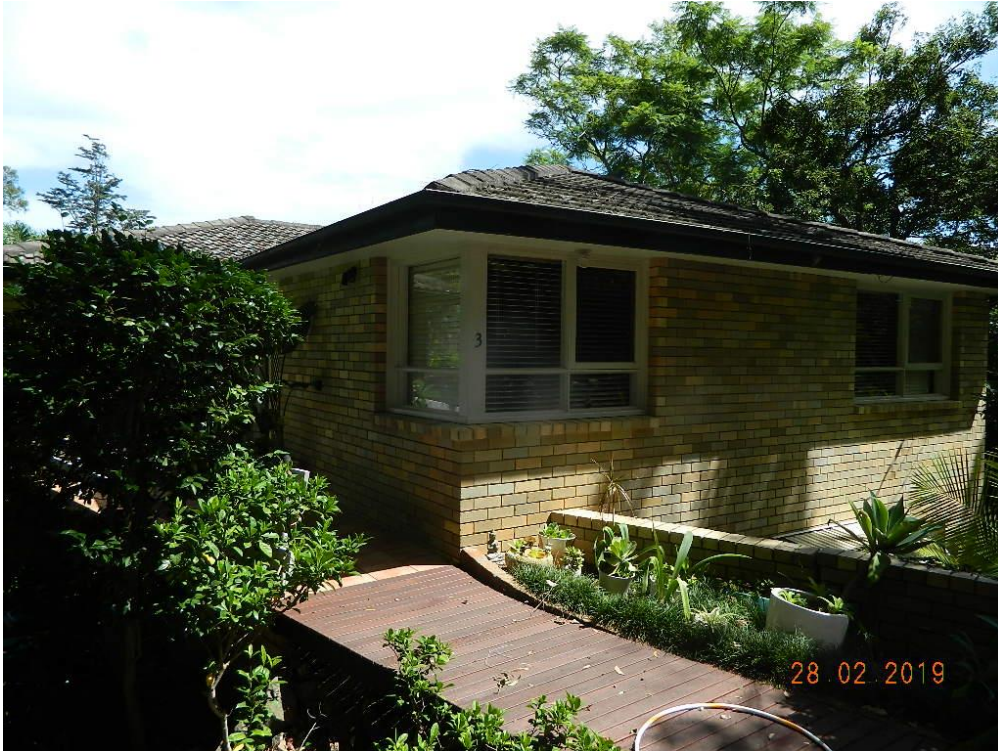
Photo 6

retaining wall (Photo 5). The cracked portion of the wall shows slight deflection downslope but this is limited to the top ~0.5m of the wall (Photo 6). The reason for cracking is unclear but it may have been due to the growth of shrub/tree that has since been removed. See recommendations in **Section 16** for advice. The two storey brick house is supported on brick walls (Photo 7). Cracking was observed in the external supporting walls of the house (Photos 8 & 9). Some of the cracking appears to be related to rusting window lintels. The majority of the cracking appears to be due to uneven settlement of the house. This type of settlement is common in houses with shallow or variable foundations on soil and surface clay. Brick paving and a level lawn area extend from the downhill side of the house (Photo 10). The ground surface around the paving and lawn has settled in places (Photo 11). Stable mortared sandstone block retaining walls reaching a maximum height of ~1.0m terrace the slope below the lawn and paved area (Photo 12). A gently sloping lawn continues from the walls to the lower common boundary (Photos 13 & 14).

The brick retaining wall on the uphill side of the house is cracked and deflected slightly over the top ~0.5m (Photo 6). To be prudent, we recommend it be inspected by the owners on an annual basis or after heavy prolonged rainfall, whichever occurs first, keeping a photographic record of the inspections. We can carry out these inspections upon request. Should any new movement be observed, the geotechnical consultant is to be engaged to assess the movement and provide remedial advice if necessary.
