## **Lot 1, 7 Trentwood Park, Avalon**

Comments on updates to Plans for House

## **GEOTECHNICAL INVESTIGATION:**

New Subdivision and Two New Houses at **7 Trentwood Park, Avalon.**

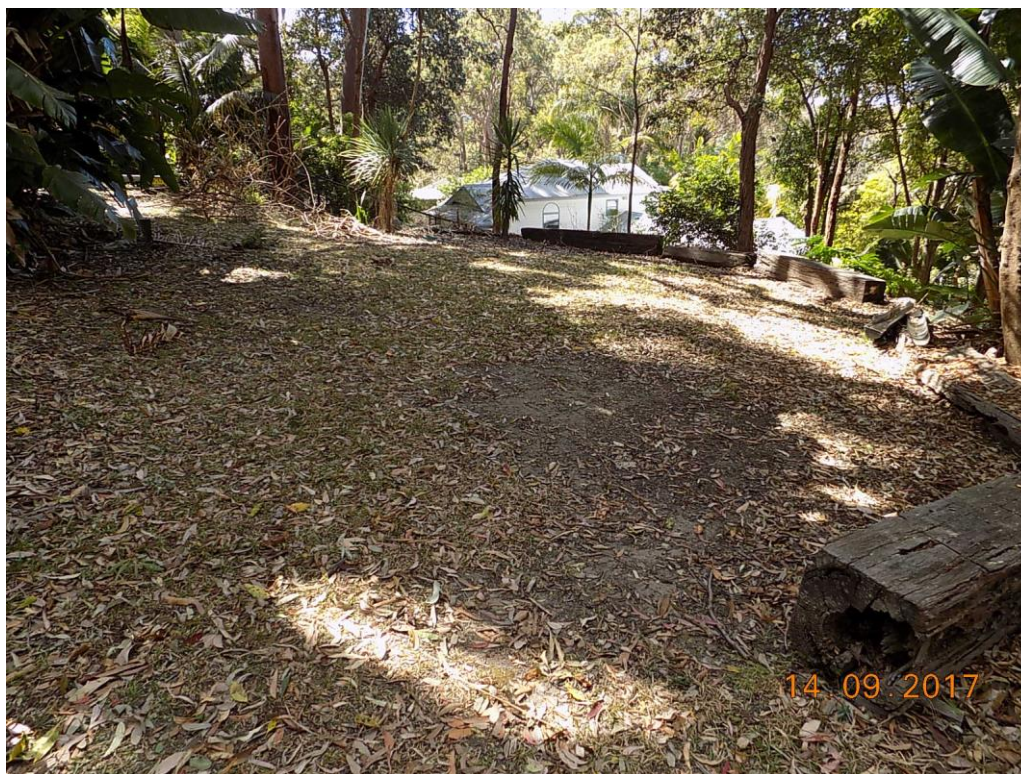
Photo 2

- 2.3** At the road frontage, a concrete driveway runs up the slope to a brick garage and brick-paved parking area on the S side of the house (Photos 1 & 2). The garage will be demolished as part of the proposed works. The driveway diverts to a lawn-covered parking area below the brick-paved parking area (Photo 3). The fill for the lawn-covered parking area is battered to stable angles and merges into the natural slope (Photo 4). Between the road frontage and the lawn-covered parking area, the slope is sparsely vegetated with native trees (Photo 5). The part two-storey timber framed and clad house will remain unchanged as part of the proposed works (Photo 6). An excavation has been made in the slope for the lower ground floor of the house. The cut was made through a
