arboricultural impact assessment report

AIA-01

Revision A, Issued for Development Application
13 June, 2018

Allambie Heights Village - Project 2

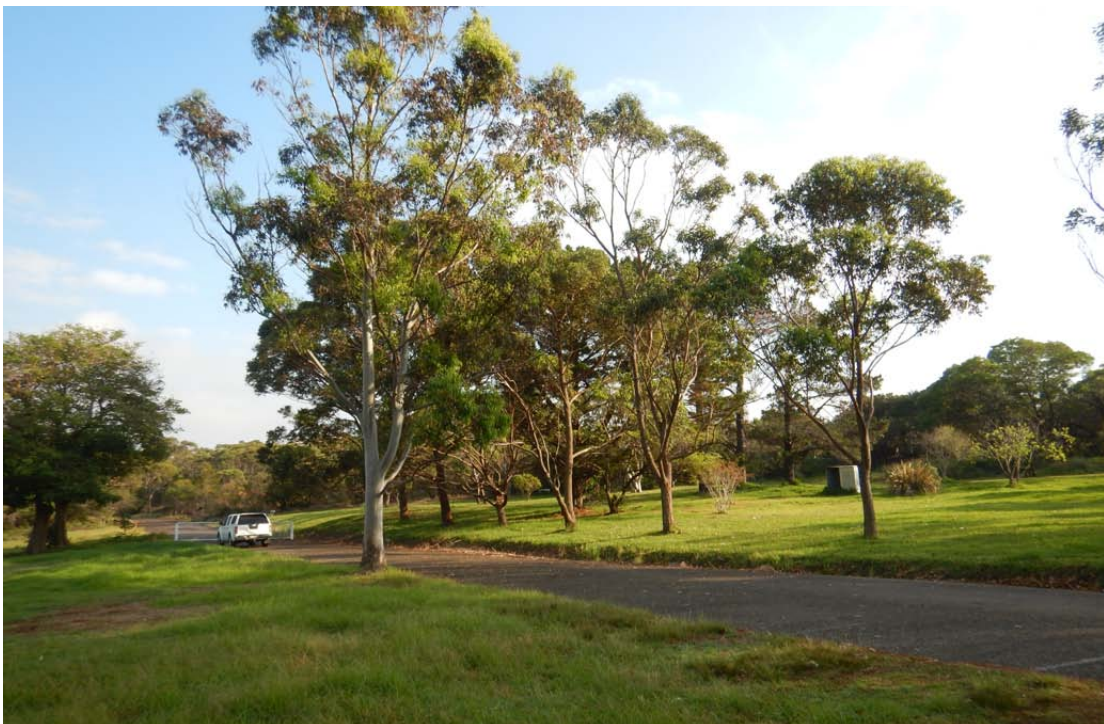
Figure 1 – Typical site conditions illustrating predominantly cleared site area and some larger trees that have either been planted or retained from pre-existing trees as amenity trees. (Photo: Arterra)

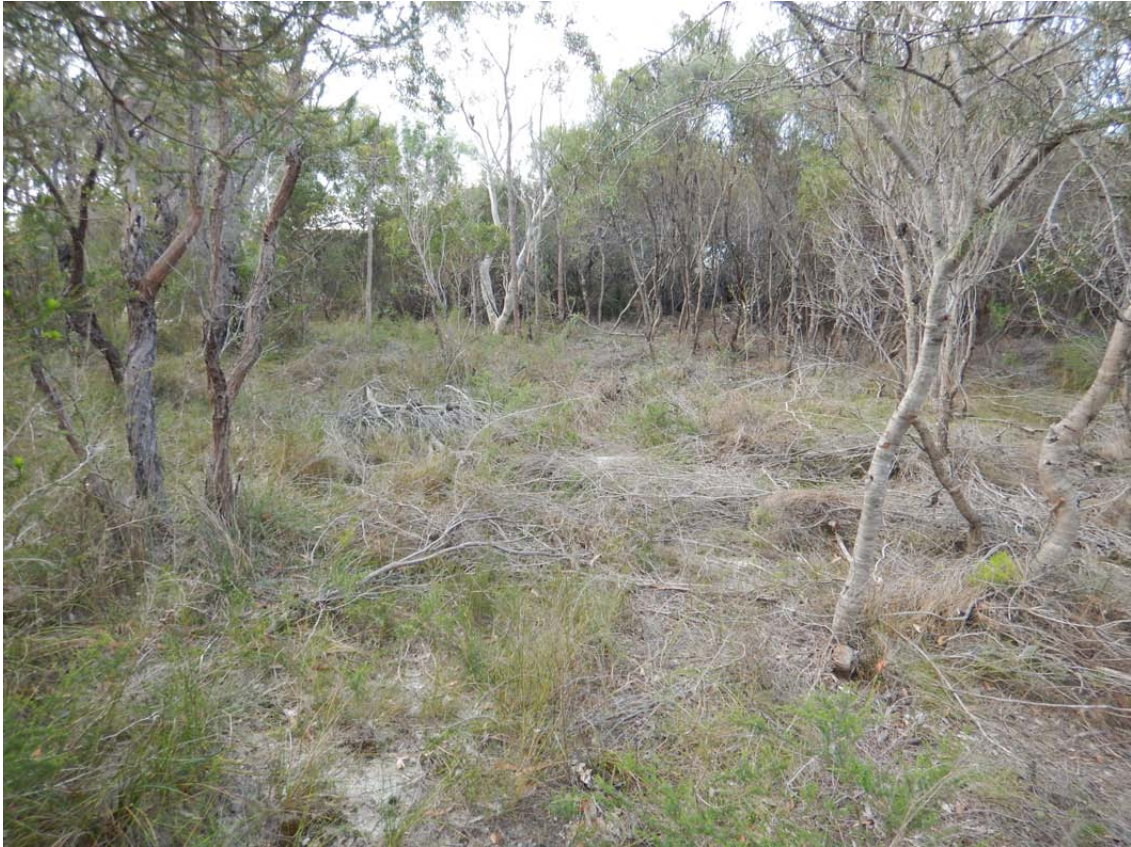
Figure 3 – The site and bushland areas to the west of the proposed development. The trees in this portion of the site are not addressed in this report but are covered in the ecological assessments. (Photo: Arterra 21/4/18)

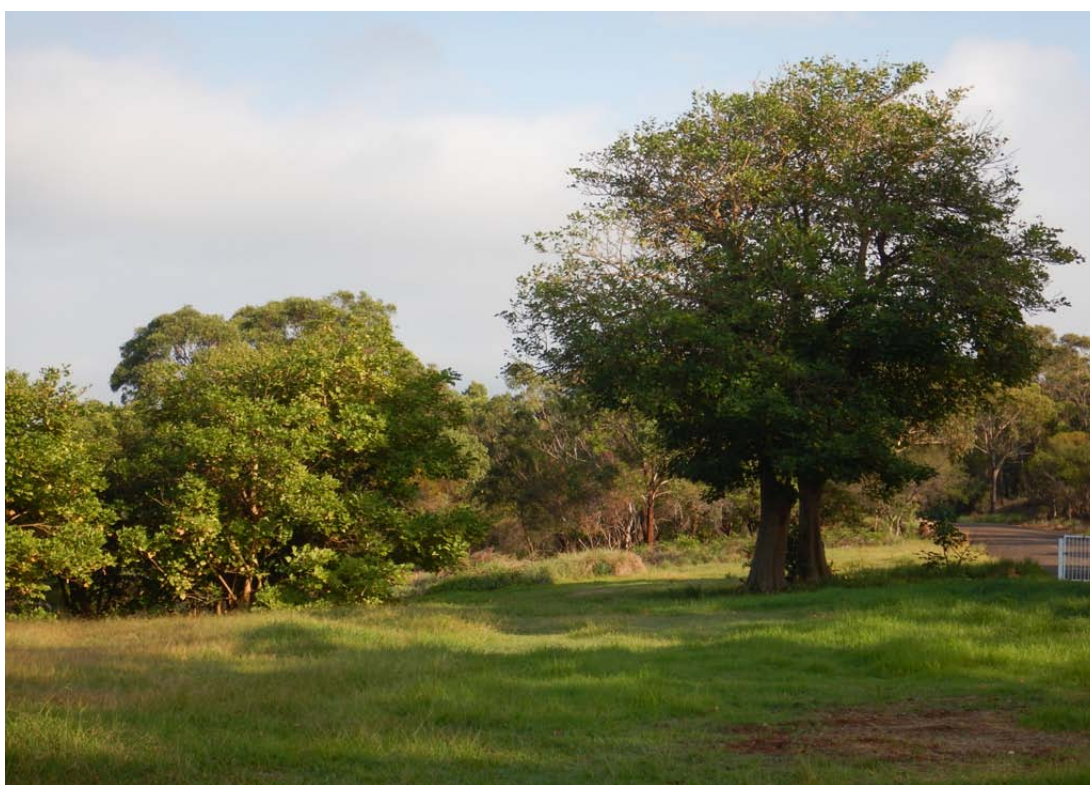
Figure 5 – View to south-west across the southern portion of the site. (Photo: Arterra 21/4/18).

There are numerous relatively short-lived Wattles (*Acacia parramattensis*), particularly along the northern boundary. Although some are in reasonable health, many are showing significant signs of decline due to borer and other insect attack. Some are very poor forms with significant leans. We believe these should not form an impediment to development and should be removed with suitable longer term replacement planting undertaken in their place.
