## ARBORICULTURAL IMPACT ASSESSMENT REPORT

54 Bardo Road, Newport

**Built Projects**

16<sup>th</sup> March 2021

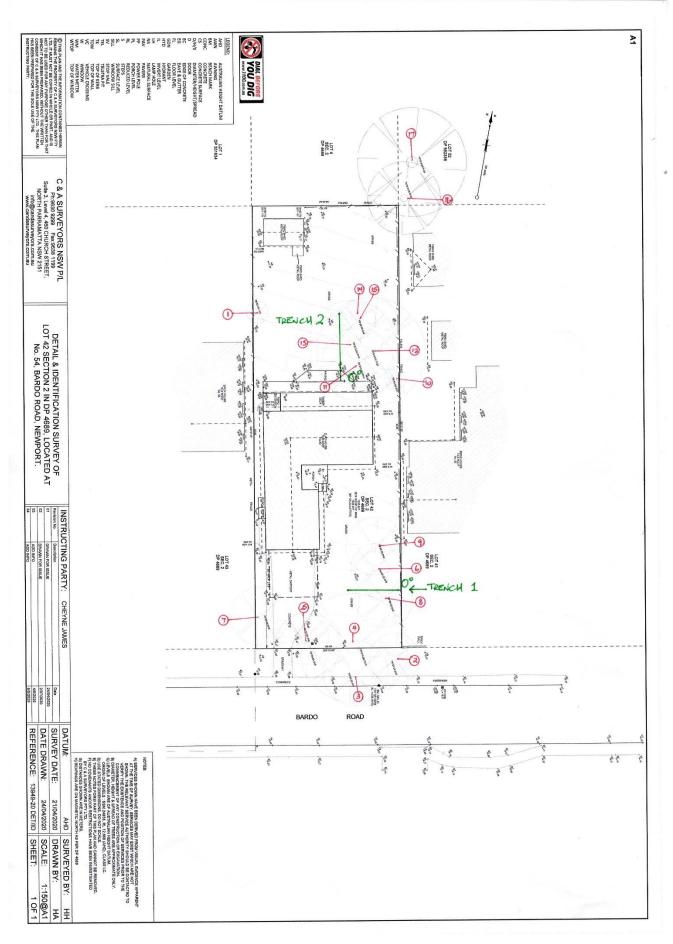
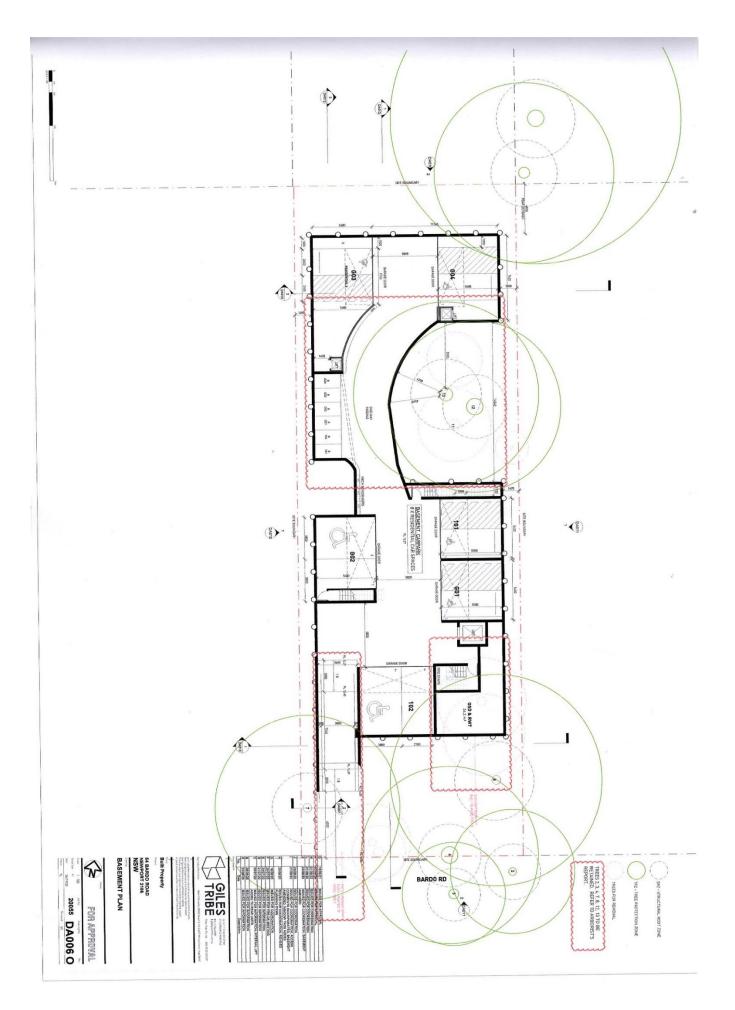
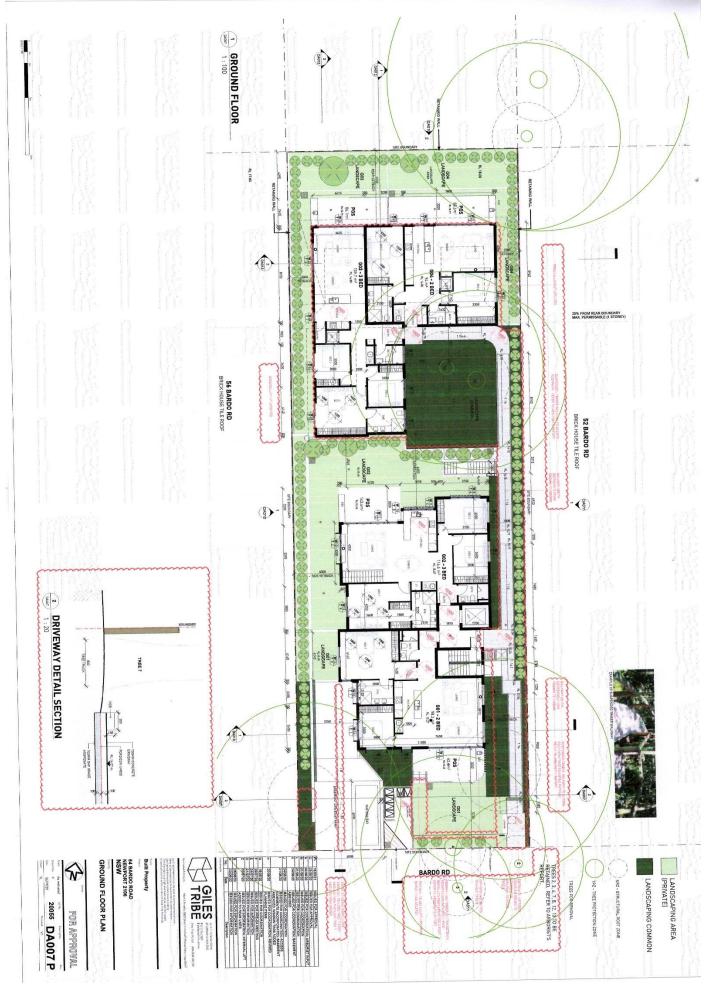
#### Annexure C: Tree impact plan and root mapping locations

Trench 2 found 24 roots varying in size from 25mm to 160mm. Roots 1, 5, 6, 7, 9, 12, 13, 16, 17, 18, 22 & 24 are non-woody roots. N.B. It was difficult to determine which roots were from these trees.
