J2915. 20<sup>th</sup> November, 2020. Page 1.

# **GEOTECHNICAL INVESTIGATION:**

## Alterations and Additions at **114 Whale Beach Road, Whale Beach**

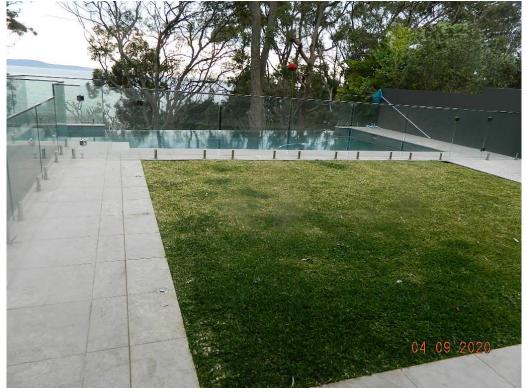
Photo 6

The driveway runs to a paved parking area and garage (Photo 4). The cut for the parking area is supported by a rendered retaining wall up to ~3m high in good condition (Photo 5). Next to the parking area is an above ground pool and terrace/lawn area in good condition (Photo 6). The garage is located below the terrace. The part three storey house is supported by rendered walls and stone dressed concrete walls (Photos 4 & 7). The external supporting walls show no significant signs of movement. Fill provides level lawn and garden areas on the SW side of the property (Photos 8 to 10). The fill is supported by low timber retaining walls and a stable ~1.6m high concrete block retaining wall. Overall the slope across the property is considered stable. The adjoining neighbouring properties pose no risk of instability to the subject property as seen from the street and subject property.
