GEOTECHNICAL INVESTIGATION:

New pool and Retaining Walls at 2/86 Anzac Avenue, Collaroy
aka: 58B Suffolk Avenue, Collaroy

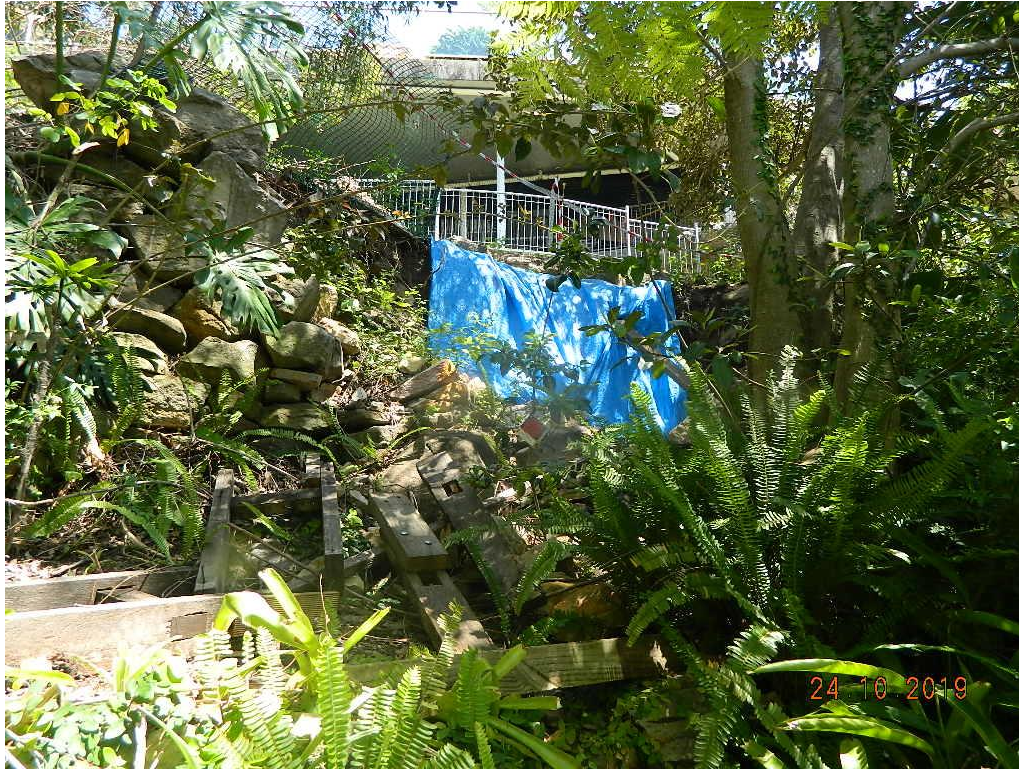
Photo 4

HAZARDS	Hazard One	Hazard Two	Hazard Three
TYPE	The vibrations produced during the proposed excavations impacting on the surrounding structures.	The proposed excavation collapsing onto the work site before the retaining walls are in place.	The fill batter for the ROW falling before new walls are in place (Photo 4).
LIKELIHOOD	'Possible' (10^{-3})	'Possible' (10^{-3})	'Likely' (10^{-2})
CONSEQUENCES TO PROPERTY	'Medium' (15%)	'Medium' (12%)	'Medium' (20%)
RISK TO PROPERTY	'Moderate' (2×10^{-4})	'Moderate' (2×10^{-4})	'Moderate' (6×10^{-4})
RISK TO LIFE	5.3×10^{-7} /annum	8.3×10^{-6} /annum	5.3×10^{-5} /annum
COMMENTS	This level of risk to property is 'UNACCEPTABLE'. To move risk to 'ACCEPTABLE' levels, the recommendations in Section 12 are to be followed.	This level of risk to life and property is 'UNACCEPTABLE'. To move risk to 'ACCEPTABLE' levels, the recommendations in Section 13 are to be followed.	This level of risk to life and property is 'UNACCEPTABLE'. To move risk to 'ACCEPTABLE' levels, the recommendations in Section 16 & 13 are to be followed.

It is recommended the failed portion of the fill batter for the ROW be temporarily supported with a sandbag retaining wall to be installed immediately. The wall is to be not less than 0.8m wide at the base. The back of the wall is to be flush against the remaining face of the failed material. The face of the sandbag wall is to be tapered back at $\sim 20^\circ$ from vertical from the downhill toe edge. It is recommended the sandbags be filled with 10% cement so once they are in place they set hard. This way they can remain in place permanently noting the proposed retaining wall below will be built and the backfill will cover/ partially cover the sandbag wall.

Until these works are complete the fill batter should be monitored by the owners on a daily basis. If further movement is noted in the fill batter the driveway is to be barricaded off so cars cannot access the ROW. Our office is to be informed immediately.
