# Arborist Impact Assessment

Proposed Development  
Lot 180 DP752017  
40 Myoora Road, Terrey Hills, NSW

**April 2025**

**AEP Ref: 3550**

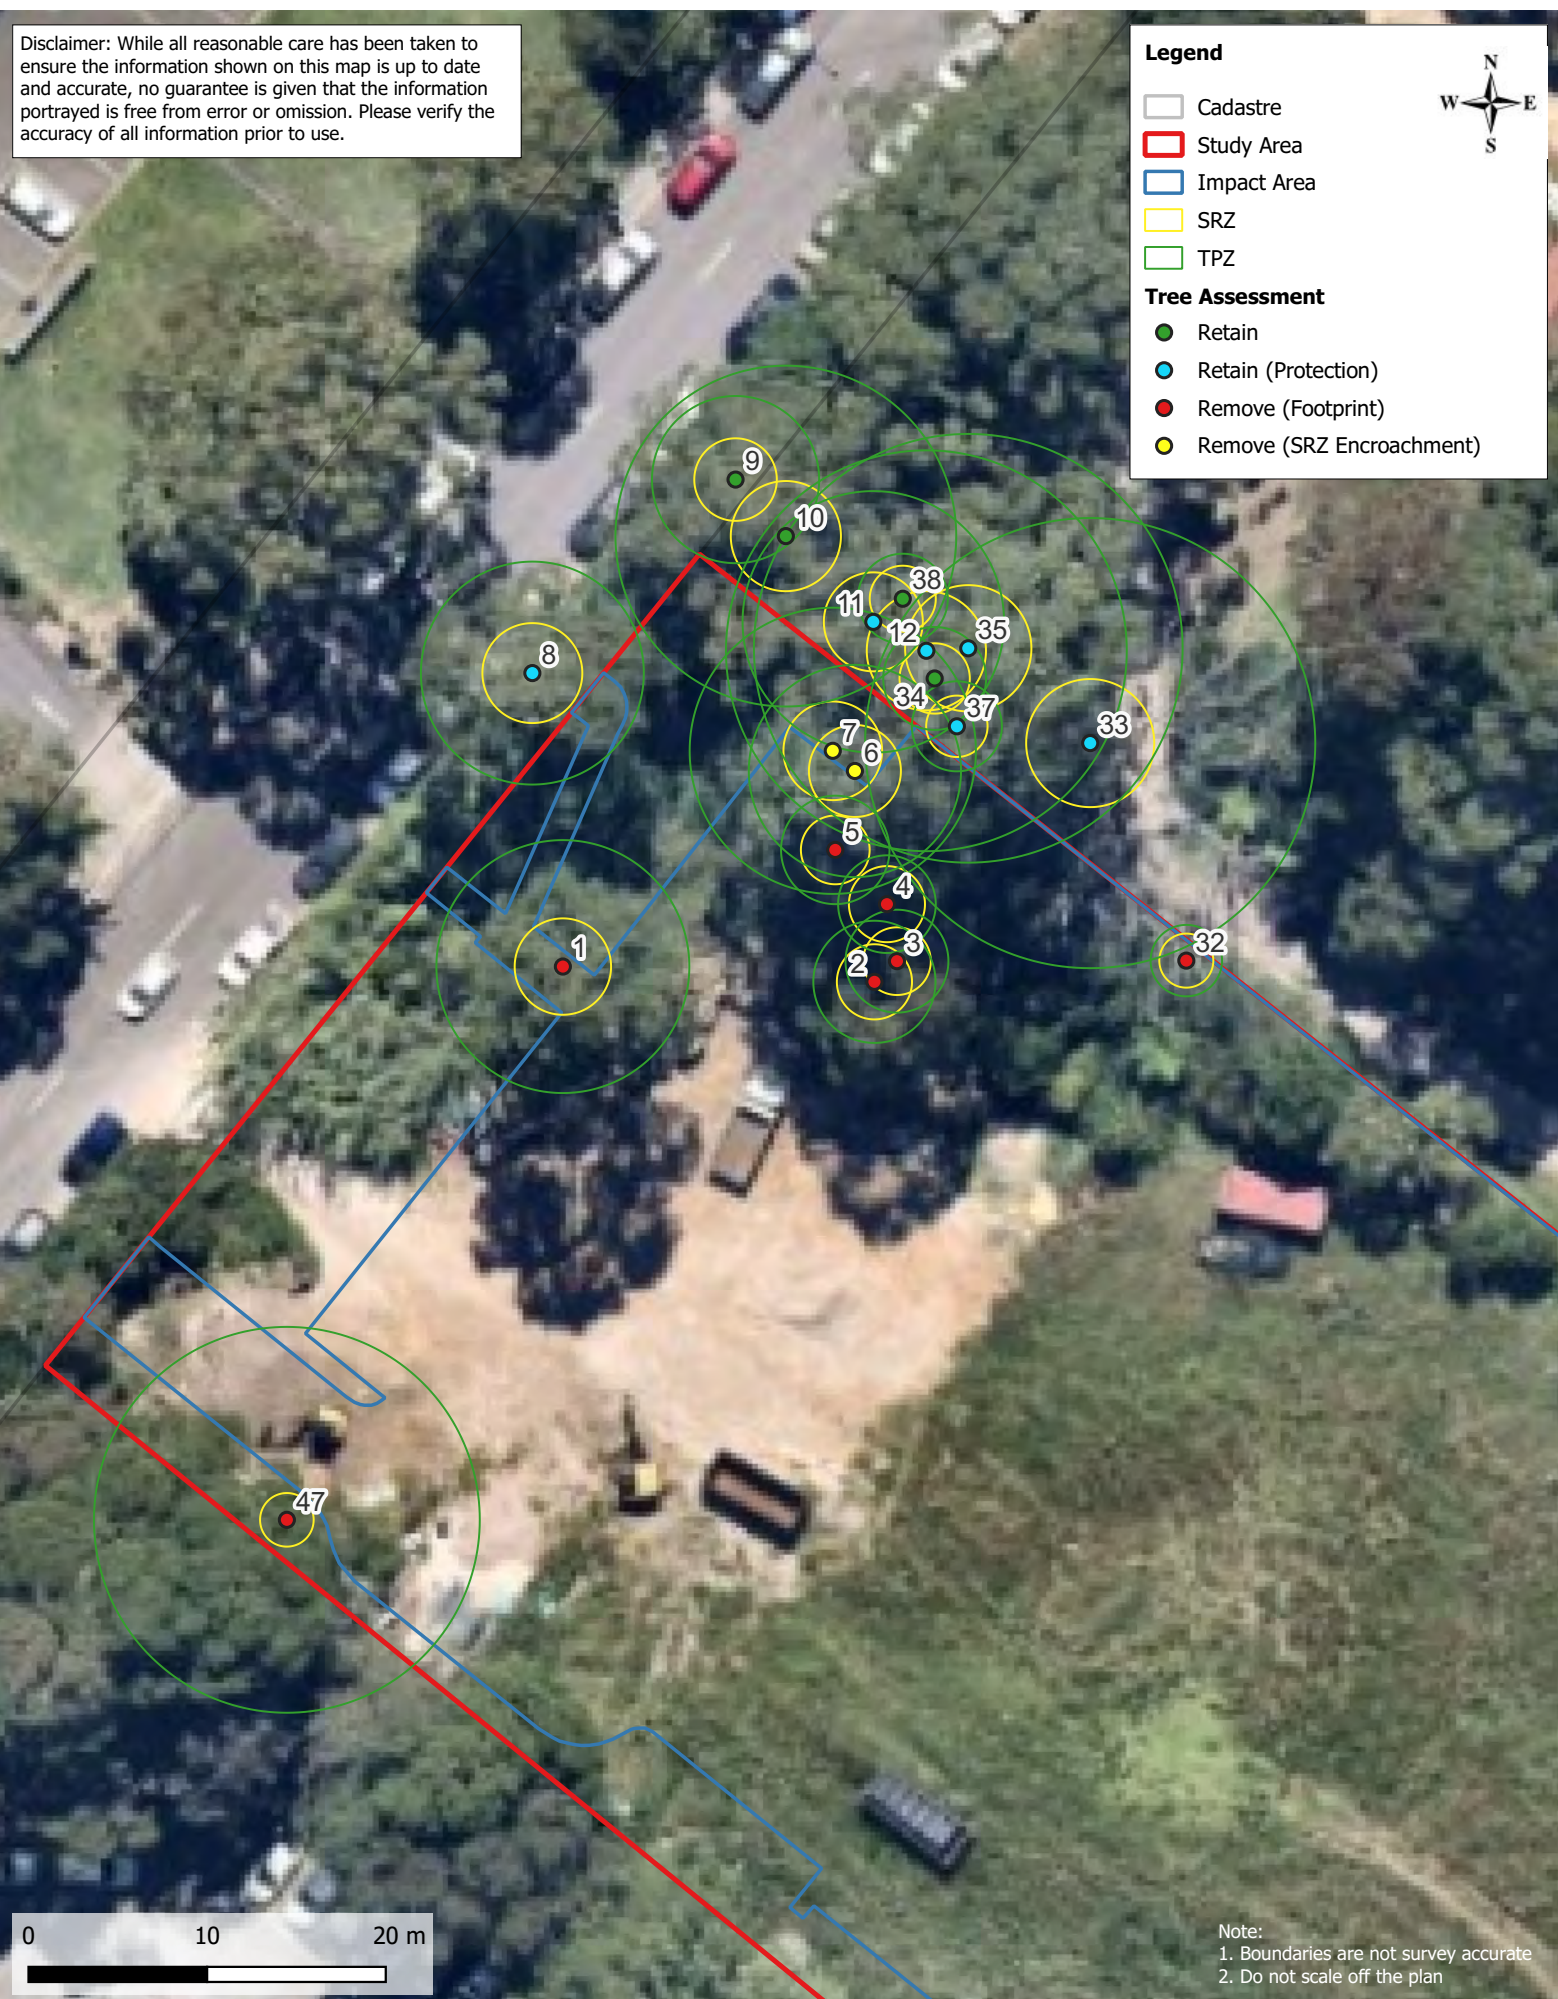
Figure 5 - Tree Assessment (West)

- Tree 33, (located north on the adjacent property), has a predicted major encroachment (~22%) by the development, however, the TPZ of this tree can be feasibly offset into unimpacted areas and these trees should be retained. This tree is over-mature and in Poor Health condition with signs of retrenchment, and this encroachment is therefore unlikely to change the Health Condition of this tree. Project Arborist supervision of works within close proximity to the fence line should occur to ensure that tree stability is not impacted by impacts to large roots. If TPZ fencing as displayed in Figure 7 is impractical for construction works for these trees, ground protection measures such as rumble boards must be installed for the duration of works with the encroached TPZ of these trees.
