## ***Arboriculture Impact Assessment with Site-Specific Preliminary Tree Plan of Management***

**August 2024**

**90 Cabbage Tree Road Bayview NSW 2104**

**Prepared by: Kyle A Hill**

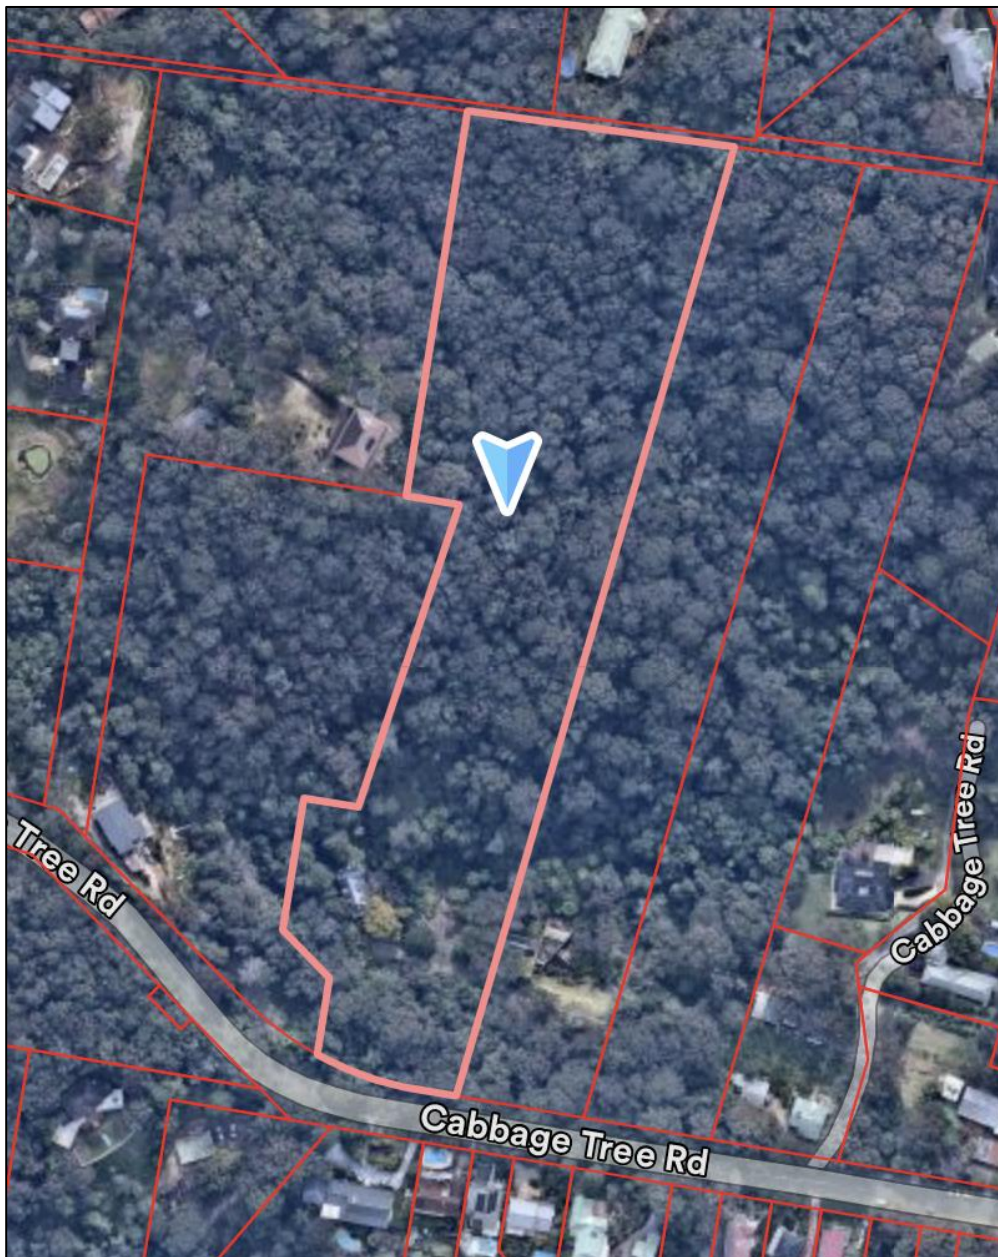
FIGURE 1: ABOVE ILLUSTRATES THE DISCUSSED TREE RELATIVE TO THE SITE 90 CABBAGE TREE ROAD BAYVIEW NSW 2104. (AERIAL PHOTOGRAPH FROM SUNDAY 04 AUGUST 2024, MAP DATA COURTESY OF NEARMAP™)

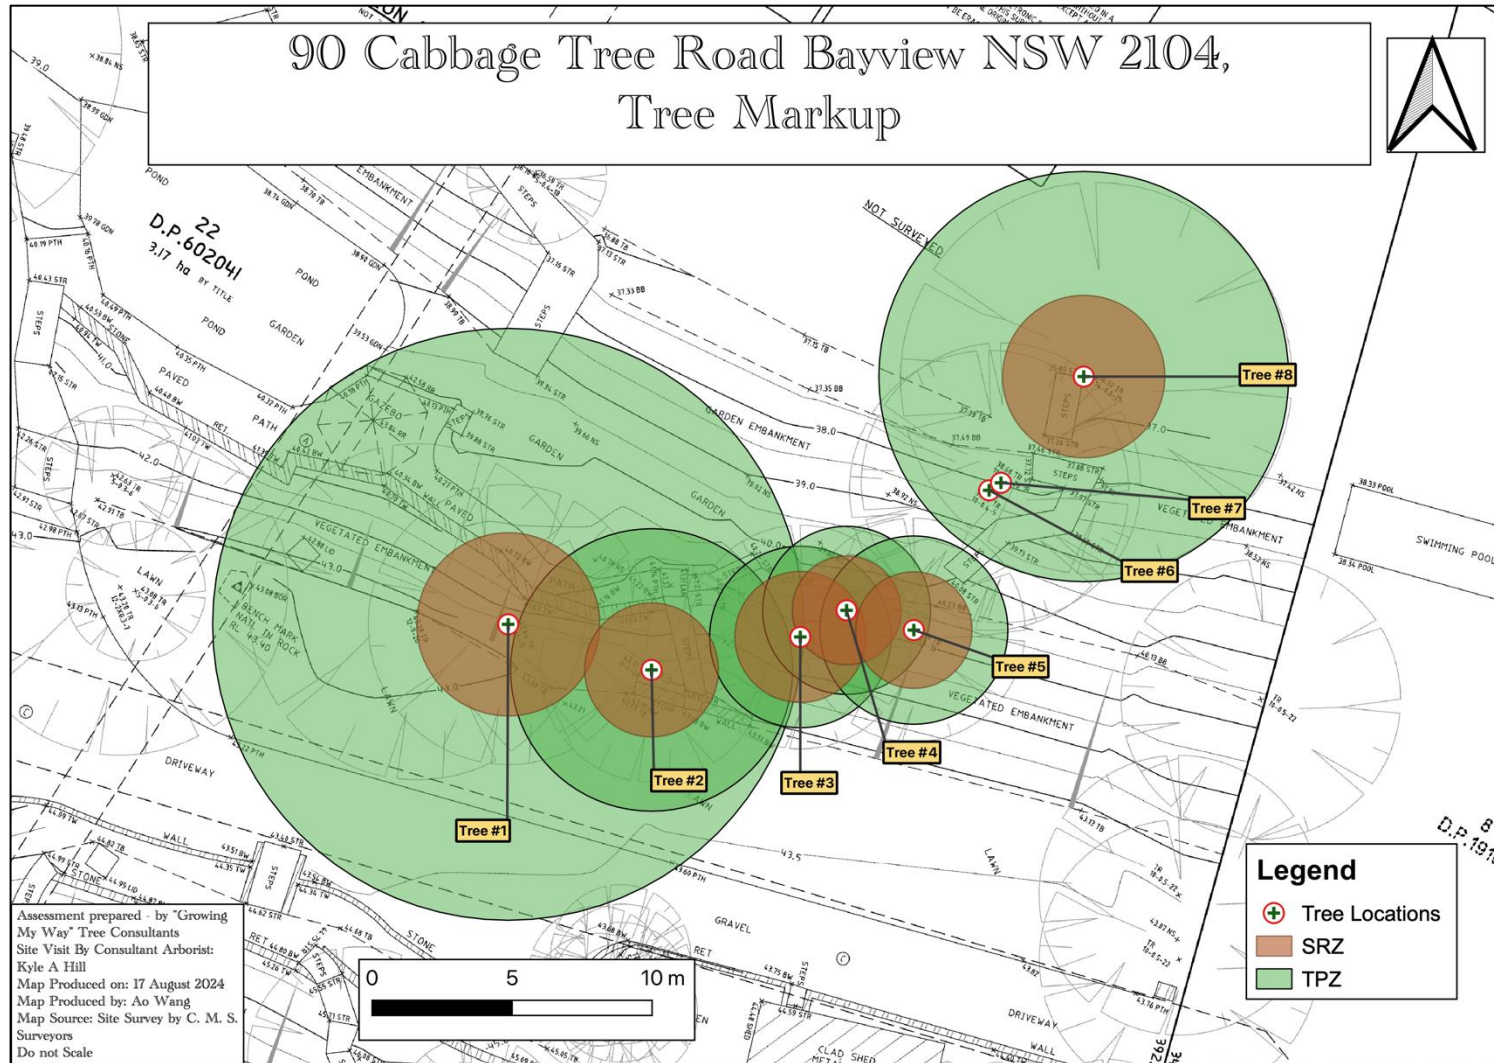
FIGURE 6: NUMBER AND LOCATION OF THE TREE ON SUBJECT SITE. (BY QGIS)
