Report Title: Geotechnical Report 114 Grandview Drive, Newport
Report Date: 23/2/21
Author: BEN WHITE
Author's Company/Organisation: WHITE GEOTECHNICAL GROUP PTY LTD

GEOTECHNICAL INVESTIGATION:

Alterations and Additions at 114 Grandview Drive, Newport

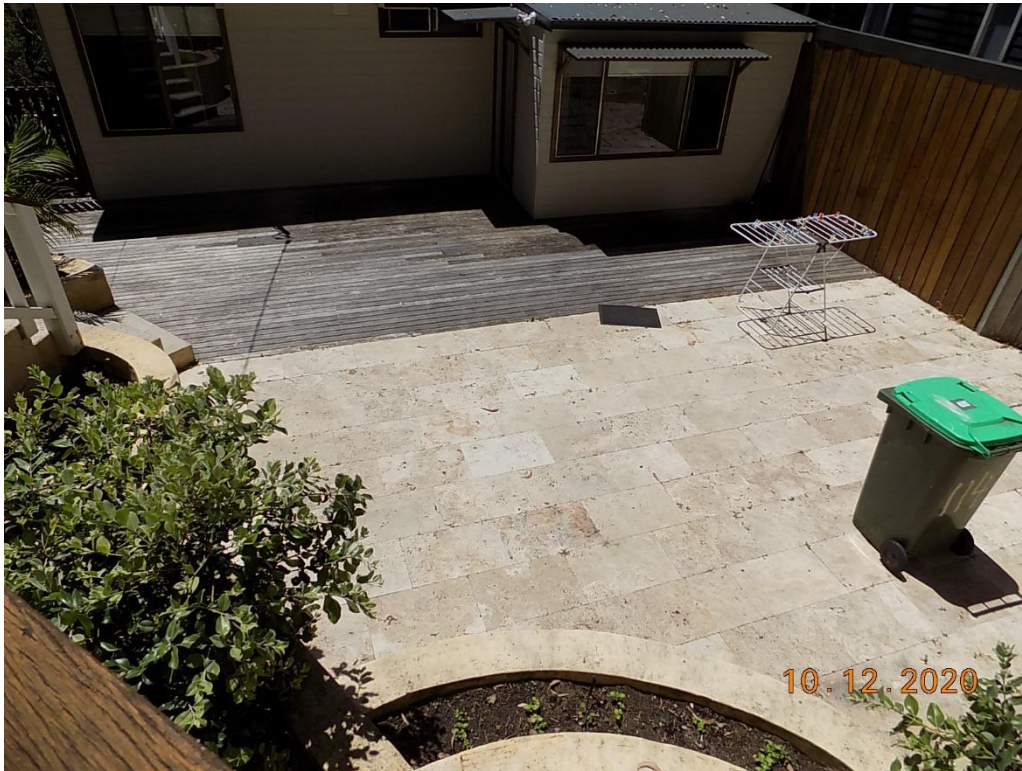
Photo 3

- 2.3** A brick-paved parking area extends directly off the road frontage (Photo 1). The fill for the parking area is supported by two stepped retaining walls (Photo 2). The upper wall is a stable treated timber retaining wall ~0.6m high and the lower wall is a stable ~1.2m high sandstone block retaining wall. An excavation has been made in the slope between the lower wall and the house for a level tile-paved area (Photo 3). This cut is supported by a stable rendered brick retaining wall reaching ~0.6m high. The single-storey timber framed and clad house is supported on vertical steel posts (Photo 4). Some of these posts were built directly off the outcropping Medium Strength Sandstone. A ~3m high sandstone rock face falls under the house (Photo 5).
