## **GEOTECHNICAL INVESTIGATION:**

### **New Boatshed at 1772 Pittwater Road, Bayview**

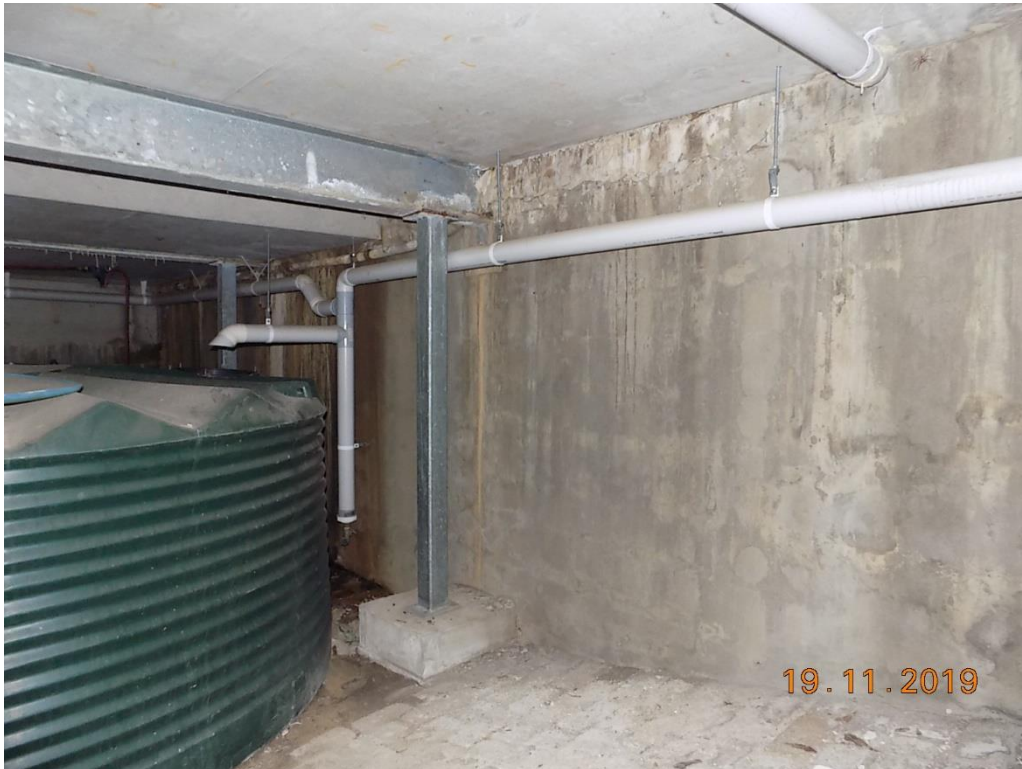
Photo 2

- 2.3** At the road frontage, a concrete driveway runs to a suspended parking platform and lawn area on the uphill side of the property (Photo 1). The platform is supported by steel posts over the old brick driveway (Photo 2). The cut for this sub-floor area is supported by a ~2.0m high stable concrete retaining wall (Photo 3). The part three-storey brick house will be demolished as part of a separate approved application (Photo 4). The cut for the house is supported by a ~5.3m high rendered masonry retaining wall that lines the NW common boundary (Photo 5). A gently sloping lawn-covered fill extends off the downhill side of the house. The fill is supported by a ~1.0m high stack rock retaining wall that will be demolished as part of a separate approved application (Photo 6). To the SE of the fill is a pool that will also
