J4921 30th May, 2023 Page 1.

GEOTECHNICAL INVESTIGATION: New Shared Jetty at 1742 & 1744 Pittwater Road, Bayview

1. Proposed Development

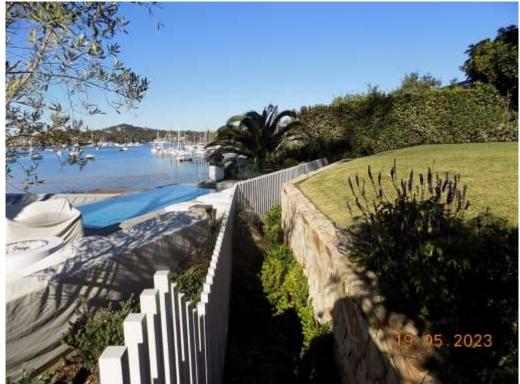
Photo 2

2.3 At the road frontage to 1742 Pittwater Road, a concrete driveway runs to a garage attached to the uphill side of the house and to a carport on the uphill side of the property (Photos 1). The part two-storey framed and clad house is recently constructed and in good condition (Photo 2). A gently sloping lawn extends off the downhill side of the house. A ~1.2m high stone clad retaining wall supports the fill for the lawn area (Photo 3). Immediately below the retaining wall is a pool that has been partially cut into the slope. No significant movement in the pool shell was observed as determined by the water level against the tiles (Photo 4). A ~1.9m high stone clad retaining wall supports a cut for the boatshed and level lawn area (Photo 5). This wall appears to be in good condition. A stable ~2.4m high sandstone block sea wall lines the lower boundary (Photo 6).

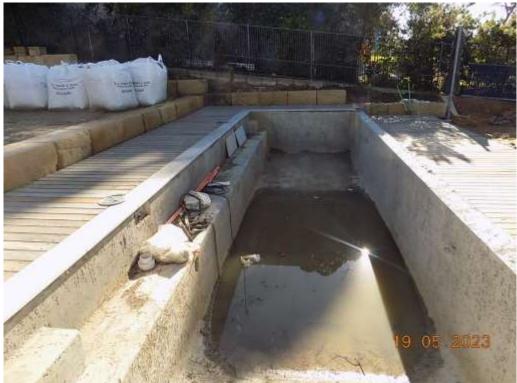
Photo 8

The property at 1744 Pittwater Road is currently undergoing construction (Photo 7). A cut for the lower level of the house is supported by a stable ~1.0m high soldier pile wall that lines the E common boundary (Photo 8). Another gently sloping lawn extends off the downhill side of the house to a pool shell cut into the slope. The pool is still currently being built (Photo 9). The ~1.7m cut for the boatshed is supported by the dincel walls of the boat shed (Photo 10). The fill for the level lawn area at the lower boundary is supported by a low stack rock sea wall (Photo 11).
