Construction Impact & Management Statement for soon to be Lodged Development Application

September 2019, updated April 2020

Site: Lot 1 in DP 308956
34 Hudson Parade
AVALON BEACH, NSW

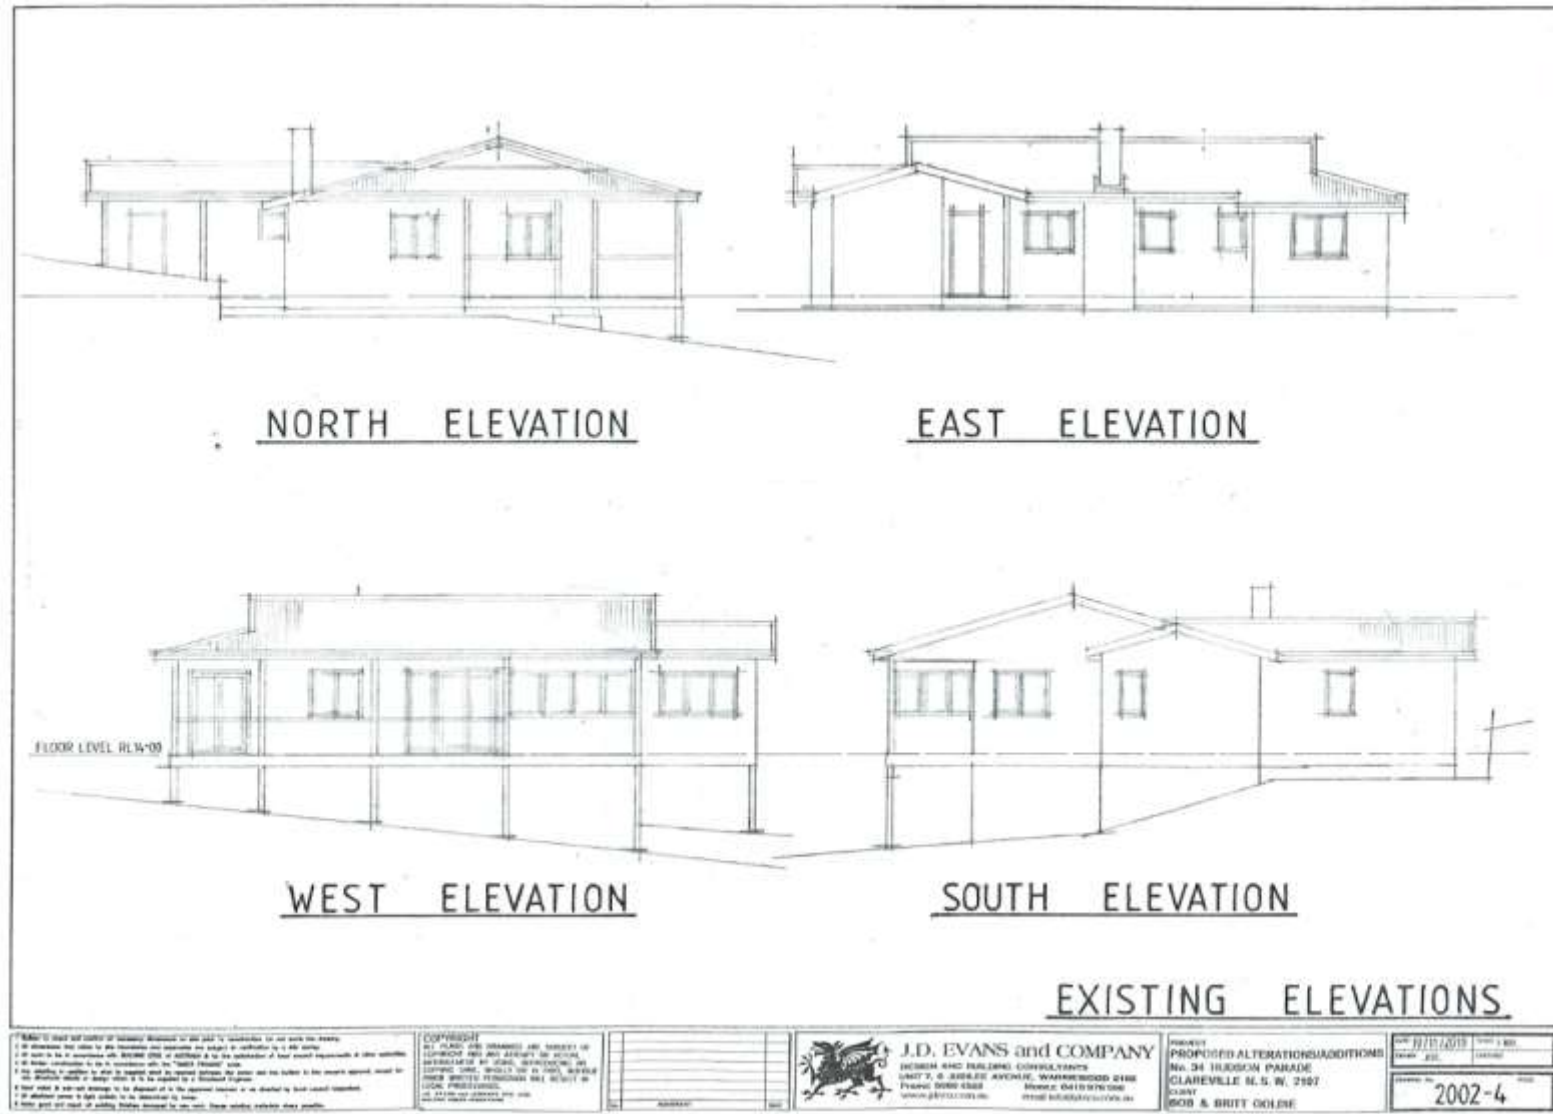
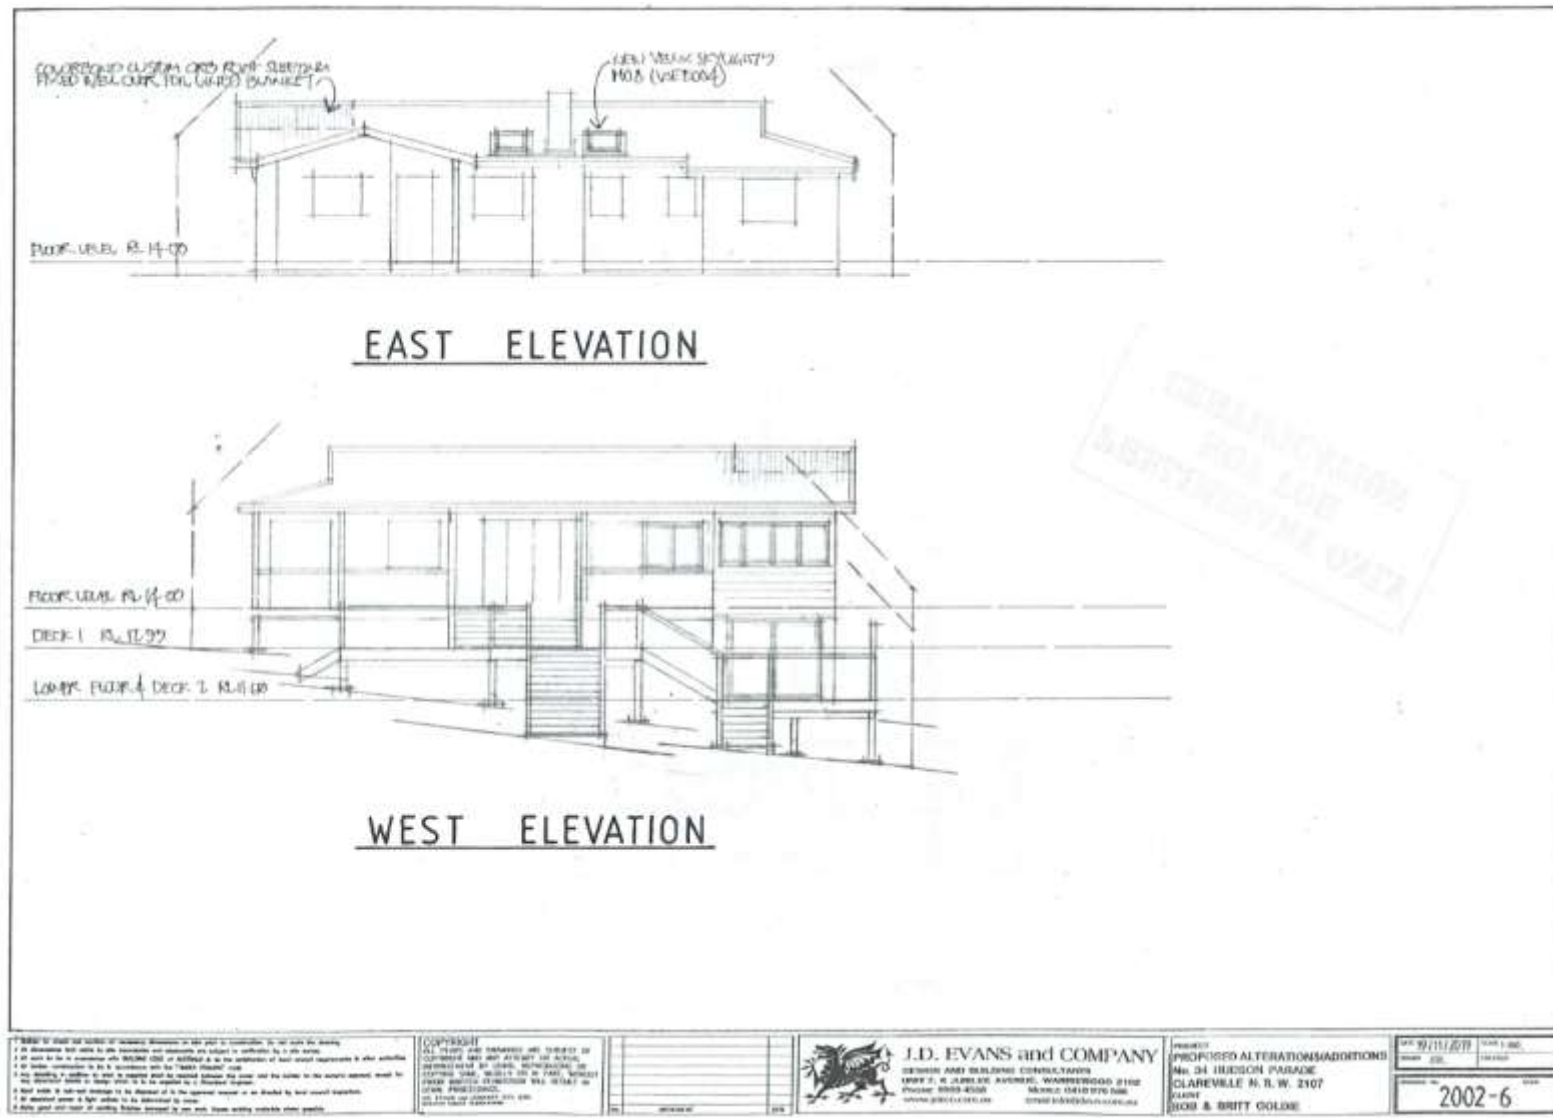
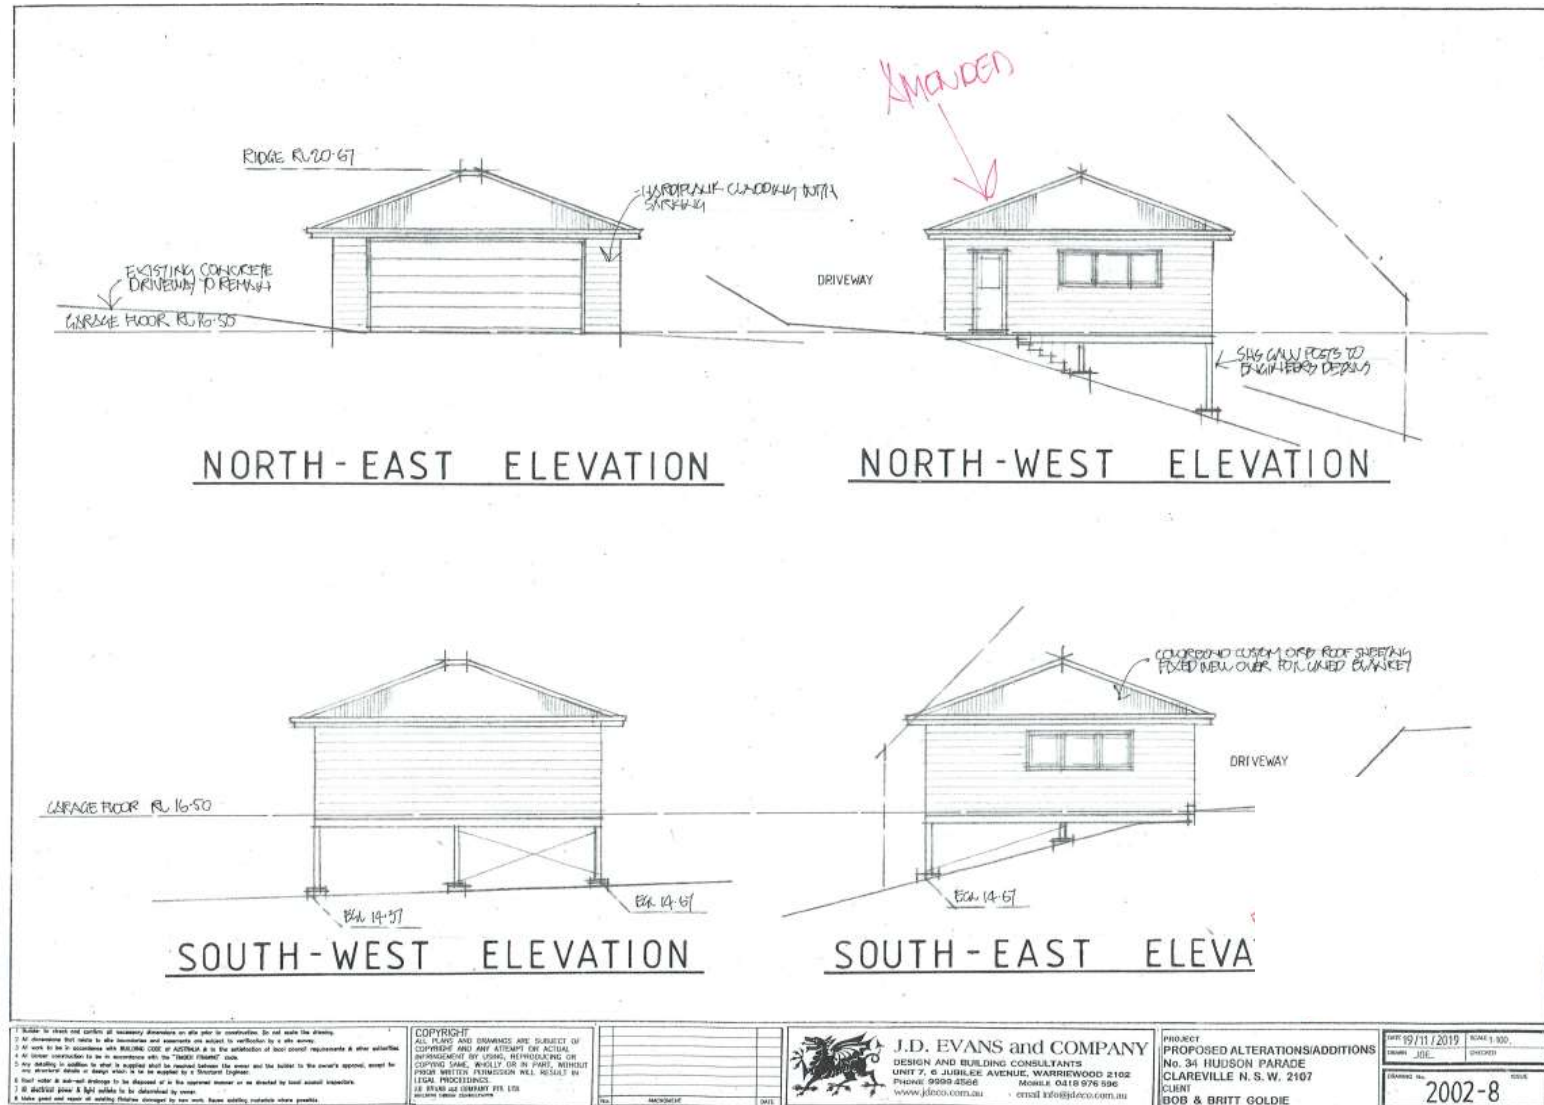
Figure 5: Proposed Residence/Deck-Stairs Elevations (pages 10, 11, 12), Proposed Garage/Home Office Elevations (above).

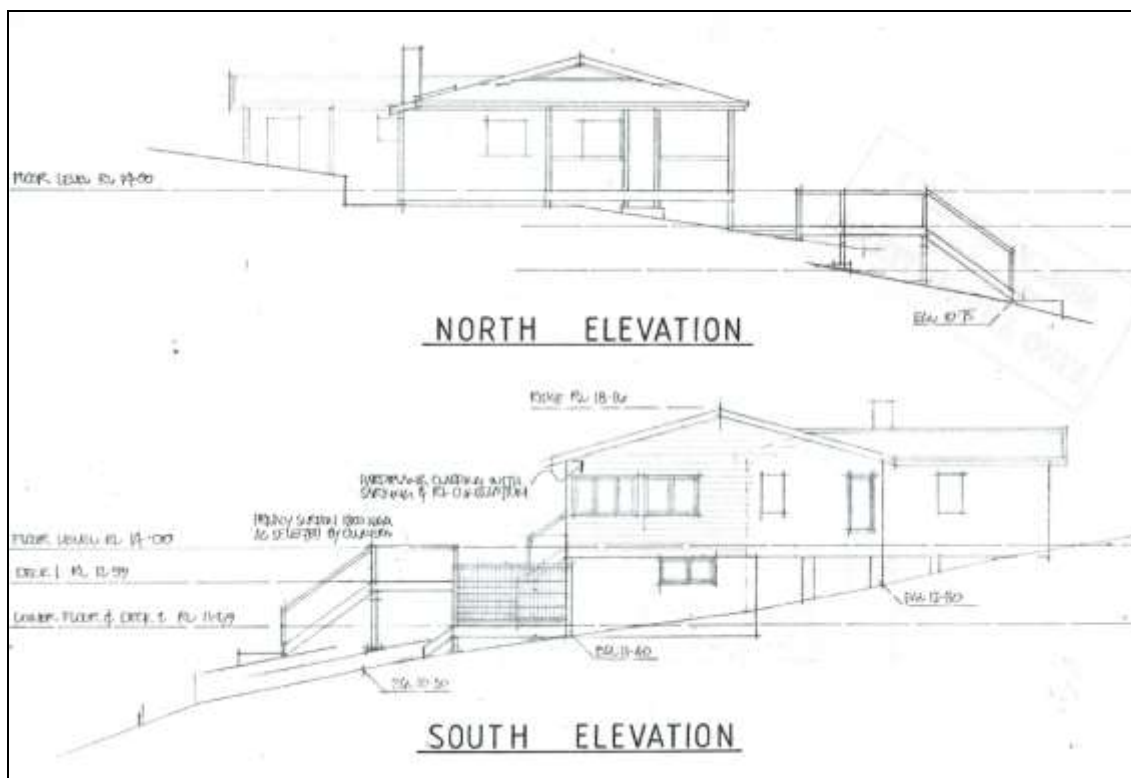
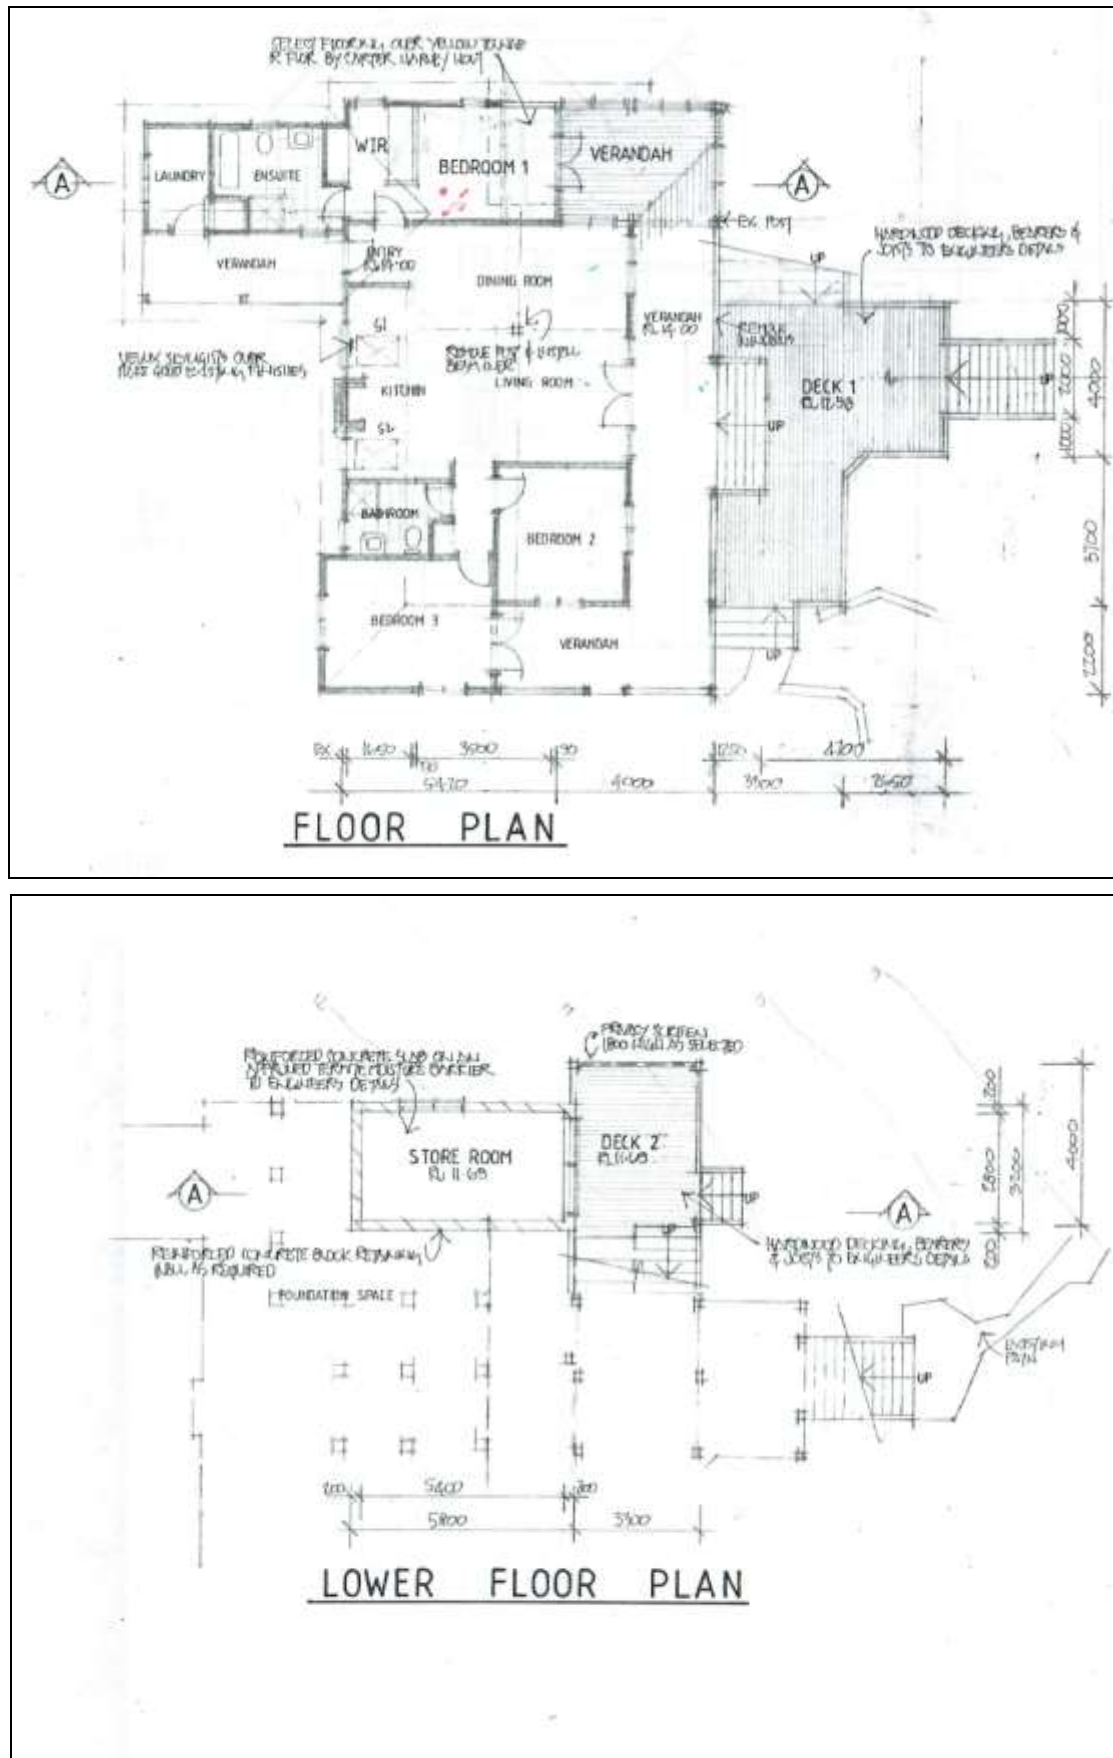
The proposal relative to the existing residence as interpreted from drawings provided by JD Evans & Company, see pages 10 thru 13 requires only the removal/replacement of one (1) tree, (Tree #8). The reason for its proposed removal/replacement is a new veranda for the lower level floor & an extension to the existing veranda (main floor of the residence) are proposed. The waterfront face of the residence is additionally confirmed to have a new deck, lower than the main floor veranda level constructed with two (2) new stairs linking to the main floor level & pathway to the waterfront.

Figure 12: Above & previous page Illustrates the proposed works North/South Elevations & Floor plans for the residence. See page 13 for Garage/Home Office Elevations.
