ARBORICULTURAL IMPACT ASSESSMENT REPORT

90 Cabbage Tree Road, Bayview

24th August 2021

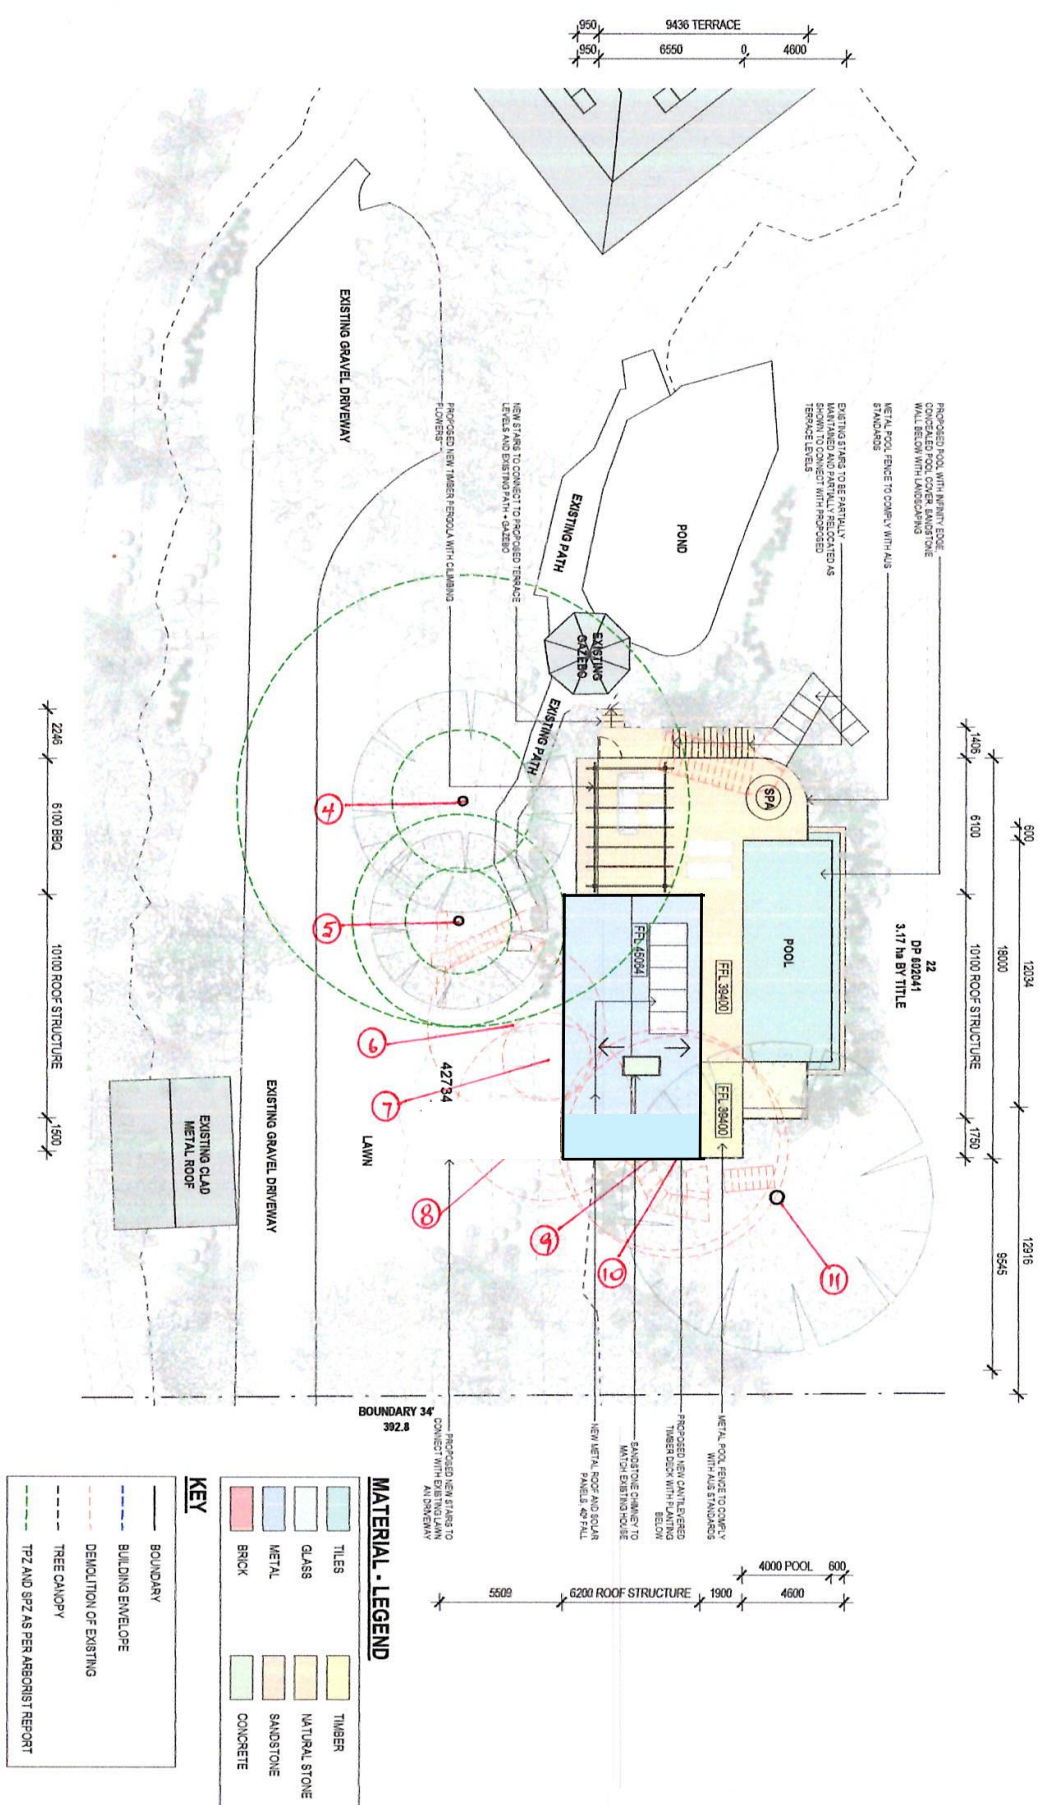
Annexure C: Tree impact plan

Tree 8 is showing good form and condition, however being within the proposed development (refer Annexure C), removal is required – refer plate 4.
