Report Title: Geotechnical Report 40 Bilwara Avenue Bilgola Plateau

Report Date: 3/7/20

GEOTECHNICAL INVESTIGATION:

Alterations and Additions at **40 Bilwara Avenue, Bilgola Plateau.**

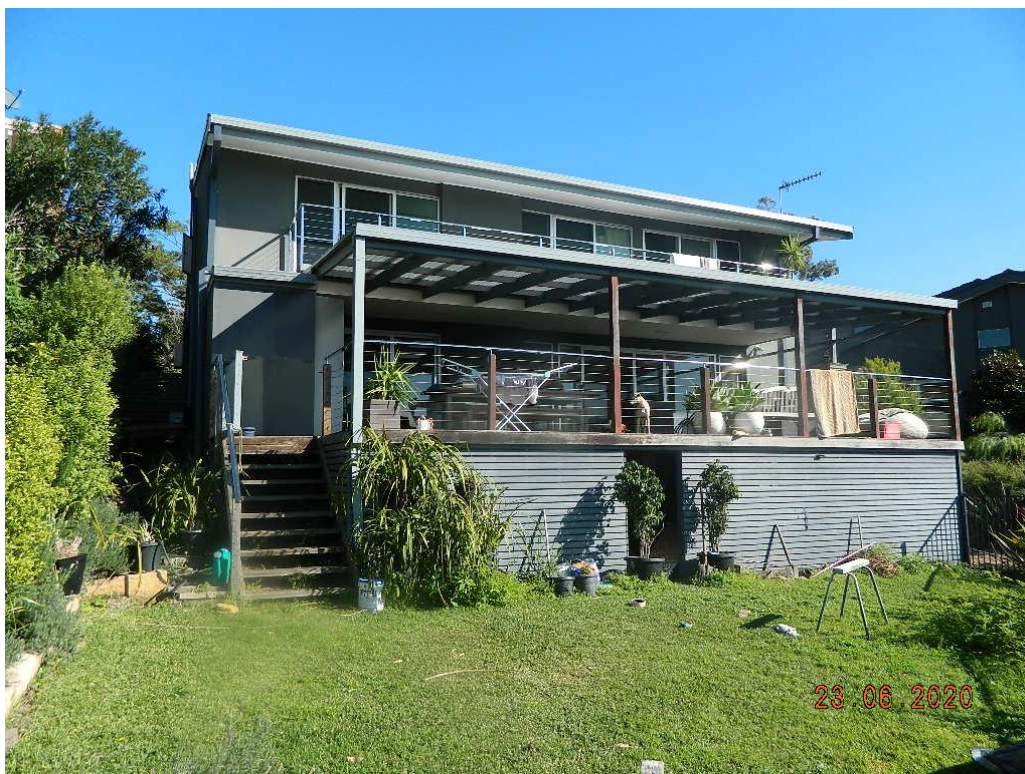
Photo 1

- 2.3** At the road frontage a concrete driveway runs to the existing house (Photo 1). The cut for the driveway and house is supported by stable low sandstone block and concrete block retaining walls. The two storey rendered brick house is supported by brick walls and brick piers (Photos 1 & 2). The supporting walls and piers stand vertical and show no significant signs of movement (Photo 3). A timber deck extends off the downhill side of the house and will be replaced as part of the proposed works (Photo 2). Fill provides level lawn areas on the downhill side of the house (Photos 4 & 5). The fill is supported by stable low sandstone block and sandstone stack
