REPORT ON GEOTECHNICAL SITE INVESTIGATION

EXISTING SITE CONDITIONS

98 OLD PITTWATER ROAD, BROOKVALE, NSW

Project No.: 2019-228 July, 2020

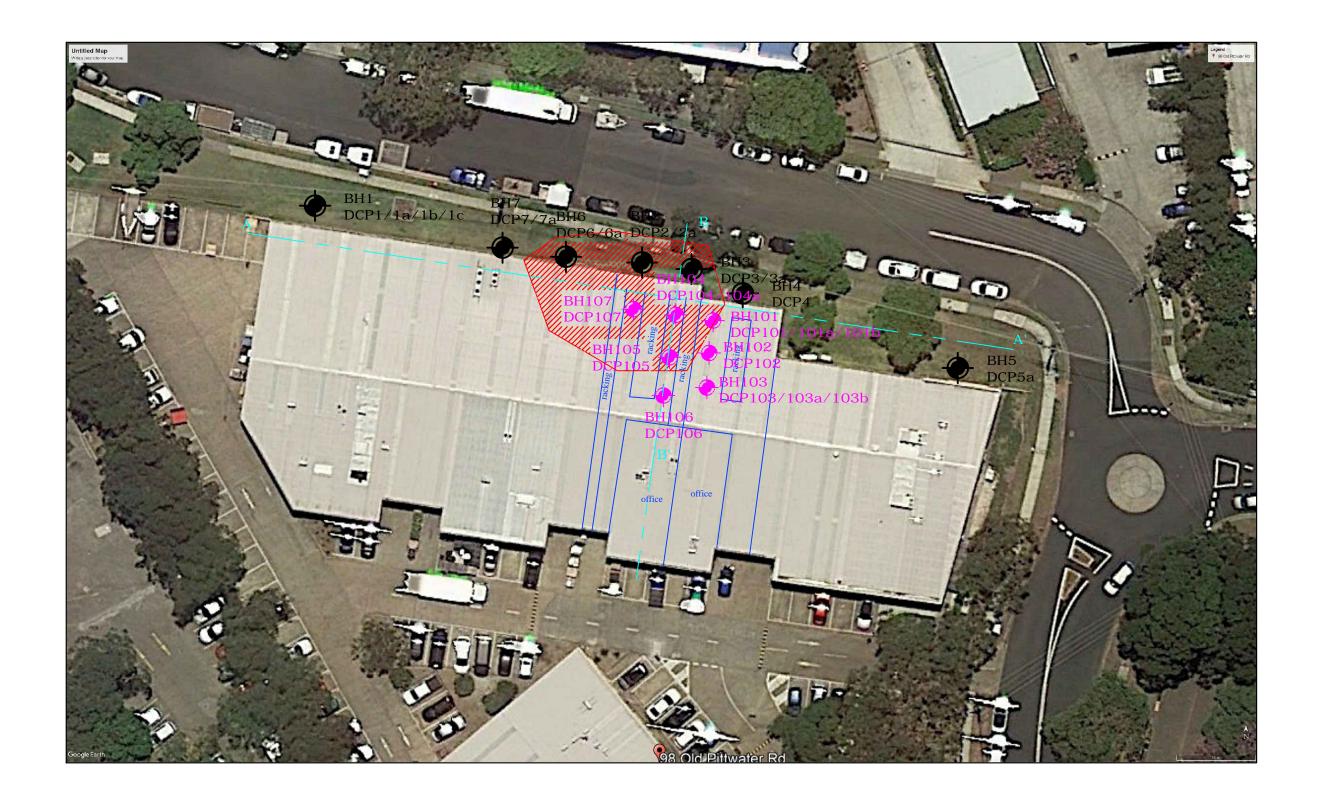
In the western portion of the site, the superficial soils below the fill are generally loose to medium dense sand and firm to stiff clay, in the eastern portion, they are medium dense to very dense sand with hard clay bands.

However, in the centre portion of the site (Unit 2, Unit 3 and part of Unit 4), the superficial soils comprise very loose to loose wet silty sand to the north of the northern external wall of the site building to at least

4.20m depth. A layer of highly compressible organic clay/peat was encountered below the superficial soils to the south of the wall, from varying depths between 2.50m (BH107) and 3.70m (BH101) to maximum investigation depth at 5.50m, and also below the very loose silty sand in BH3.

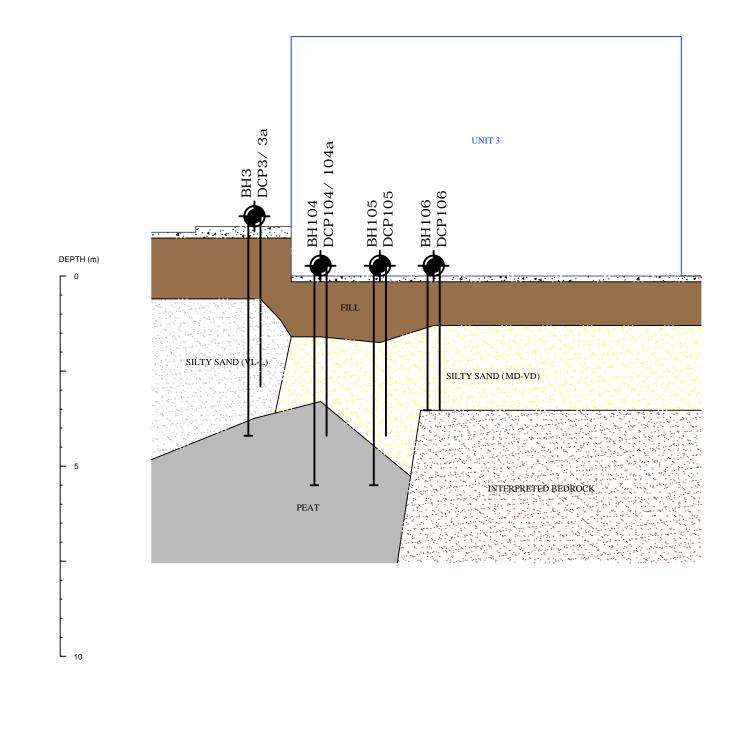
FIGURE 2.

Considering that the settlement and cracking is occurring mostly in the centre north of the building and that relatively shallow bedrock was interpreted underlying the south of the building, it is expected that differential settlement between the very loose wet silty sand and organic clay/peat and shallow soil above bedrock is the primary cause of the excess cracking. This could also explain why the previous attempts to lift slabs and footings by injection system at the north end of the site have been unsuccessful.
