29th January 2025

Addendum B: Arboricultural Impact Assessment Report – 60 Hudson Parade, Clareville, NSW

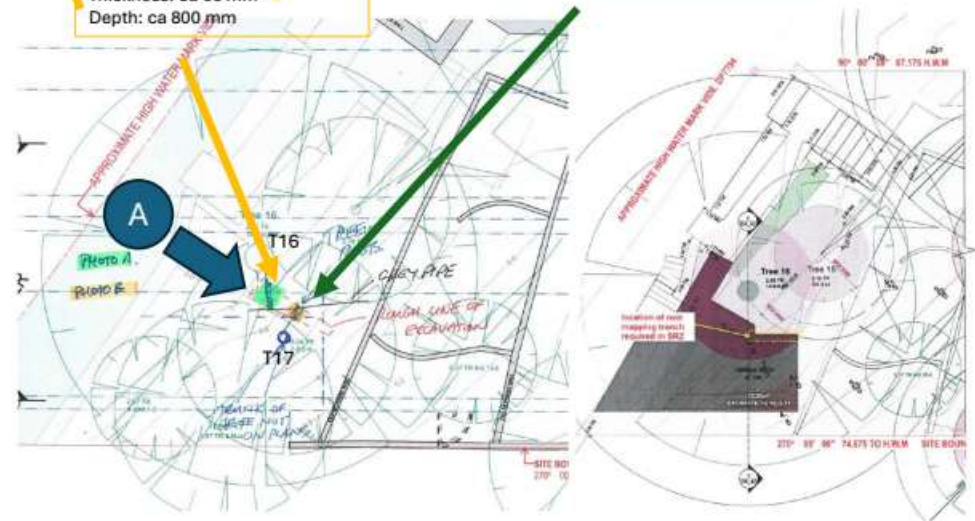
Root mapping results - prepared by Newmark Constructions

Tree root 1 of T16  
 (potentially also of T17)  
 Thickness: ca 60 mm  
 Depth: ca 800 mm

Tree root 2 of T17  
 Thickness: ca 60-70 mm  
 To be removed
