Report Title: Geotechnical Report 7 Crane Lodge Place, Palm Beach
Report Date: 12/6/24

GEOTECHNICAL INVESTIGATION:

Alterations and Additions at 7 Crane Lodge Place, Palm Beach

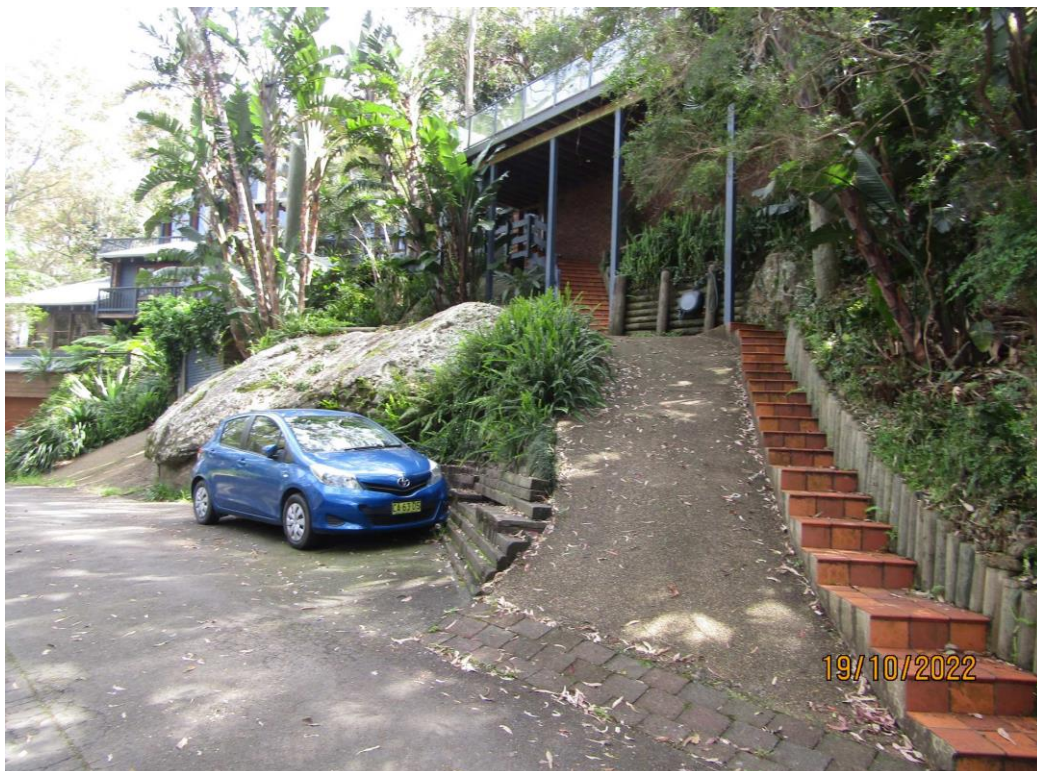
Photo 4

estimated to be ~2m deep. A suspended carport and garage is located on the downhill side of the ROW (Photo 1) and another garage is located on the uphill side (Photo 3). A detached sandstone joint block is located in a stable position beside the upper garage (Photo 4). A concrete driveway runs up the slope to a parking area above the rock (Photos 4 & 5). A cut and fill provides a level platform for the driveway and parking area. The cut and fill is supported by stable timber retaining walls up to ~2.0m high.
