Report Title: Geotechnical Report 7 PACIFIC ROAD, PALM BEACH
Report Date: 1/12/16
Author : BEN WHITE
Author's Company/Organisation : WHITE GEOTECHNICAL GROUP PTY LTD

GEOTECHNICAL INVESTIGATION:

Alterations & Additions at 7 Pacific Road, Palm Beach.

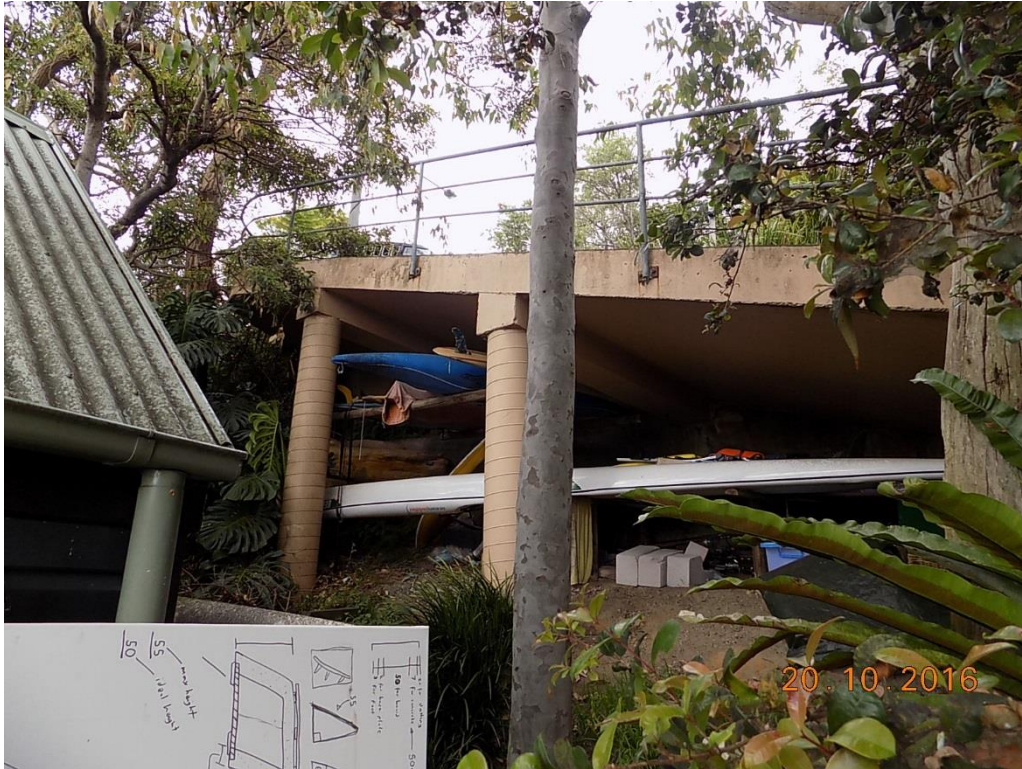
Photo 3

- 2.3 At the road frontage a suspended concrete driveway runs down and across the slope then cuts back 180° to a timber framed and clad garage (Photos 1 & 2). The driveway is supported by concrete piers, some of which can be seen to be founded directly onto medium strength sandstone bedrock (Photo 3). Below the driveway is a steep, densely vegetated slope that has been terraced with three retaining walls (Photo 4). The upper wall is a concrete block wall and the middle wall is a brick wall. Both walls are $\sim 1.0\text{m}$ high and from what could be seen of them through the dense vegetation, they appear stable. The lower wall is a concrete block wall $\sim 1.4\text{m}$ high. It also appears stable and is supported directly onto medium strength sandstone. Below the garage is a densely vegetated slope that falls to the top of a cut made to accommodate the house. The cut is through medium strength sandstone, is $\sim 2.0\text{m}$ high and is considered to be stable (Photo 5). The part three storey brick and timber framed and clad house is in good condition (Photo 6). No significant cracking or movement was observed in its external supporting walls and its supporting concrete piers stand vertical. A tiled patio area extends off the downhill side of the house and around a pool that displays no signs of movement. A lawn covered fill below the house is supported by a timber

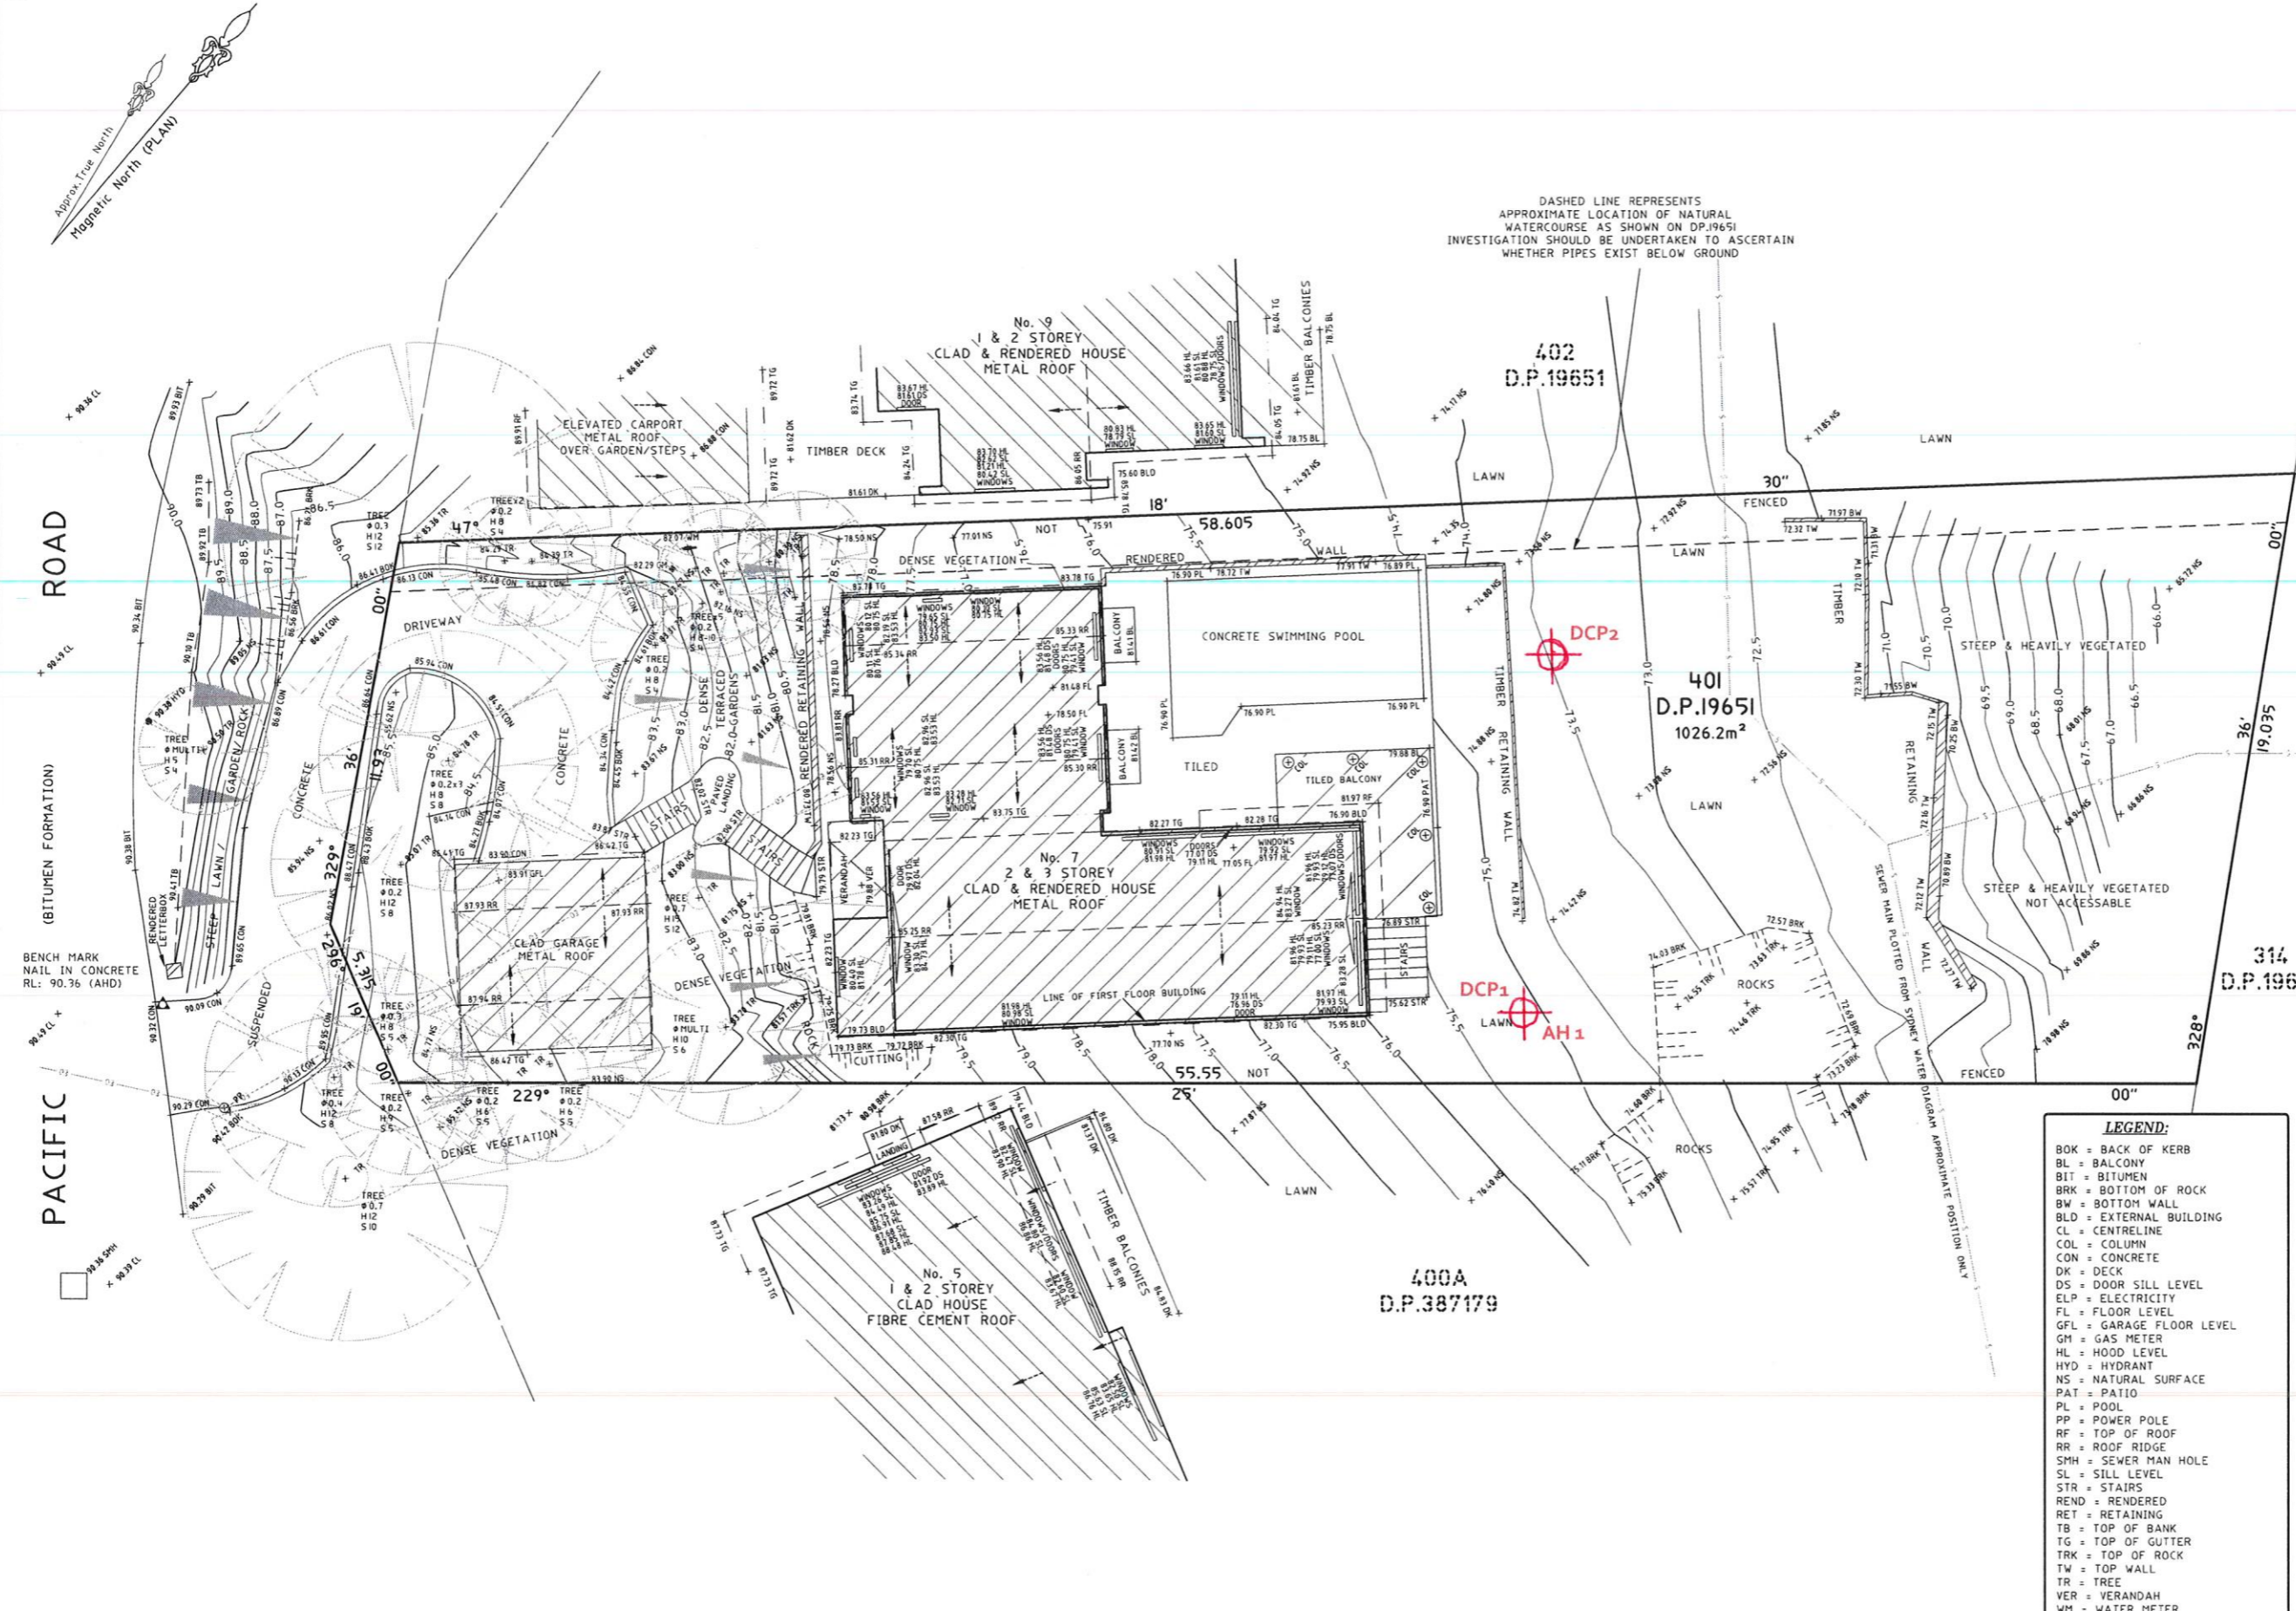
SITE PLAN – showing test locations

DASHED LINE REPRESENTS APPROXIMATE LOCATION OF NATURAL WATERCOURSE AS SHOWN ON DP.19651 INVESTIGATION SHOULD BE UNDERTAKEN TO ASCERTAIN WHETHER PIPES EXIST BELOW GROUND
