**GEOTECHNICAL RISK MANAGEMENT POLICY FOR PITTWATER  
FORM NO. 1 – To be submitted with Development Application**

Report Title: Geotechnical Report <b>29 Calvert Parade, Newport</b>
Report Date: <b>8/1/25</b>
Author: <b>BEN WHITE</b>
Author's Company/Organisation: <b>White Geotechnical Group Pty Ltd</b>

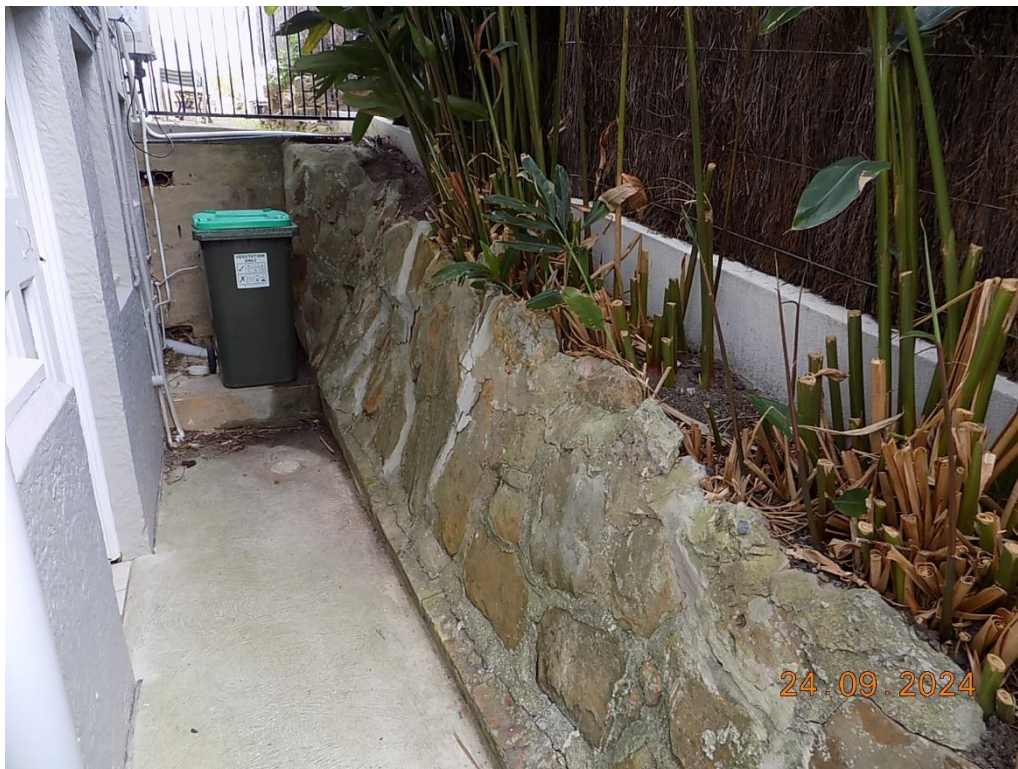
Photo 2

road frontage and the house is supported by stable low mortared sandstone retaining walls. The part two-story rendered brick house is supported on brick walls. A cut for the lower floor of the house is supported by a ~1.5m high mortared sandstone retaining wall (Photo 2) as well as the brick walls of the house. Thin cracking was visible in the supporting walls of the house as well as in the mortared sandstone wall. This cracking is typical in houses of this age and construction. The house walls and the sandstone retaining wall are considered stable. A low brick wall (Photo 3) supports a cut for a level area on the uphill side of the house. The wall was measured to be cracked up to ~4mm in width. However, no deflection was observed and the wall is considered stable. A timber deck has been constructed in this location. The brick piers for the deck stand vertical (Photo 4).

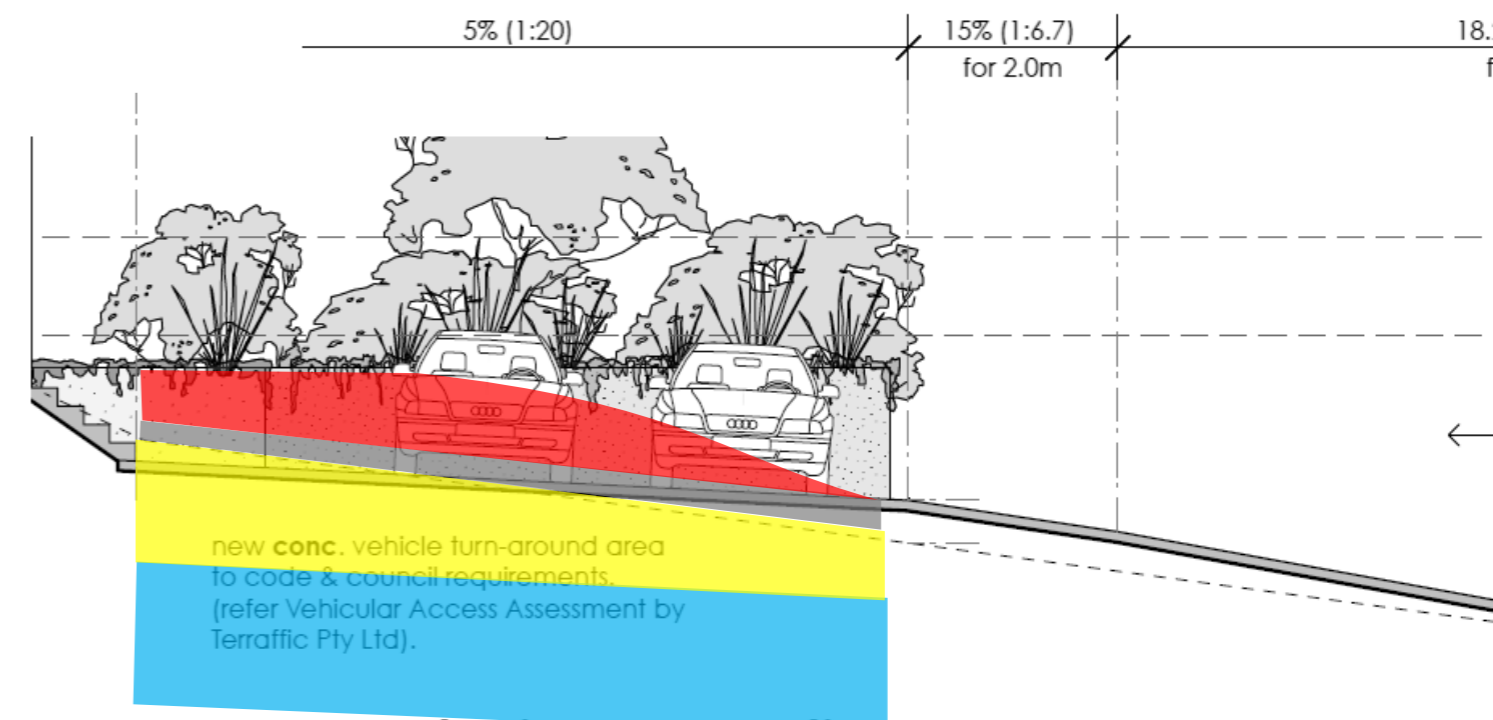
Proposed Driveway Section

new conc. vehicle turn-around area to code & council requirements. (refer Vehicular Access Assessment by Terraffic Pty Ltd).

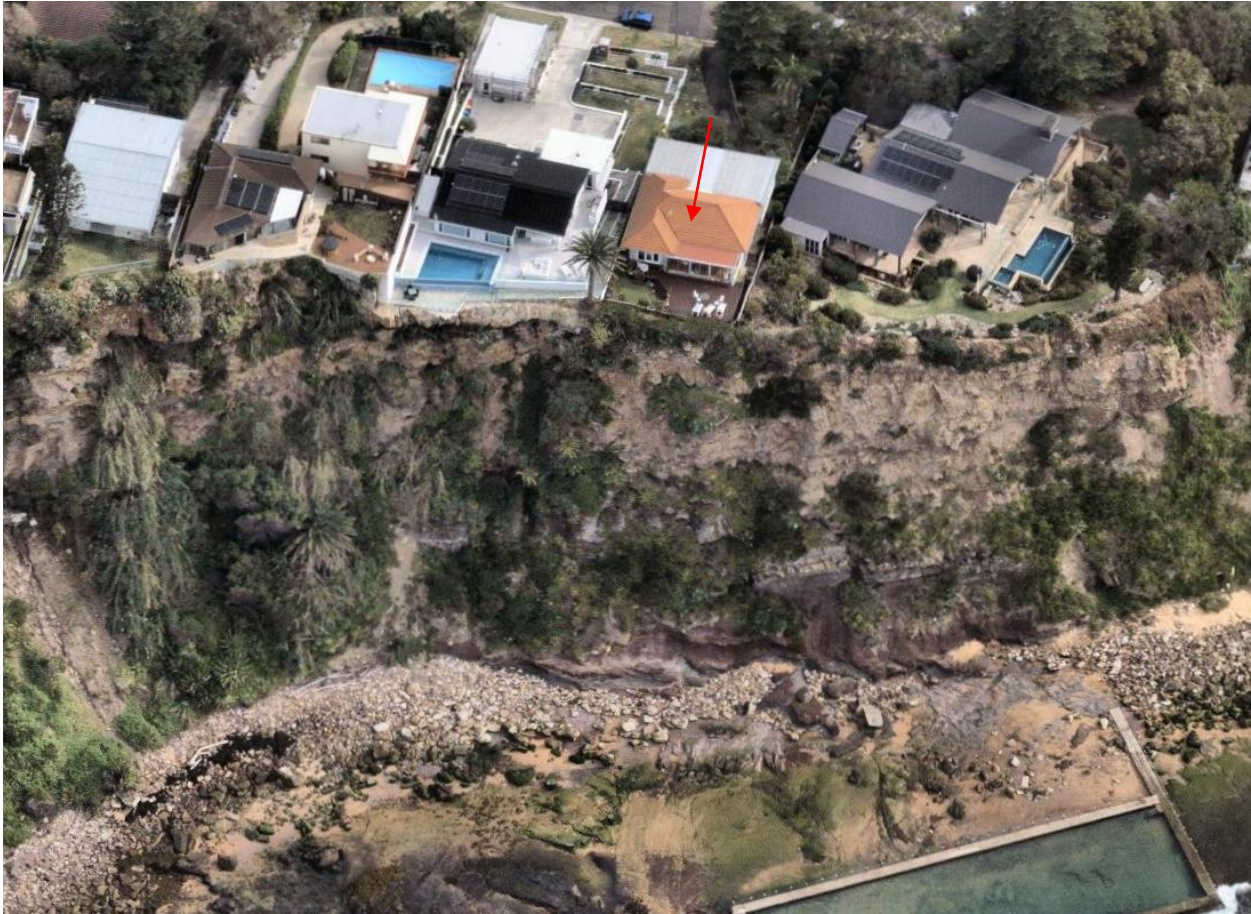
An oblique aerial view of the site (including the cliff and adjacent rock platform) is provided in Figure 2, with a photograph of the cliff at the site (taken from the adjacent rock platform) provided in Figure 3.

**Figure 2: Oblique aerial view of site (at arrow) on 22 July 2024, facing west**
