Report Title: Geotechnical Report 100A Wakehurst Parkway, Elanora Heights
Report Date: 31/8/20

GEOTECHNICAL INVESTIGATION:

New Inclined lift at **100A Wakehurst Parkway, Elanora Heights**

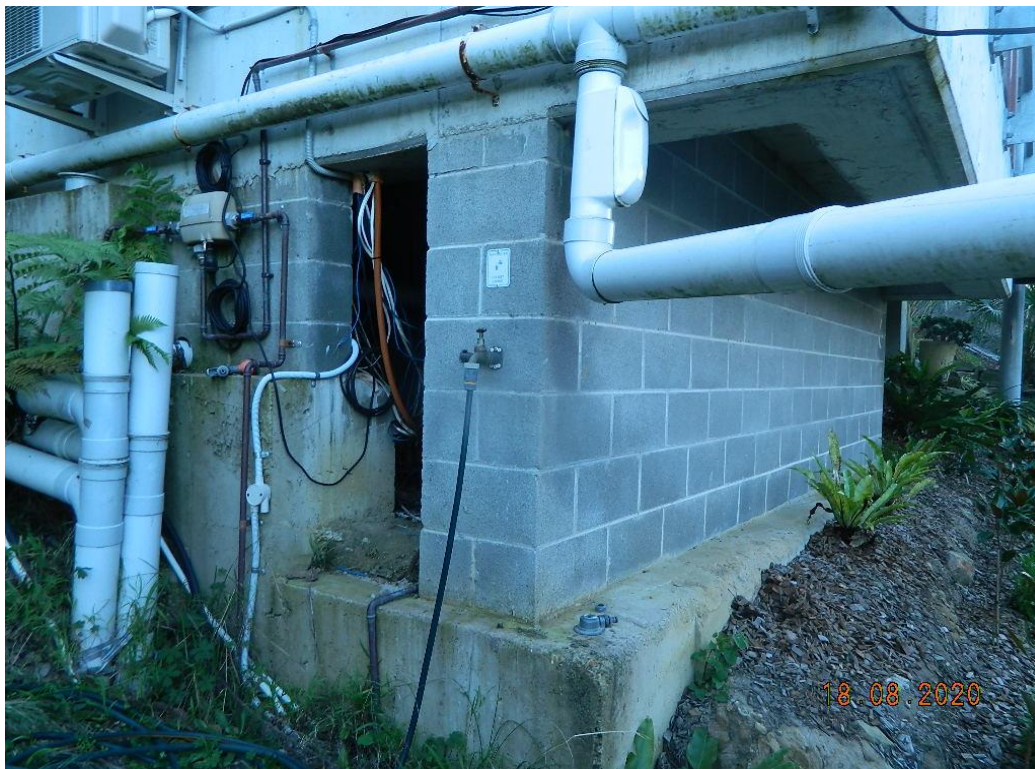
Photo 3

- 2.3** The property is accessed by a concrete right of carriageway (ROW) which runs up the slope to a parking area and garage (Photos 1 & 2). Uphill of the garage is a large sandstone boulder in a stable position (Photo 3). The part three storey concrete and steel clad house is supported by concrete block walls, formed concrete walls and steel posts (Photos 4 & 5). The supporting walls and posts stand vertical and show no significant signs of movement. Each level of the house has been cut into the slope on the uphill side (Photo 6). The cuts are supported by formed concrete retaining walls up to $\sim 2.3\text{m}$ high and in good condition. A suspended timber deck in good condition extends off the E side of the house. Medium Strength Hawkesbury Sandstone bedrock

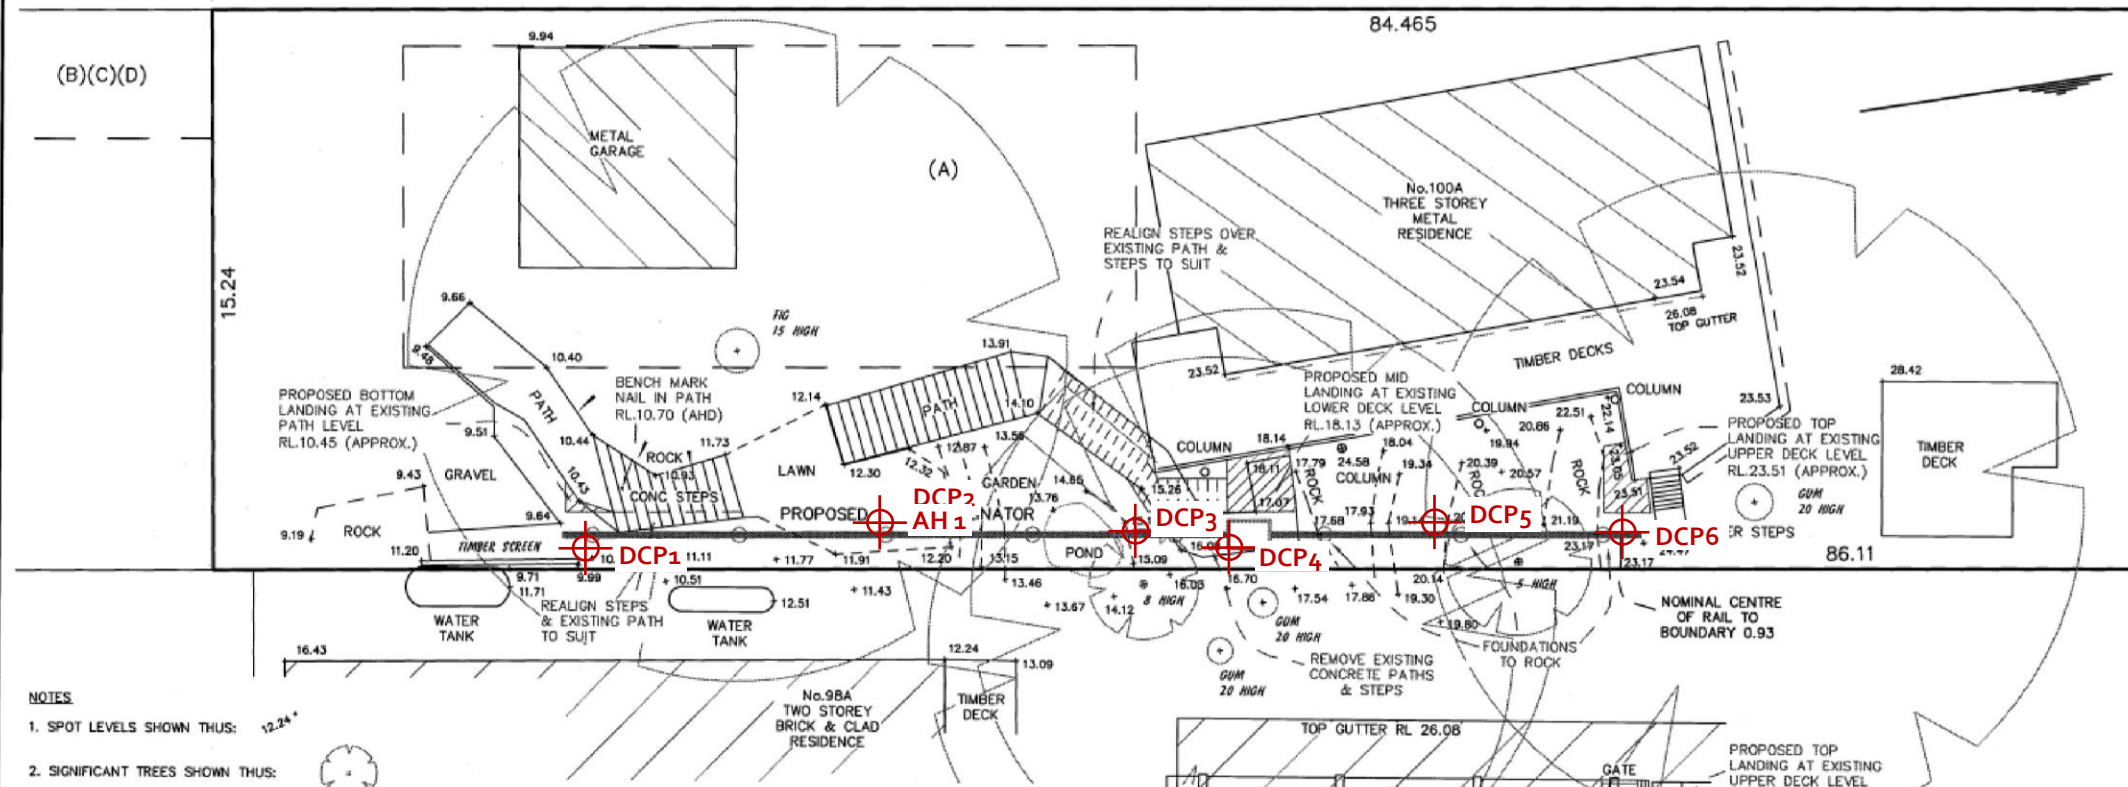
SITE PLAN – showing test locations

DCP4 – Refusal @ 0.2m, white sandstone fragments on moist tip.
