Tree Report

Westfield Warringah Mall

For DEM Australia Pty Ltd

June 2013

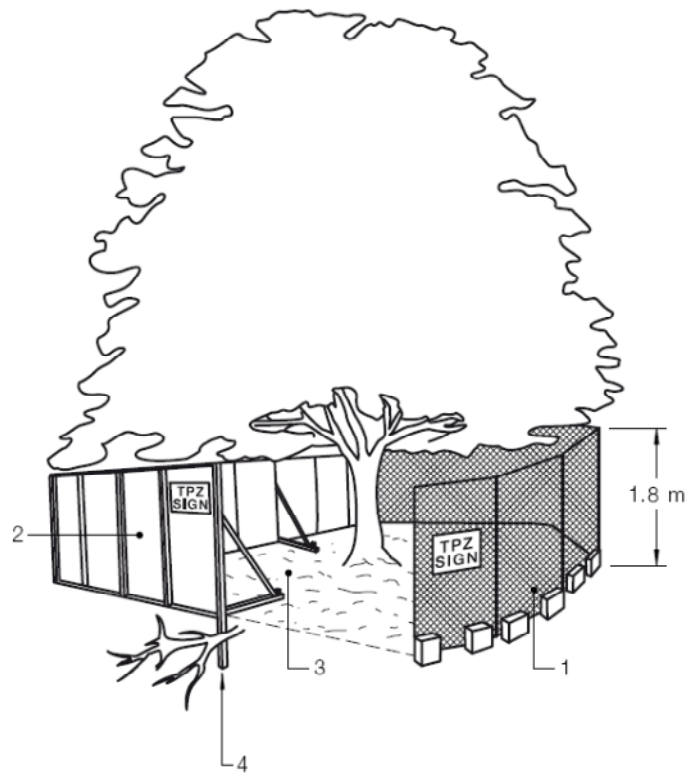
- 1 Chain wire mesh panels with shade cloth (if required) attached, held in place with concrete feet.
- 2 Alternative plywood or wooden paling fence panels. This fencing material also prevents building materials or soil entering the TPZ.
- 3 Mulch installation across surface of TPZ (at the discretion of the project arborist). No excavation, construction activity, grade changes, surface treatment or storage of materials of any kind is permitted within the TPZ.
- 4 Bracing is permissible within the TPZ. Installation of supports should avoid damaging roots.

Guidelines for tree protection are noted in Australian Standard AS4970-2009 *Protection of Trees on Development Sites*. Figures below show fencing, ground protection and scaffold fencing details.

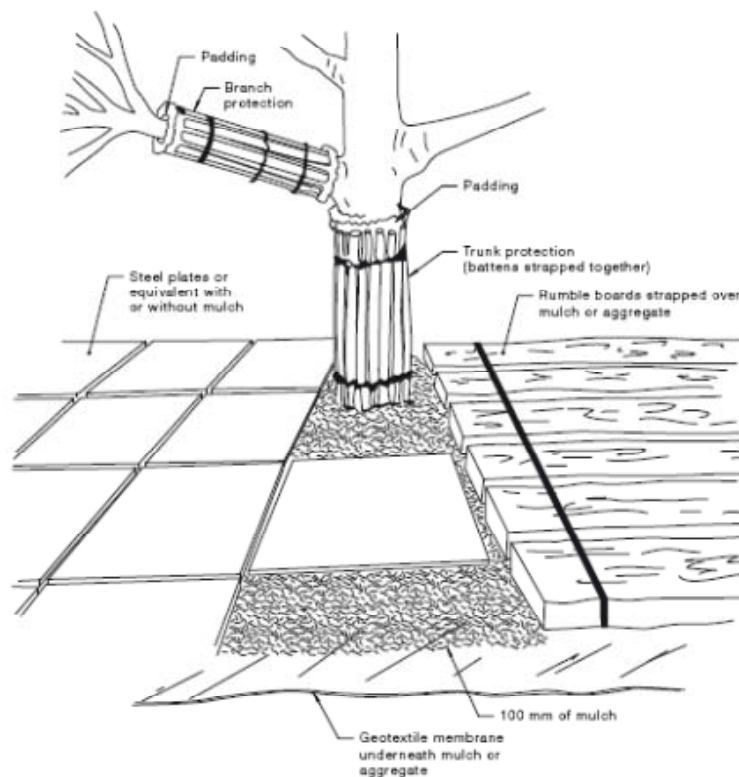
FIGURE 4 EXAMPLES OF TRUNK, BRANCH AND GROUND PROTECTION

- 1 For trunk and branch protection use boards and padding that will prevent damage to bark. Boards are to be strapped to trees, not nailed or screwed.
- 2 Rumble boards should be of a suitable thickness to prevent soil compaction and root damage.

Where necessary, install protection to the trunk and branches of trees as shown in Figure 4. The materials and positioning of protection are to be specified by the project arborist. A minimum height of 2 m is recommended.

If temporary access for machinery is required within the TPZ ground protection measures will be required. The purpose of ground protection is to prevent root damage and soil compaction within the TPZ. Measures may include a permeable membrane such as geotextile fabric beneath a layer of mulch or crushed rock below rumble boards as per Figure 4.

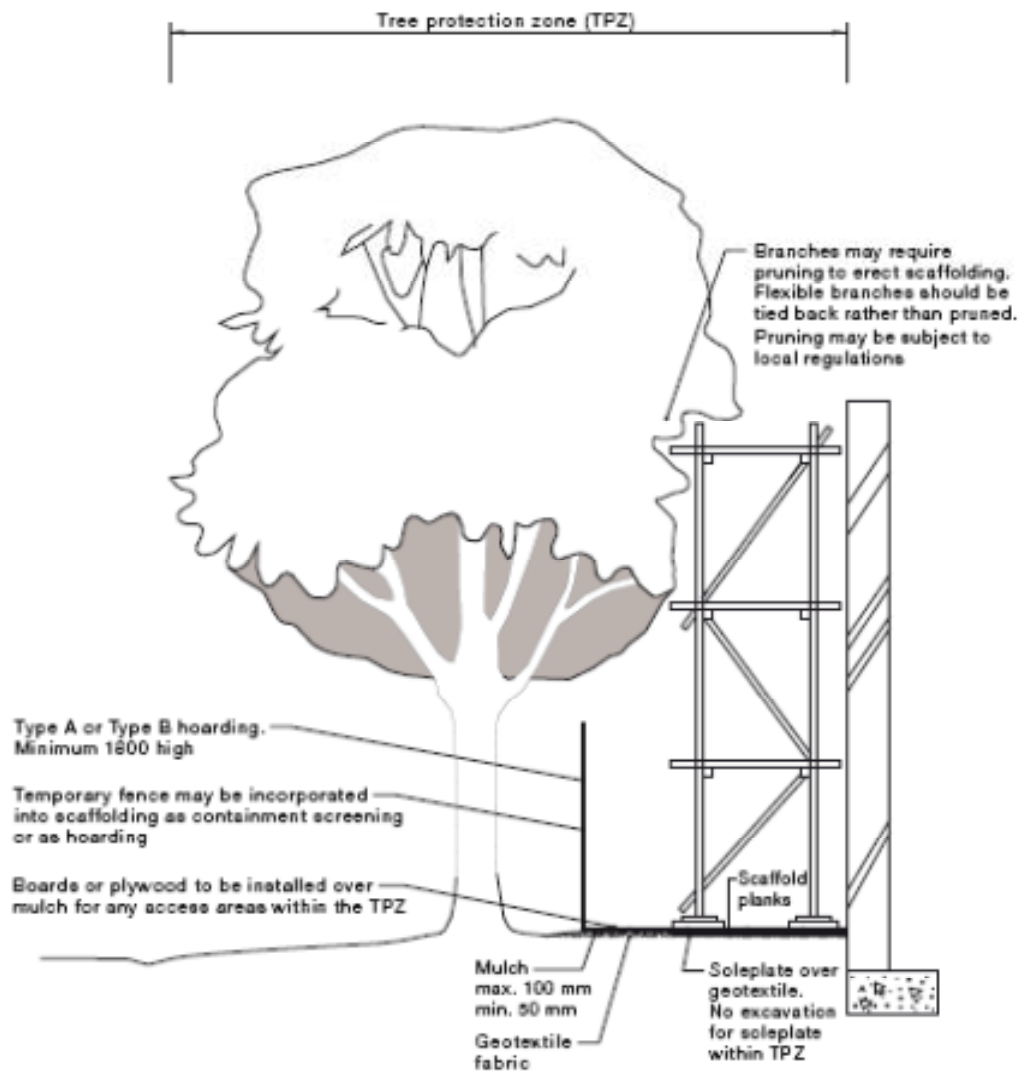
FIGURE 5 INDICATIVE SCAFFOLDING WITHIN A TPZ

NOTE: Excavation required for the insertion of support posts for tree protection fencing should not involve the severance of any roots greater than 20 mm in diameter, without the prior approval of the project arborist.
