Geotechnical Assessment

Project: Alterations & Additions
19 Wandearah Avenue, Avalon Beach NSW

Prepared for:
Arclab Pty Ltd

Ref: AG 24534
6 December 2024

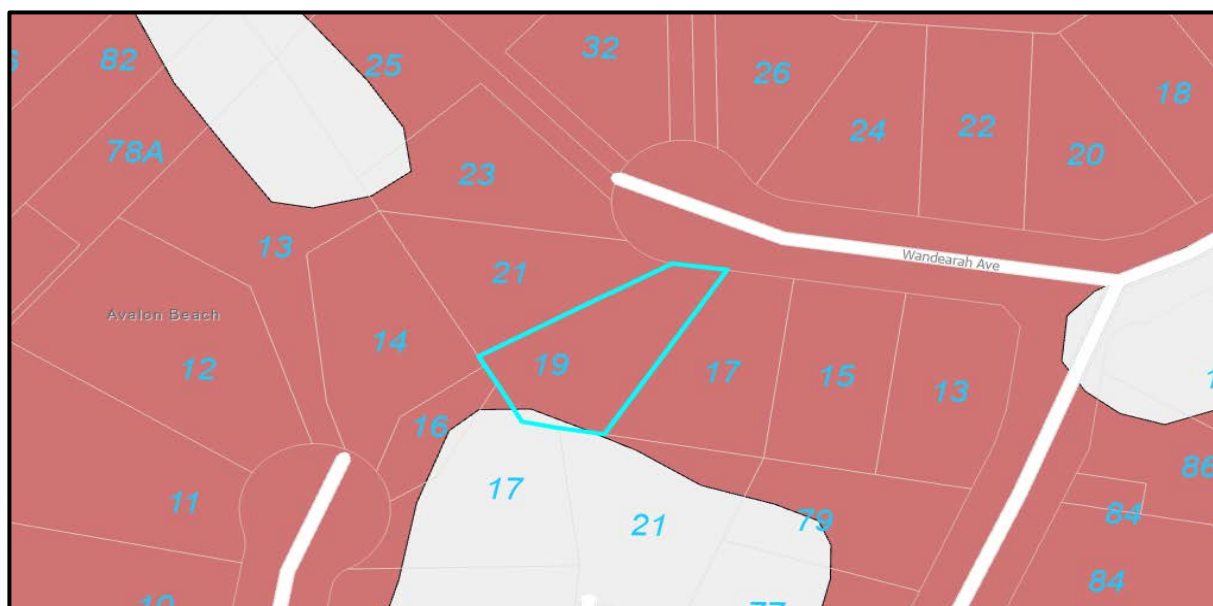
Image 2. PLEP Geotechnical Hazard Map
– 19 Wandearah Avenue, Avalon Beach © NBC Maps

- No evidence of significant soil creep, tension cracks or landslip instability were identified across the site or on adjacent properties as viewed from the subject site at the time of our inspection.
- There are heavily weathered sandstone boulders and semi to fully detached joint blocks at various locations in the slope at the rear existing house. The sandstone boulders may have been originally mobilised by a large-scale historical (>100 years) rockfall/landslip event originating from the Hawkesbury unit above the site.
- Based on reference to the plan entitled "Geotechnical Hazard Mapping" (Ref. P21DCP-BC-MDCP2002, dated 2007) prepared by GHD LONGMAC on behalf of Northern Beaches Council (Pittwater), the site is mapped in a **Geotechnical Hazard H1** zone.
