Report Title: Geotechnical Report 21 Palm Beach Road, Palm Beach

Report Date: 9/4/19

GEOTECHNICAL INVESTIGATION:

Proposed New Garage at 21 Palm Beach Road, Palm Beach

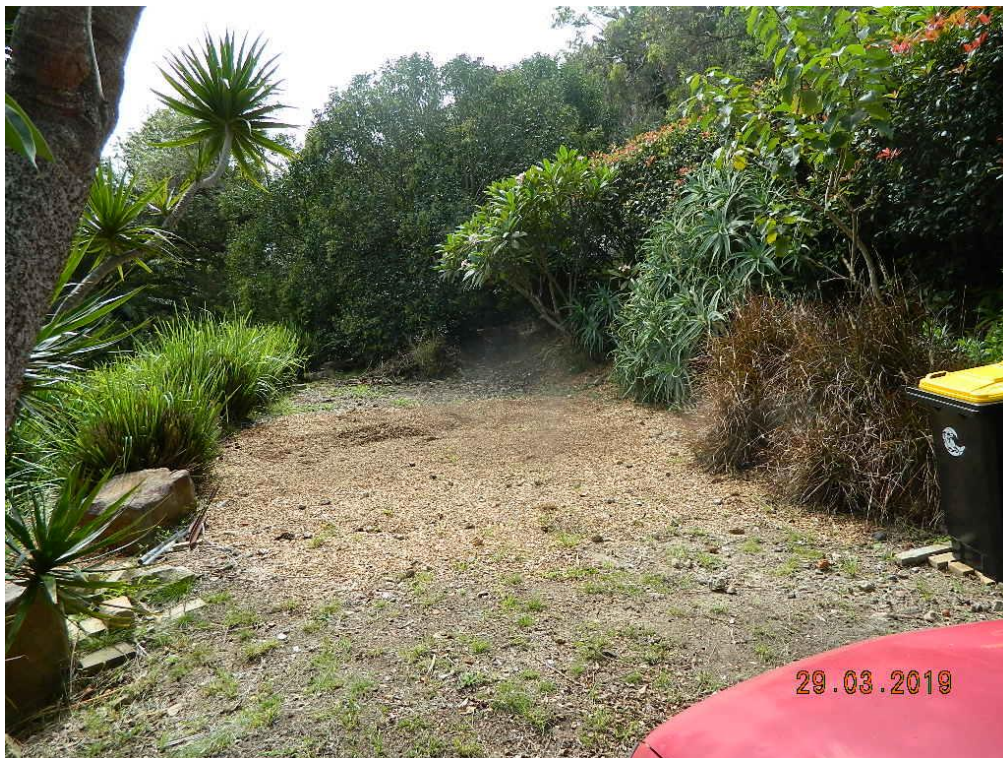
Photo 2

- 2.3** At the road frontage a concrete driveway runs down and across the slope to a garage and gravel parking area on the N side of the property (Photos 1 & 2). The garage will be demolished as part of the proposed works. Fill has been placed on the slope to level an area for a lawn to the N of the gravel parking area (Photo 3). The fill is battered at stable angles and has been planted with native vegetation to stabilise the slope (Photo 4). A moderately sloping garden encompasses the area between the road frontage and the house (Photo 5). An excavation to a maximum depth of ~1.2m has been made on the uphill side of the house to level an area for the house and for a paved patio (Photo 6). The cut is supported by a stable dimensioned sandstone block wall. The part two storey sandstone block, timber framed and clad house is supported

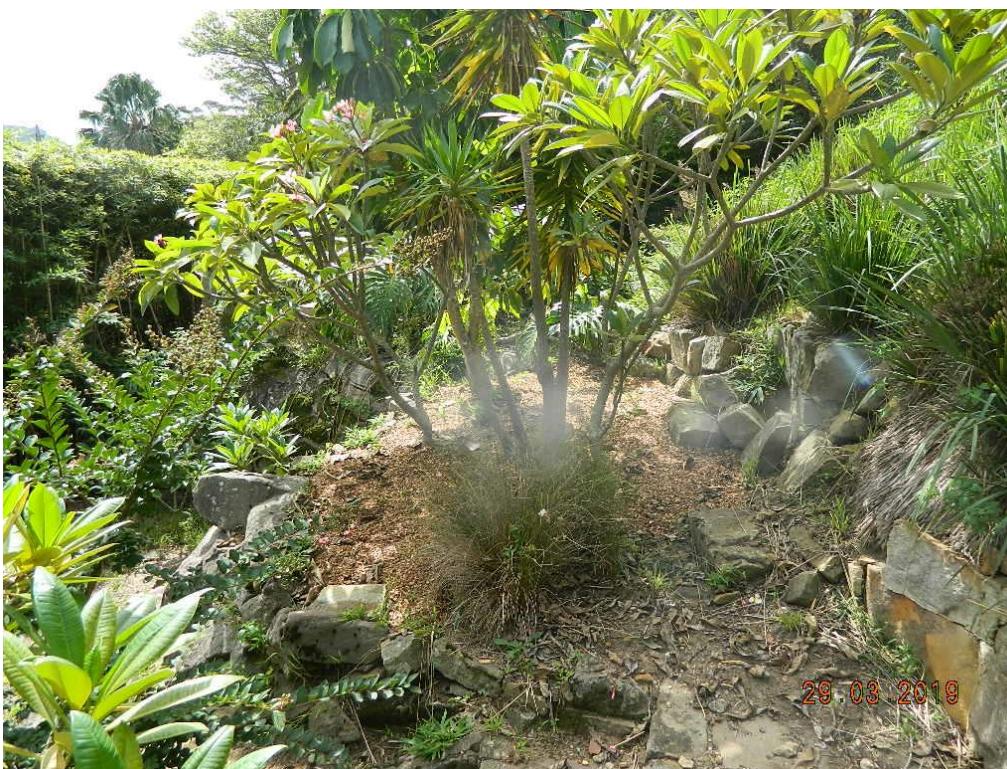
Photo 7

on sandstone block walls and sandstone block piers (Photo 7). No significant signs of movement or cracking were observed in the external supporting walls of the house and the supporting sandstone block piers stand vertical. The slope on either side of the house has been terraced with stable, rough sandstone block retaining walls that reach a maximum height of ~0.5m (Photo 8). Some of the walls have been constructed over sandstone boulders that are sitting in stable positions. Sandstone boulders and smaller joint blocks scatter the slope across the site (Photo 9). The boulders and joint blocks appear to have been in place for some time and are in stable positions. A bed of Medium Strength Sandstone outcrops in the NW corner of the property (Photo 10). The remains of a mortared sandstone block building sit upon the sandstone bed. A narrow lawn extends along the downhill boundary. The garage will be demolished as part of the proposed works.
