Development Application for <u>Reform Projects Pty Ltd</u>	Name of Applicant
Address of site <u>1102-1106 Barrenjoey Road, Palm Beach, NSW</u>

REPORT TO
REFORM PROJECTS PTY LTD

ON
**SEEPAGE ANALYSIS AND GEOTECHNICAL
ASSESSMENT**
(In Accordance with Pittwater Council Risk
Management Policy)

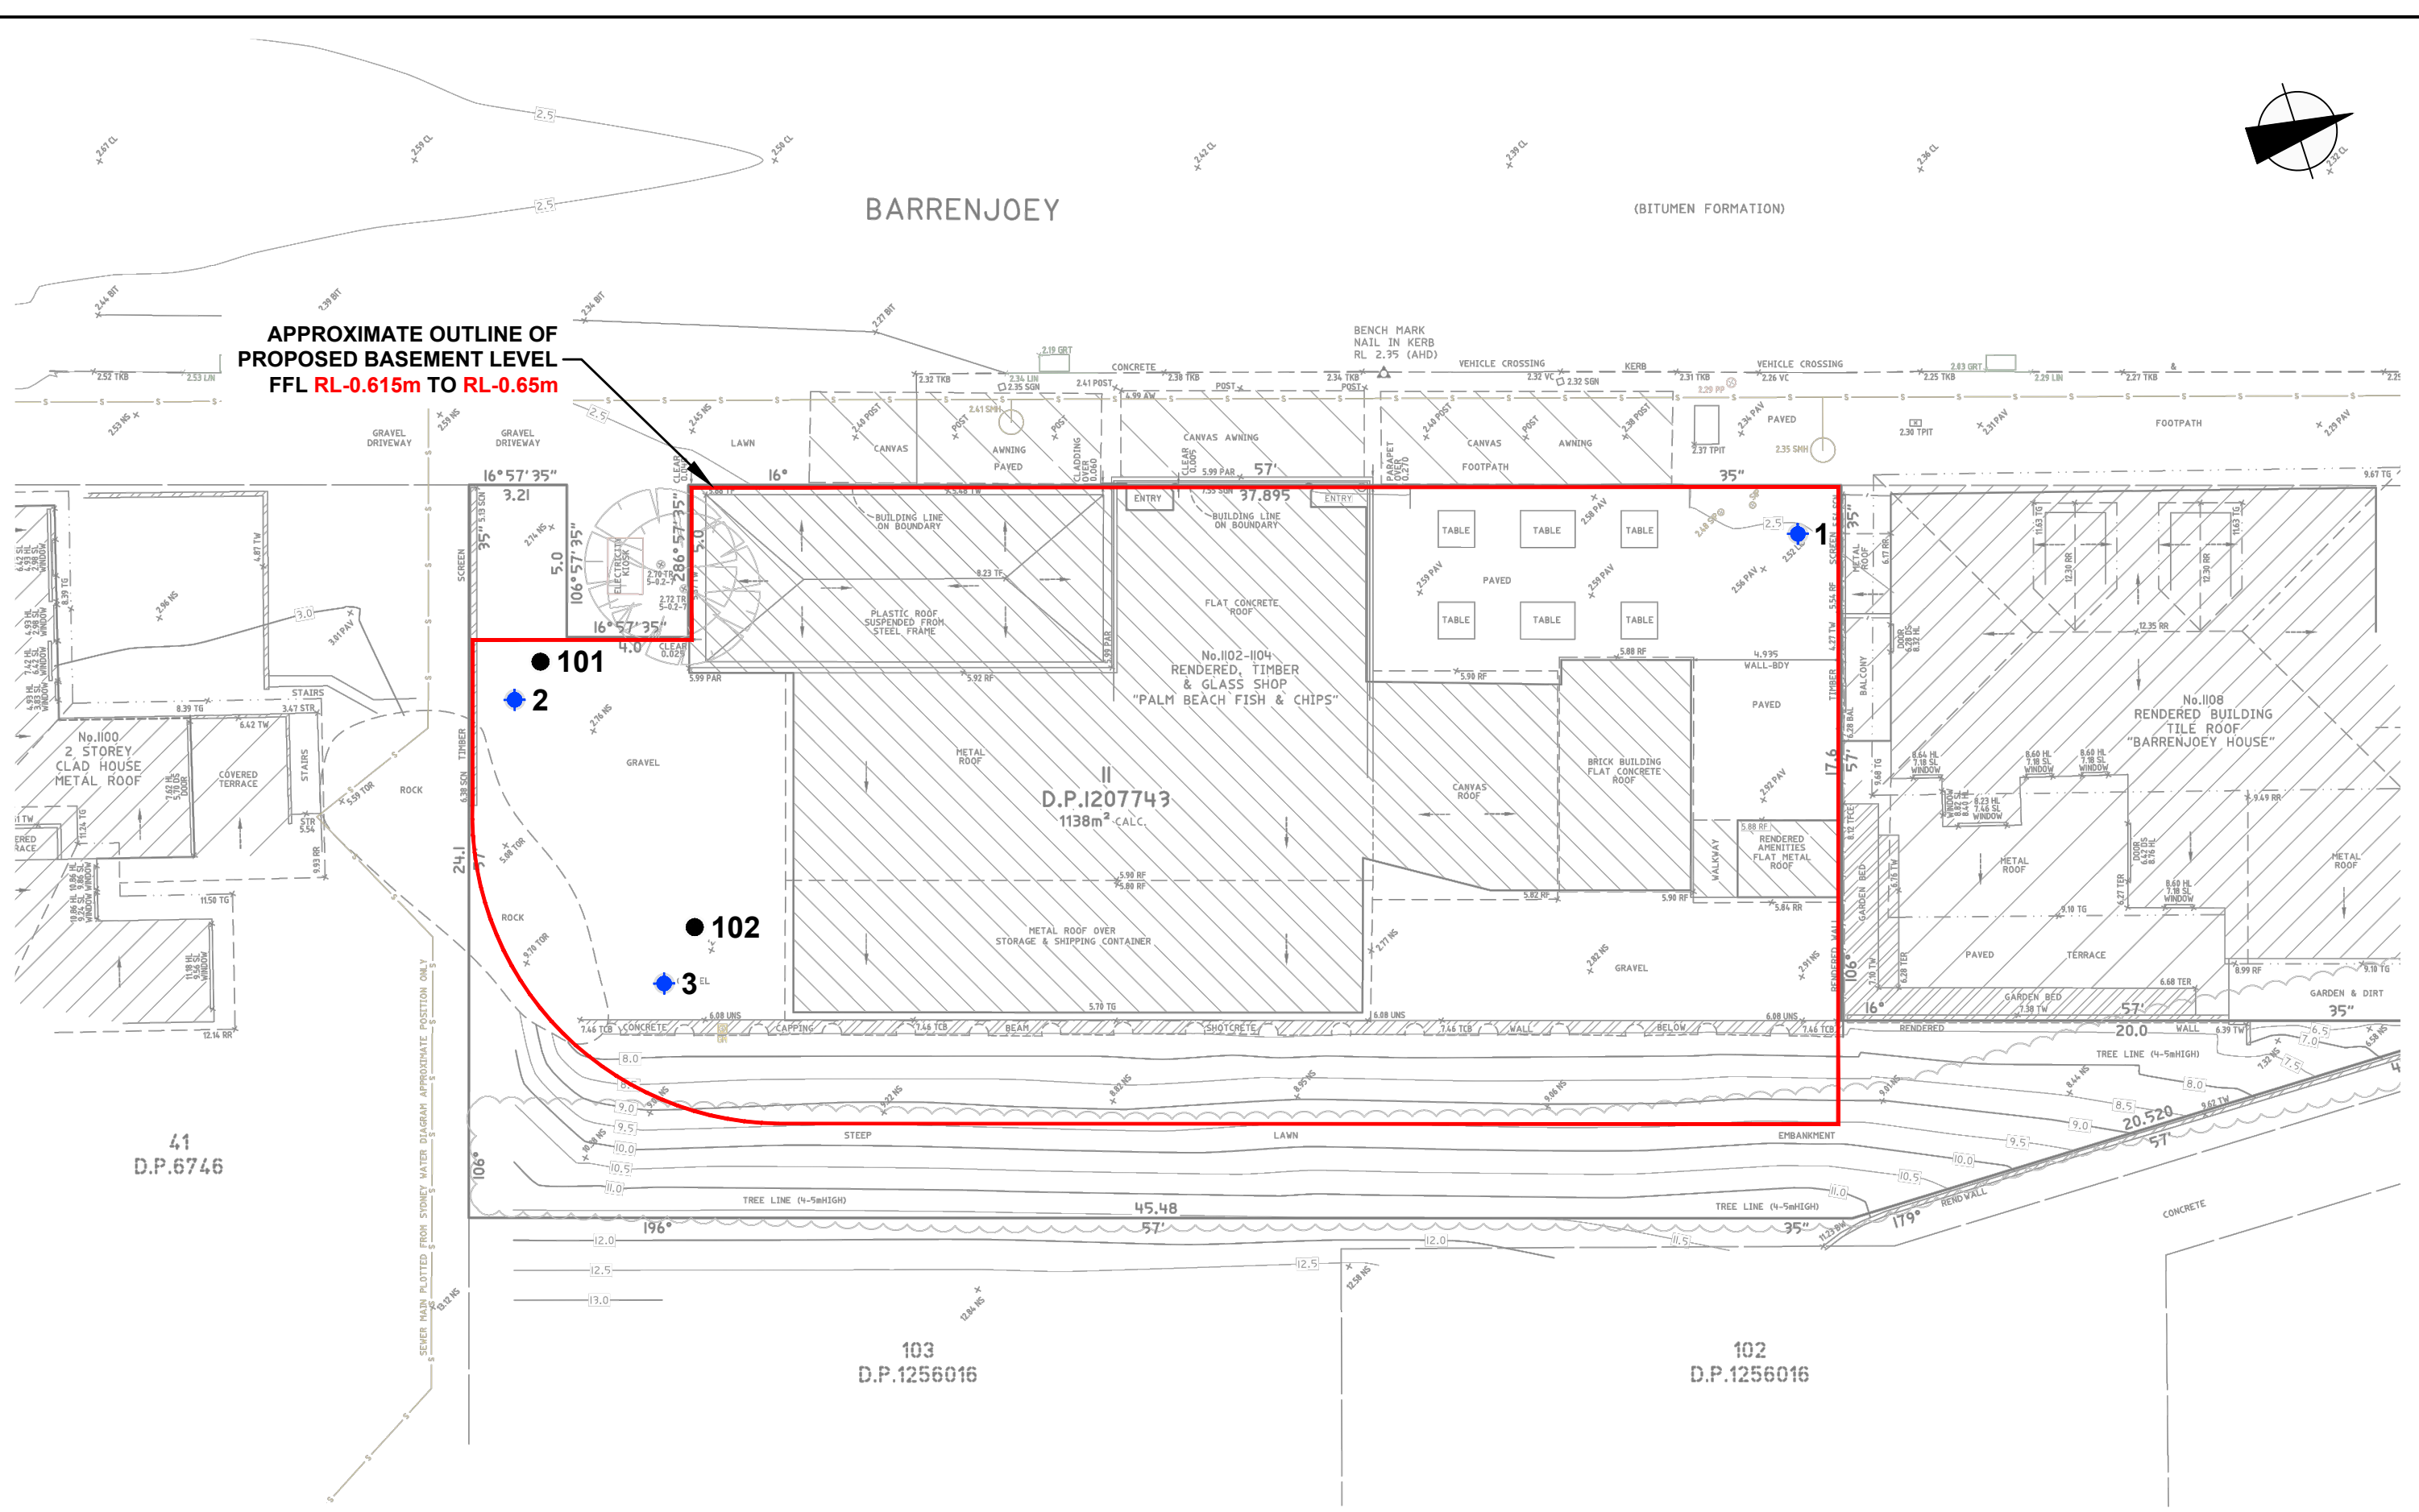
The attached Figure 3 presents a plan showing notable geotechnical site features and geotechnical hazards. Figure 3 is based on the survey plan prepared by CMS Surveyors Pty Ltd (CMS, Ref: Drawing No. 19783detail, Issue 1, date of survey as 3 November 2020). We also received an older survey plan by Adam Clerke Surveyors Pty Ltd (Ref: 20688L, dated 26 April 2012), which we used to review former levels at the site. Additional features on Figure 3 have been measured by hand held clinometer and tape measure techniques and hence are only approximate. Should any of the features be critical to the proposed development, we recommend they be located more accurately using instrument survey techniques. Figure 6 defines the geotechnical mapping symbols adopted and used in Figure 3. Figures 4 and 5 present typical cross-sections (Sections A-A' and B-B', respectively) through the site based on the survey data augmented by our mapping observations. These sections include potential landslide hazards.

These potential hazards are indicated in schematic form on the attached Figure 3.

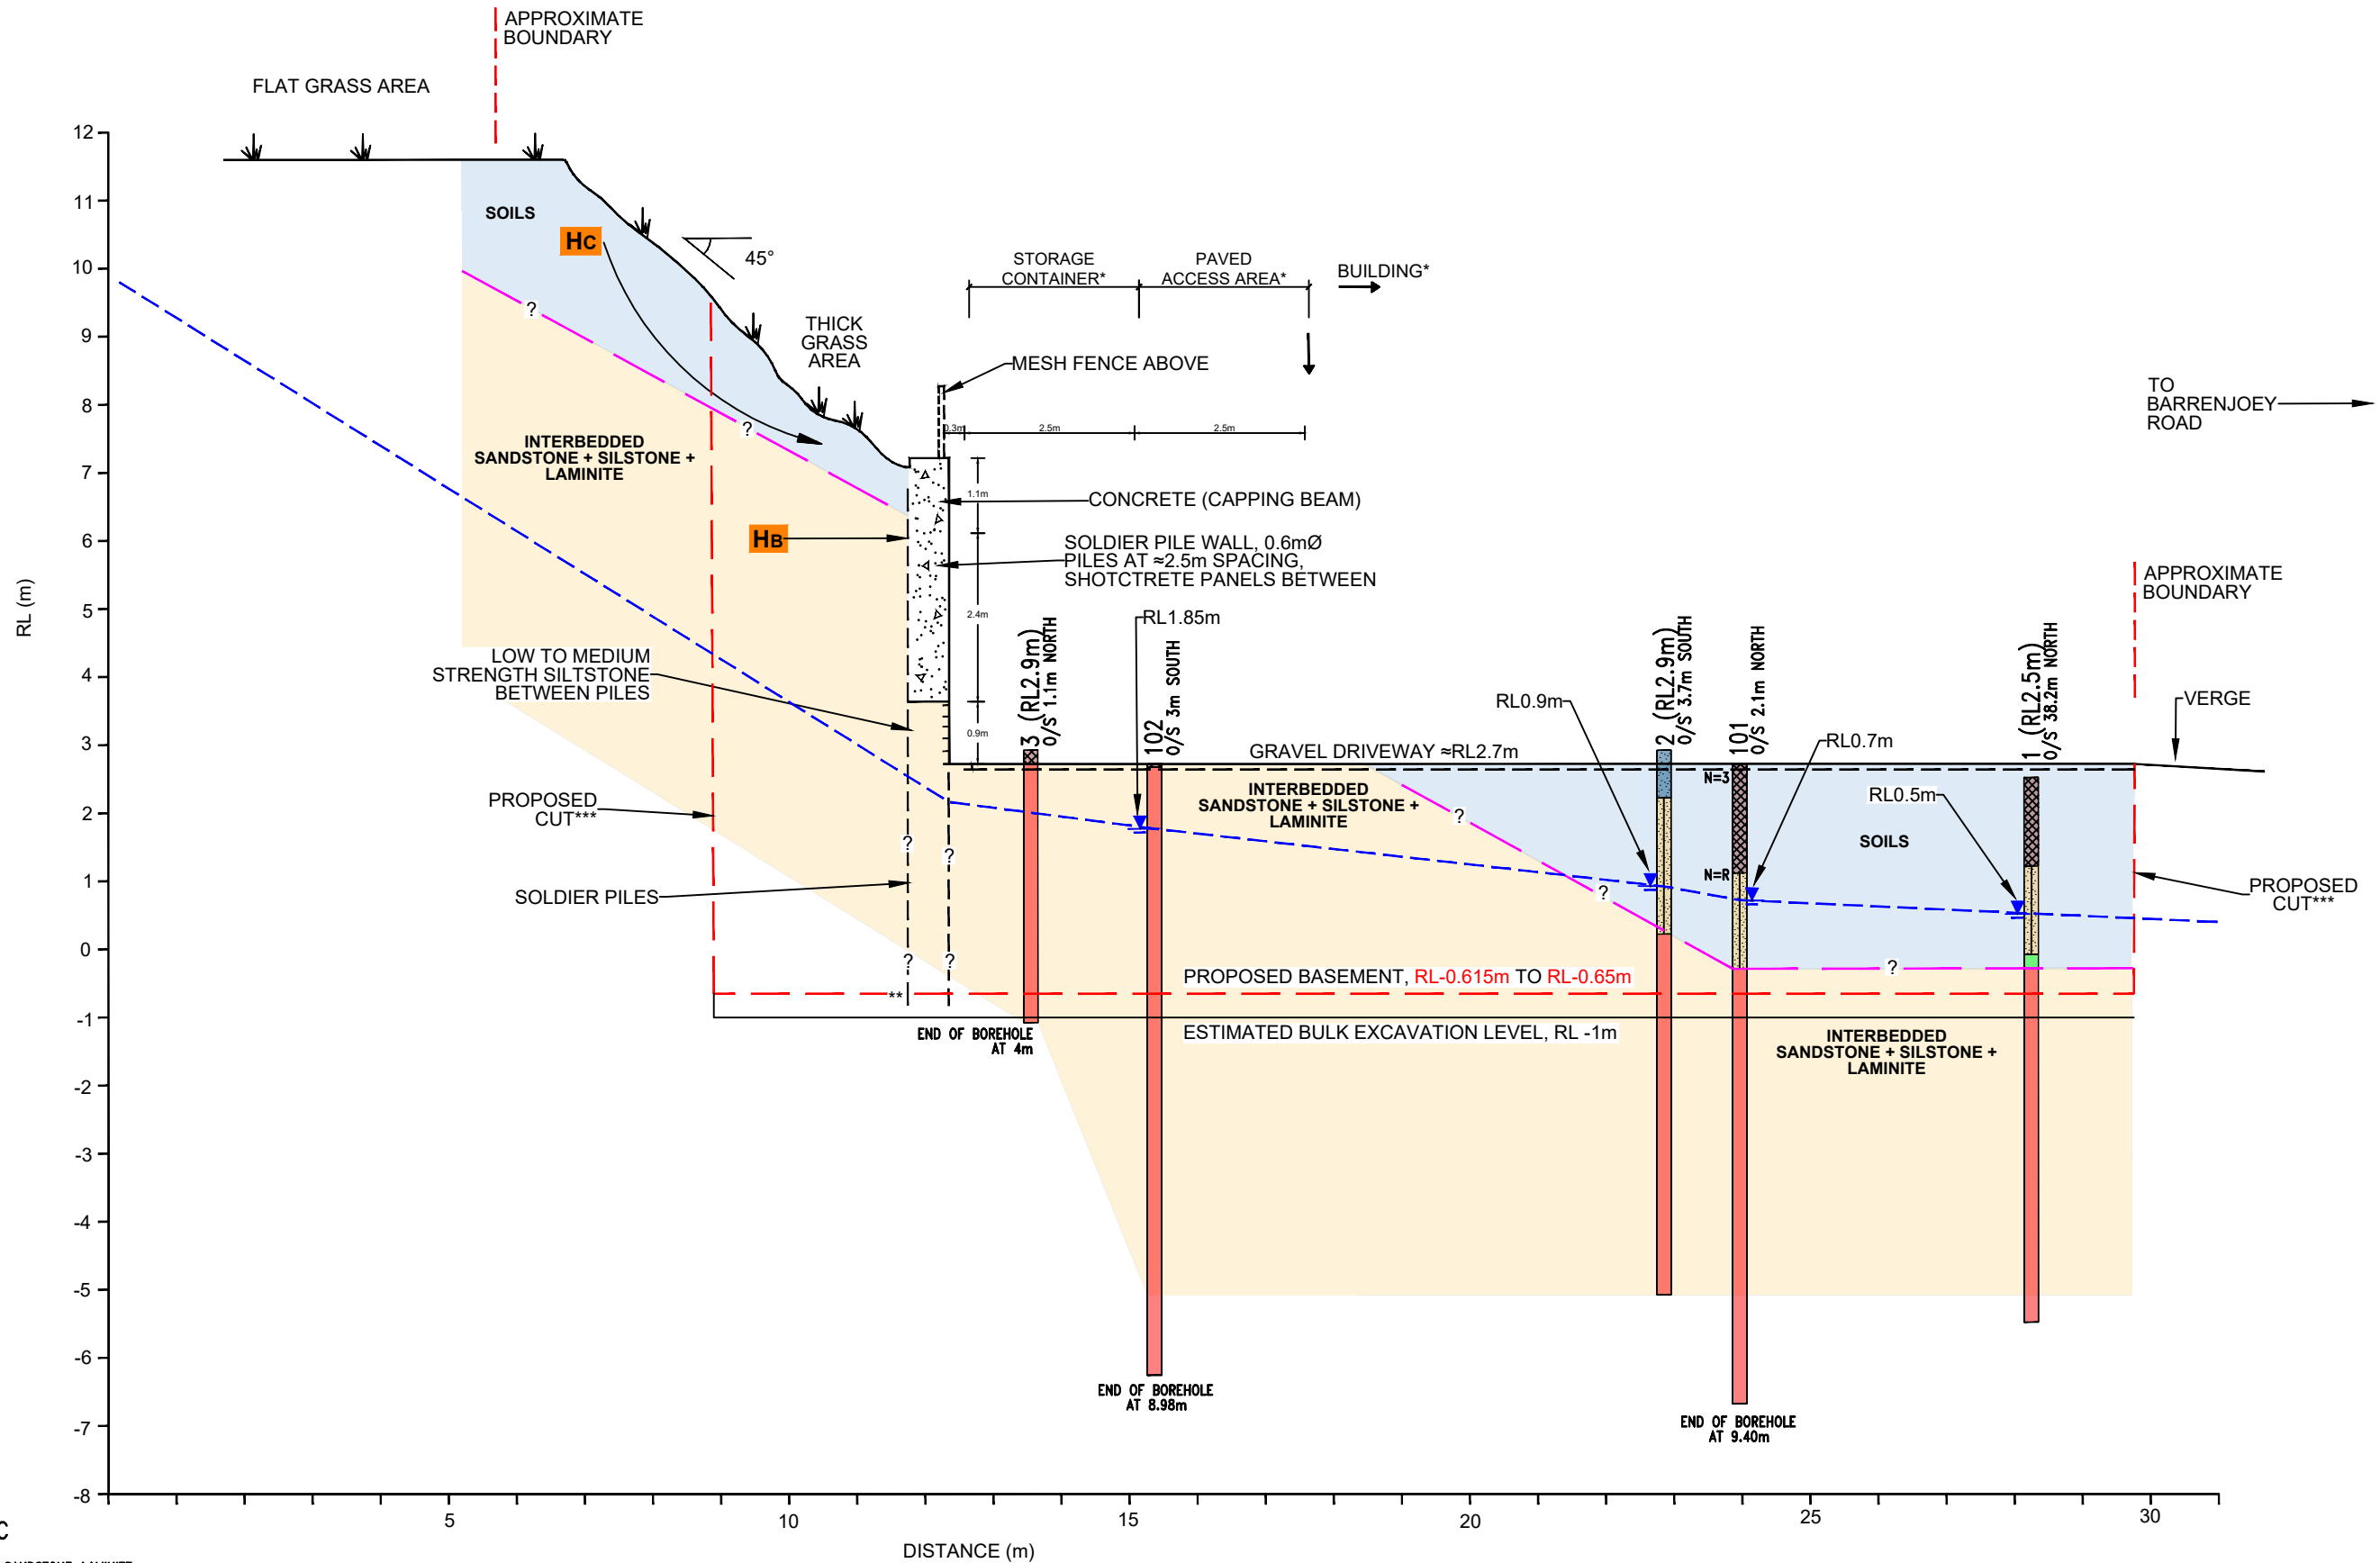
SECTION A-A'	
Location: 1102 - 1106 BARRENJOEY ROAD, PALM BEACH, NSW	
Report No: 33618YJrptrev2	Figure No: 4
JK Geotechnics

Steady state seepage analysis has been carried out on one section, Section A-A', which is shown on the attached Figure 3. The purpose of the modelling was to provide an estimate of extraction rates required during construction. The section is based on the survey plan by CMS and was chosen as it represented a 'typical' section through the site in terms of the proposed boundary set-backs, depth of proposed excavations, gradient of the existing ground and groundwater and subsurface conditions.
