## **129 George Street, Avalon**

### Geotechnical Comments in Regards to New Plans

## **GEOTECHNICAL INVESTIGATION:**

New Secondary Dwelling at **129 George Street, Avalon**

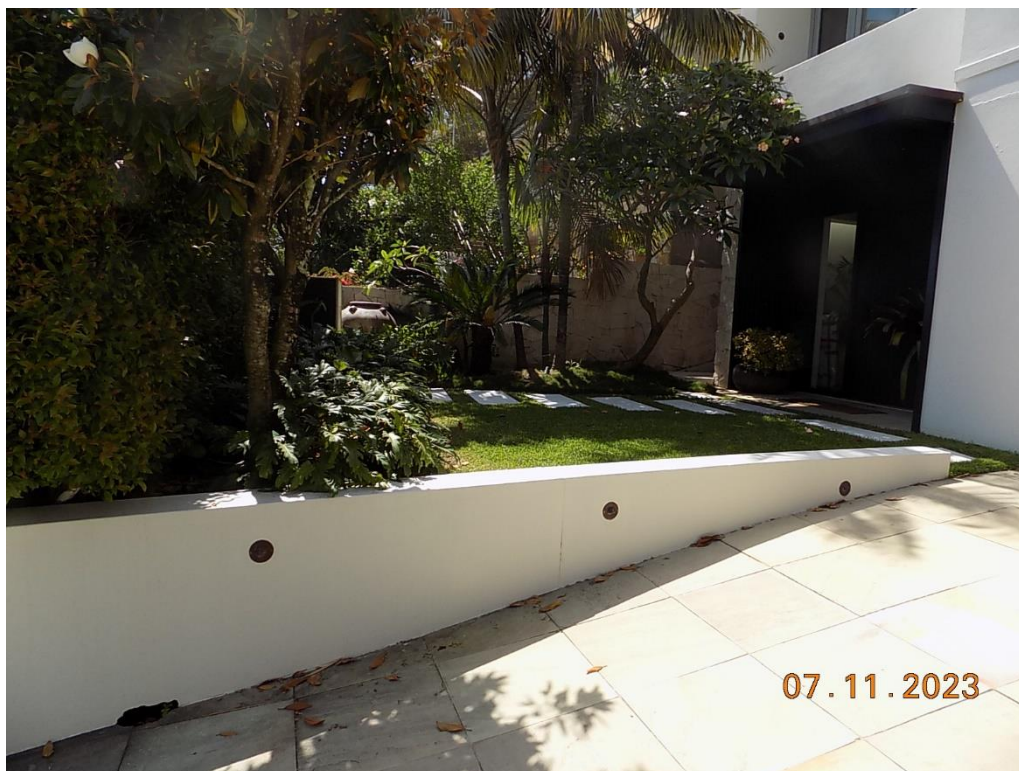
Photo 2

- 2.3** At the road frontage to George Street (Photo 1), a sandstone paved driveway runs to a garage under the downhill side of the house. Between the road frontage and the house, stable low rendered masonry retaining walls support a cut for the driveway and fill for a level lawn area (Photo 2). The part three-story house is supported on rendered masonry walls. No significant signs of movement were observed in the supporting walls. A pool has been cut into the slope above the house (Photo 3). The water level indicates no ground movement has occurred in the shell of the pool since its construction. A stable sandstone clad concrete retaining wall reaching up to ~2.6m

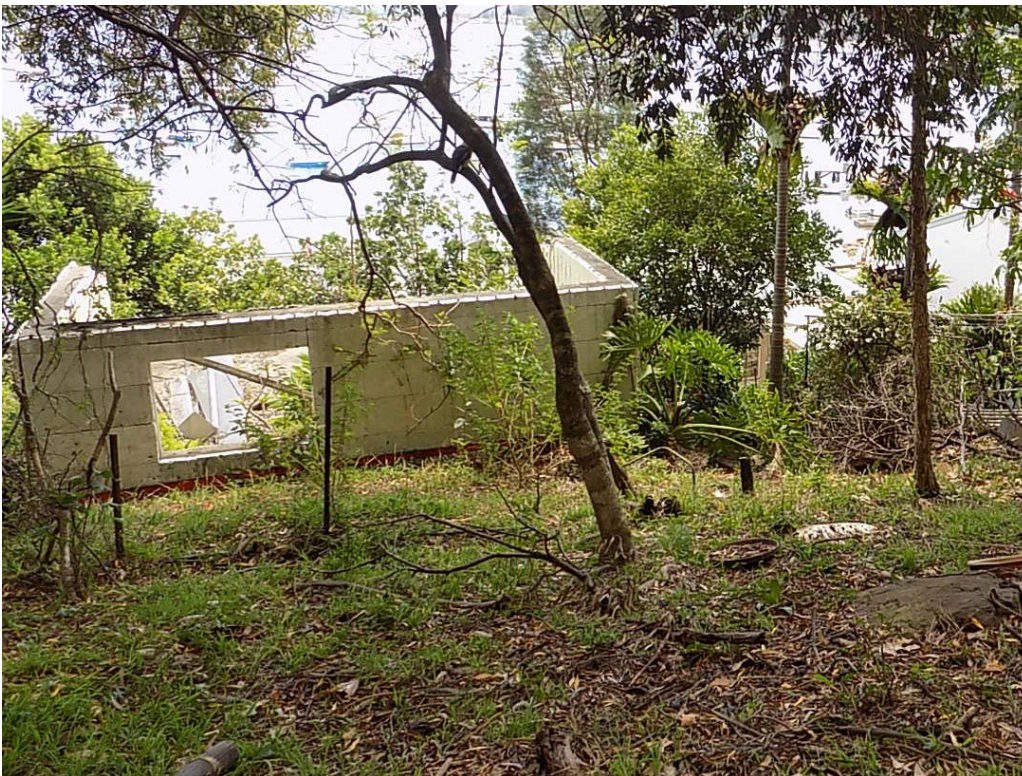
Photo 5

supports the cut for the pool area (Photo 3). A stable low timber retaining wall supports the natural slope immediately above the cut for the pool (Photo 4). A partially constructed pool pavilion remains on the uphill slope (Photo 5) and is supported on concrete piers. Sandstone boulders are scattered across the moderate slope in the middle of the property (Photo 6). These rocks are partially embedded into the slope and are considered to be in stable positions. Competent Medium Strength Sandstone outcrops and underlies the remainder of the steep slope to the Cabarita Road frontage (Photo 7). The outcropping portions of rock were observed to be free from significant geological defects that could affect their stability.
