## **5 Kooloora Avenue, Freshwater**

### Comments on updates to Plans

## **GEOTECHNICAL INVESTIGATION:**

Alterations and Additions at **5 Koolooro Avenue, Freshwater**

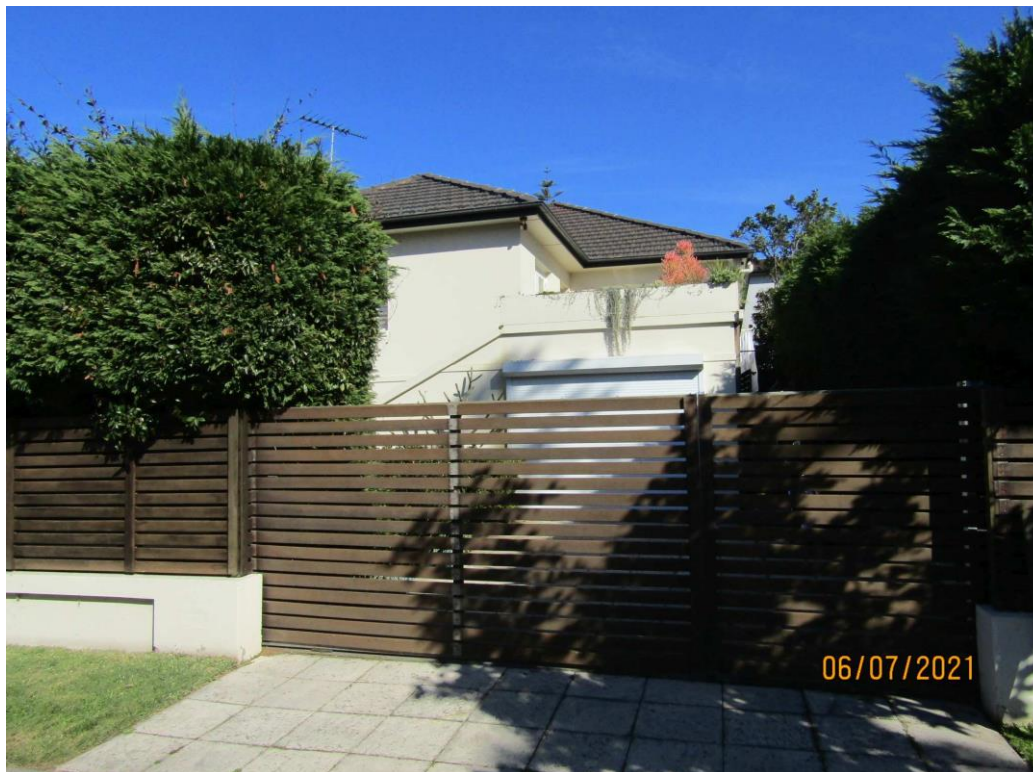
Photo 1

- 2.1** The site was inspected on the 6<sup>th</sup> of July, 2021.
- 2.2** This residential property is on the corner of Koolooro Avenue and Murray Road. It is on the uphill side of Koolooro Avenue and is near level with Murray Road. The property has a NE aspect. The natural slope rises across the property at an average angle of ~5°. The slope above the property gradually increases in grade. Below the property is near level at the valley floor.
- 2.3** At the road frontage, a paved driveway runs to a garage attached to the house (Photo 1). Between the road frontage and the house is a near level lawn area. The part
