GEOTECHNICAL ASSESSMENT

PROPOSED SECONDARY DWELLING

48 NAREEN PARADE, NORTH NARRABEEN

Project No.: 2019-116

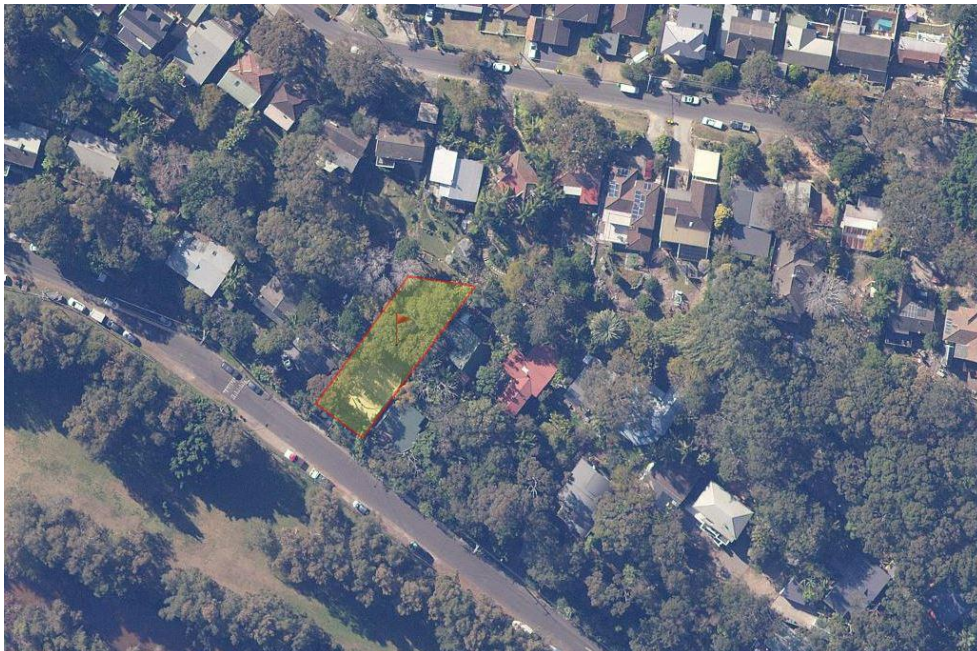
Photograph: 1 of site and surrounding properties

An aerial photograph of the site and its surrounds is provided below, as sourced from NSW Government Six Map spatial data, as Photograph 1.
