87 Alexandra Crescent, Bayview

Comments on Updates to Plans

GEOTECHNICAL INVESTIGATION:

Alterations and Additions at **87 Alexandra Crescent, Bayview.**

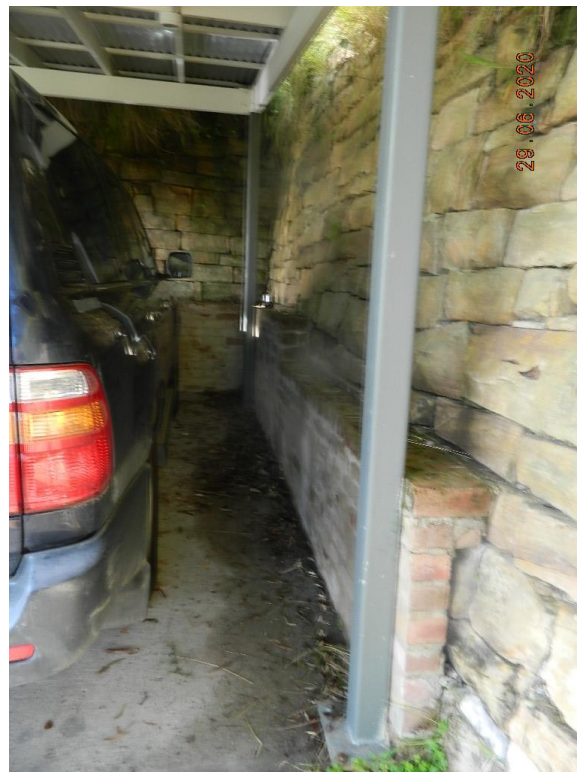
Photo 2

2.3 At the road frontage a concrete driveway runs to a carport cut into the slope (Photo 1). The cut is supported by sandstone block, brick and concrete block retaining walls up to ~3.4m high (Photos 1 to 3). The highest portion of the sandstone block wall is supported by a brick wall in front of the base of the retaining wall (Photo 2). The retaining walls are considered to be stable. Between the carport and the house is a steep and thickly vegetated slope (Photo 1). The part three storey rendered brick and weatherboard clad house is supported by brick walls and brick piers Photos (1 & 4). The supporting walls and piers stand vertical and show no significant signs of movement (Photo 5). Uphill of the house a cut in the slope provides a level platform for the house. The cut is supported by concrete block and sandstone flagging retaining walls up to ~2.7m high. (Photos 6 & 7). The W portion of the concrete block retaining wall is tilting at up to ~4° from vertical. See 'Section 16 Ongoing Maintenance'. A Medium Strength Sandstone bedrock cliff face up to ~7m outcrops above the cut for the house (Photo 8). A portion of the cliff face is undercut by up to ~4.4m (Photo 9). The undercut is considered stable. No geotechnical hazards were observed on the neighbouring properties that could impact on the subject property as seen from the street and subject property.

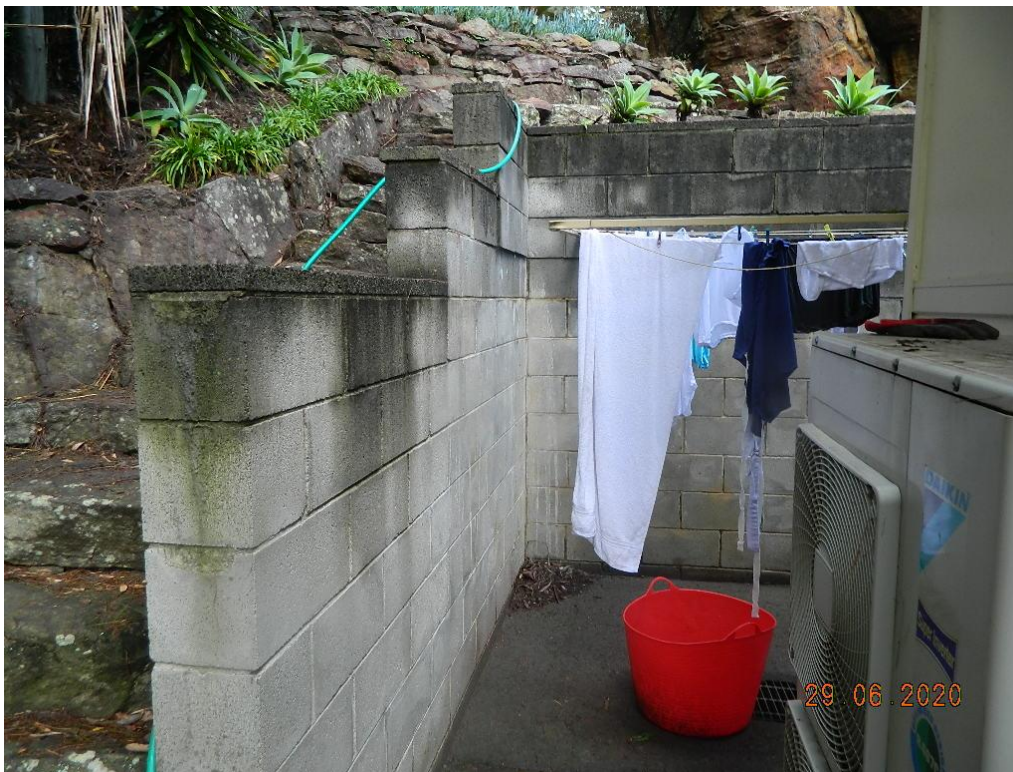
Photo 6

The concrete block retaining wall (Photo 6) is to be monitored by the owners on an annual basis or after heavy prolonged rainfall events, whichever occurs first. A photographic record of these inspections is to be kept. Should further movement occur the wall is to be remediated so it meets current engineering standards. We can carry out these inspections upon request.

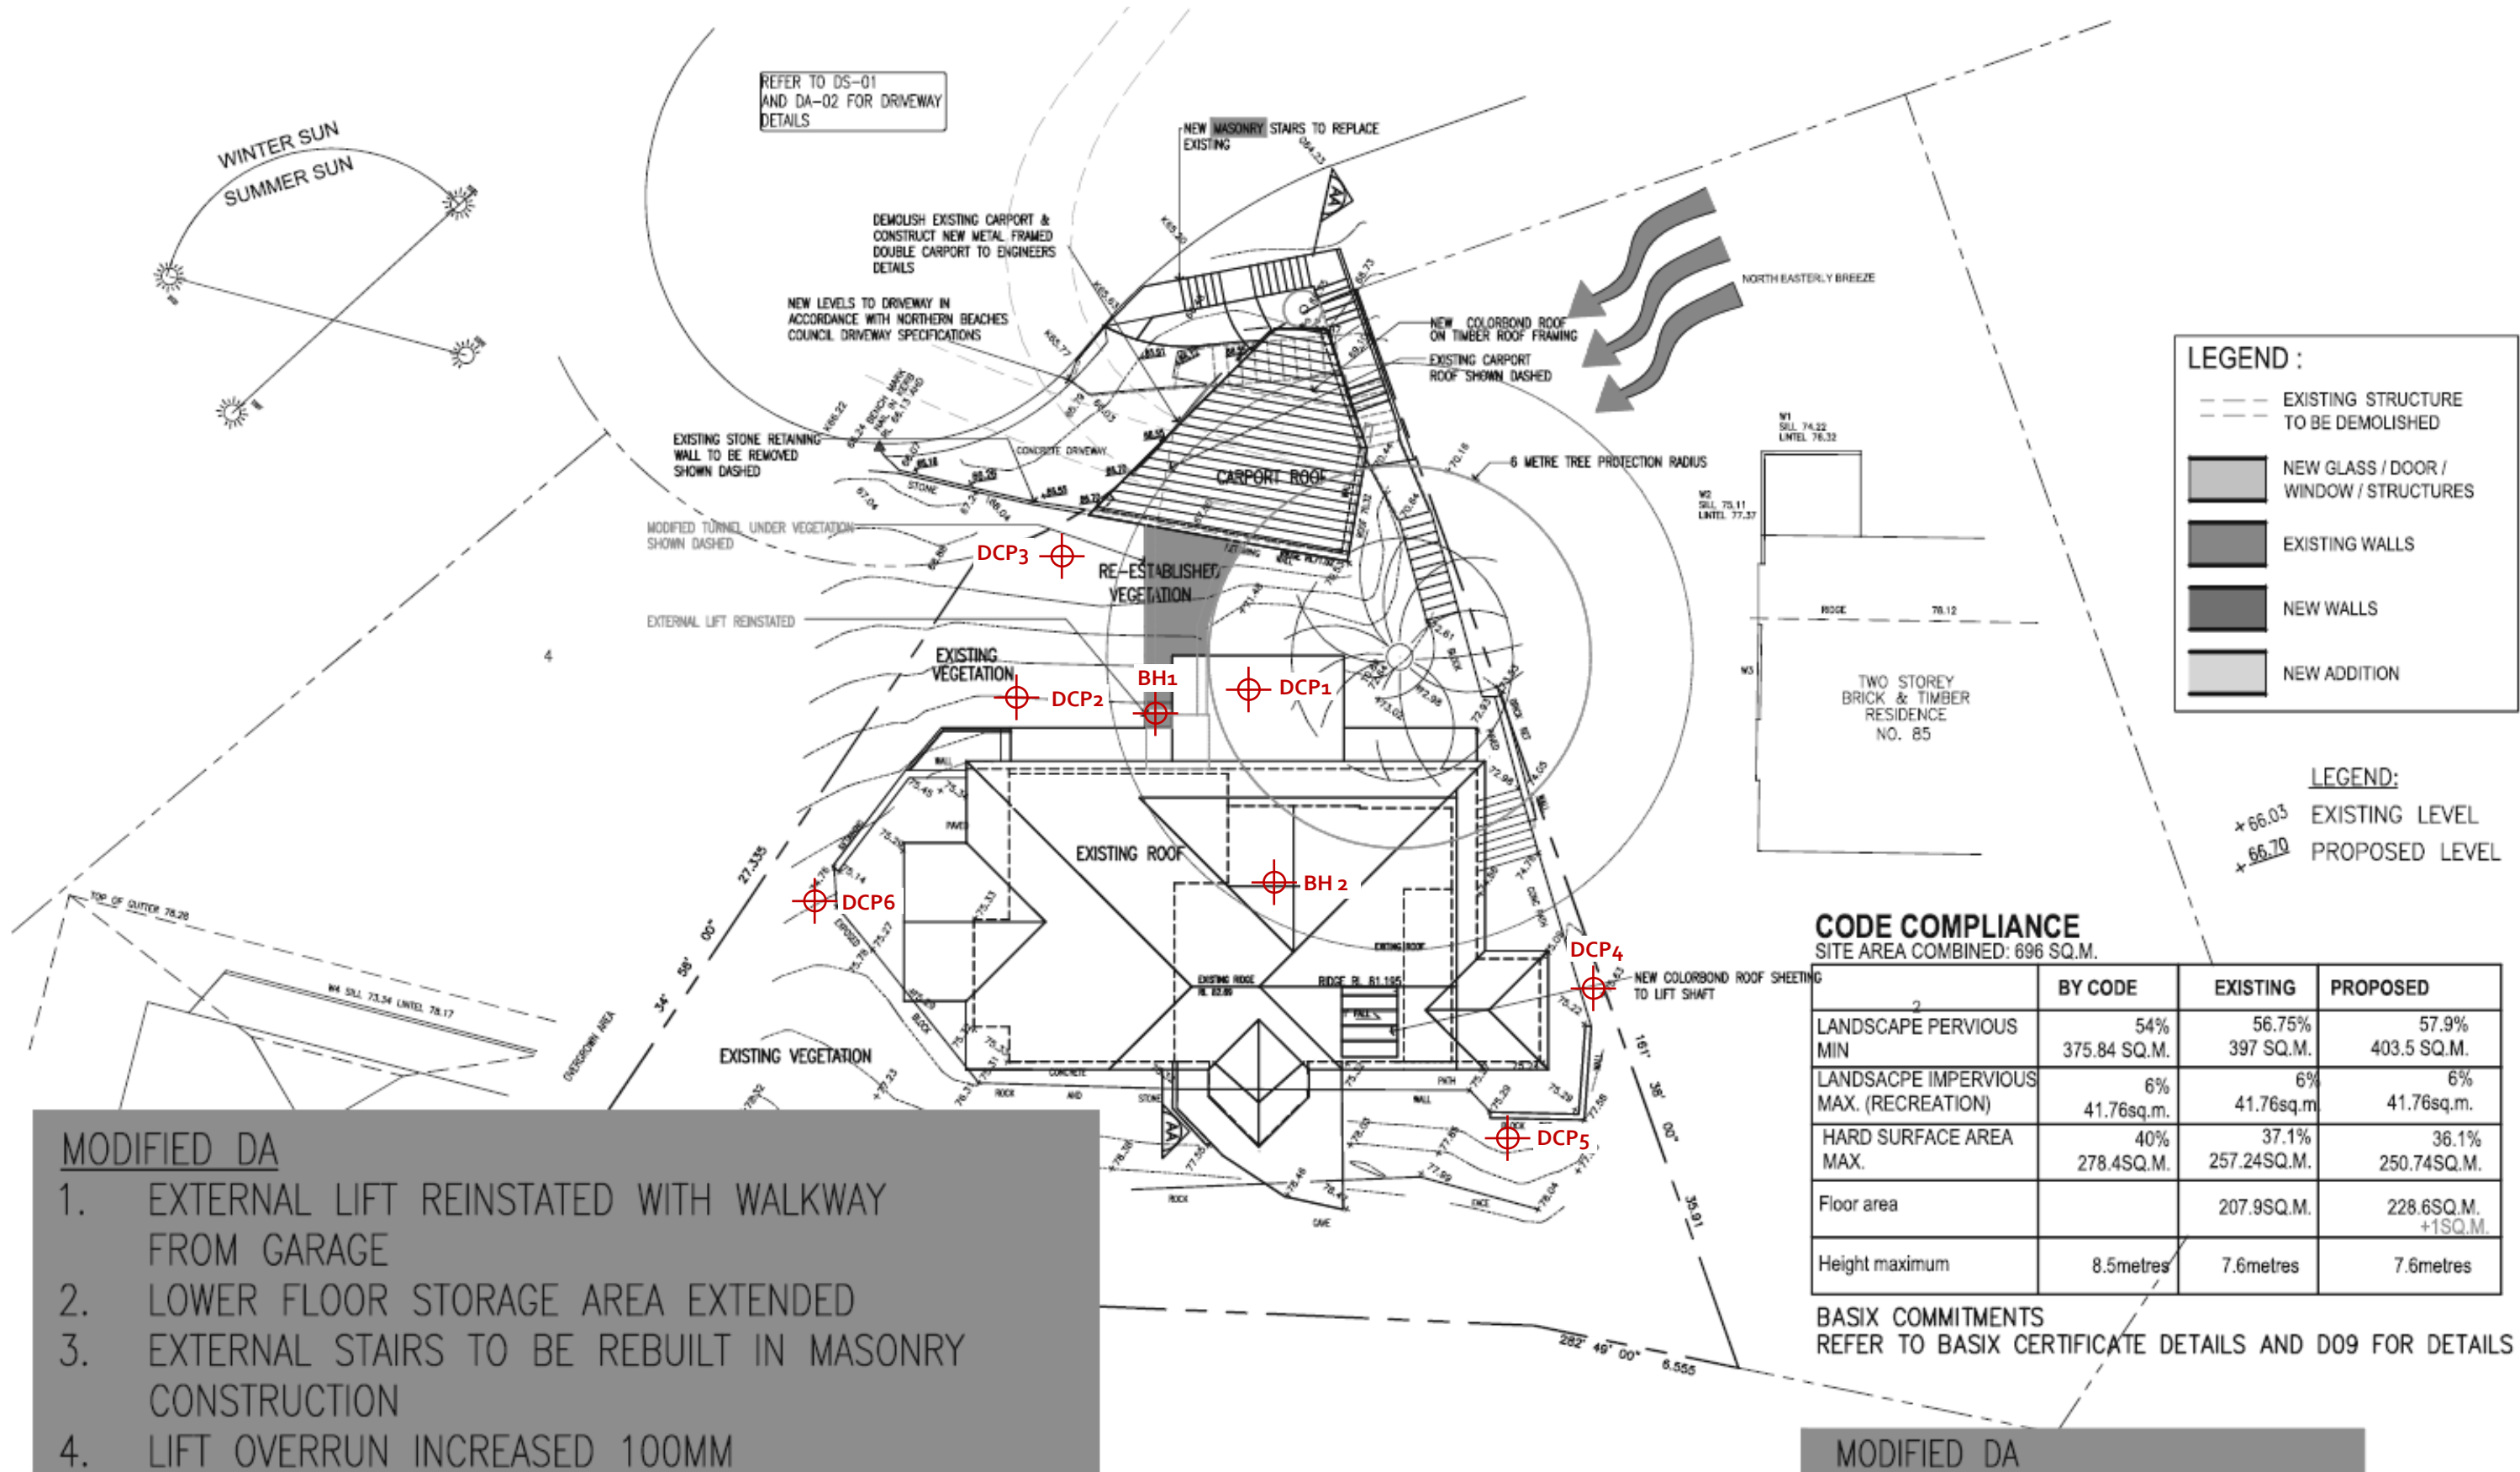
SITE PLAN – showing test locations

Two bore holes (BH) were drilled at the location of the proposed lift and lift accessway to determine the depth and strength of the rock. The drill used was a hand portable rig running an NMLC core barrel. Six Dynamic Cone Penetrometer (DCP) tests were put down to determine the relative density of the overlying soil and the depth to weathered rock. The locations of the tests are shown on the site plan. It should be noted that a level of caution should be applied when interpreting DCP test results. The test will not pass through hard buried objects so in some instances it can be difficult to determine whether refusal has occurred on an obstruction in the profile or on the natural rock surface. This may have occurred for DCP4. Due to the possibility that the actual ground conditions vary from our interpretation there should be allowances in the excavation and foundation budget to account for this. We refer to the appended "Important Information about Your Report" to further clarify. The results are as follows:

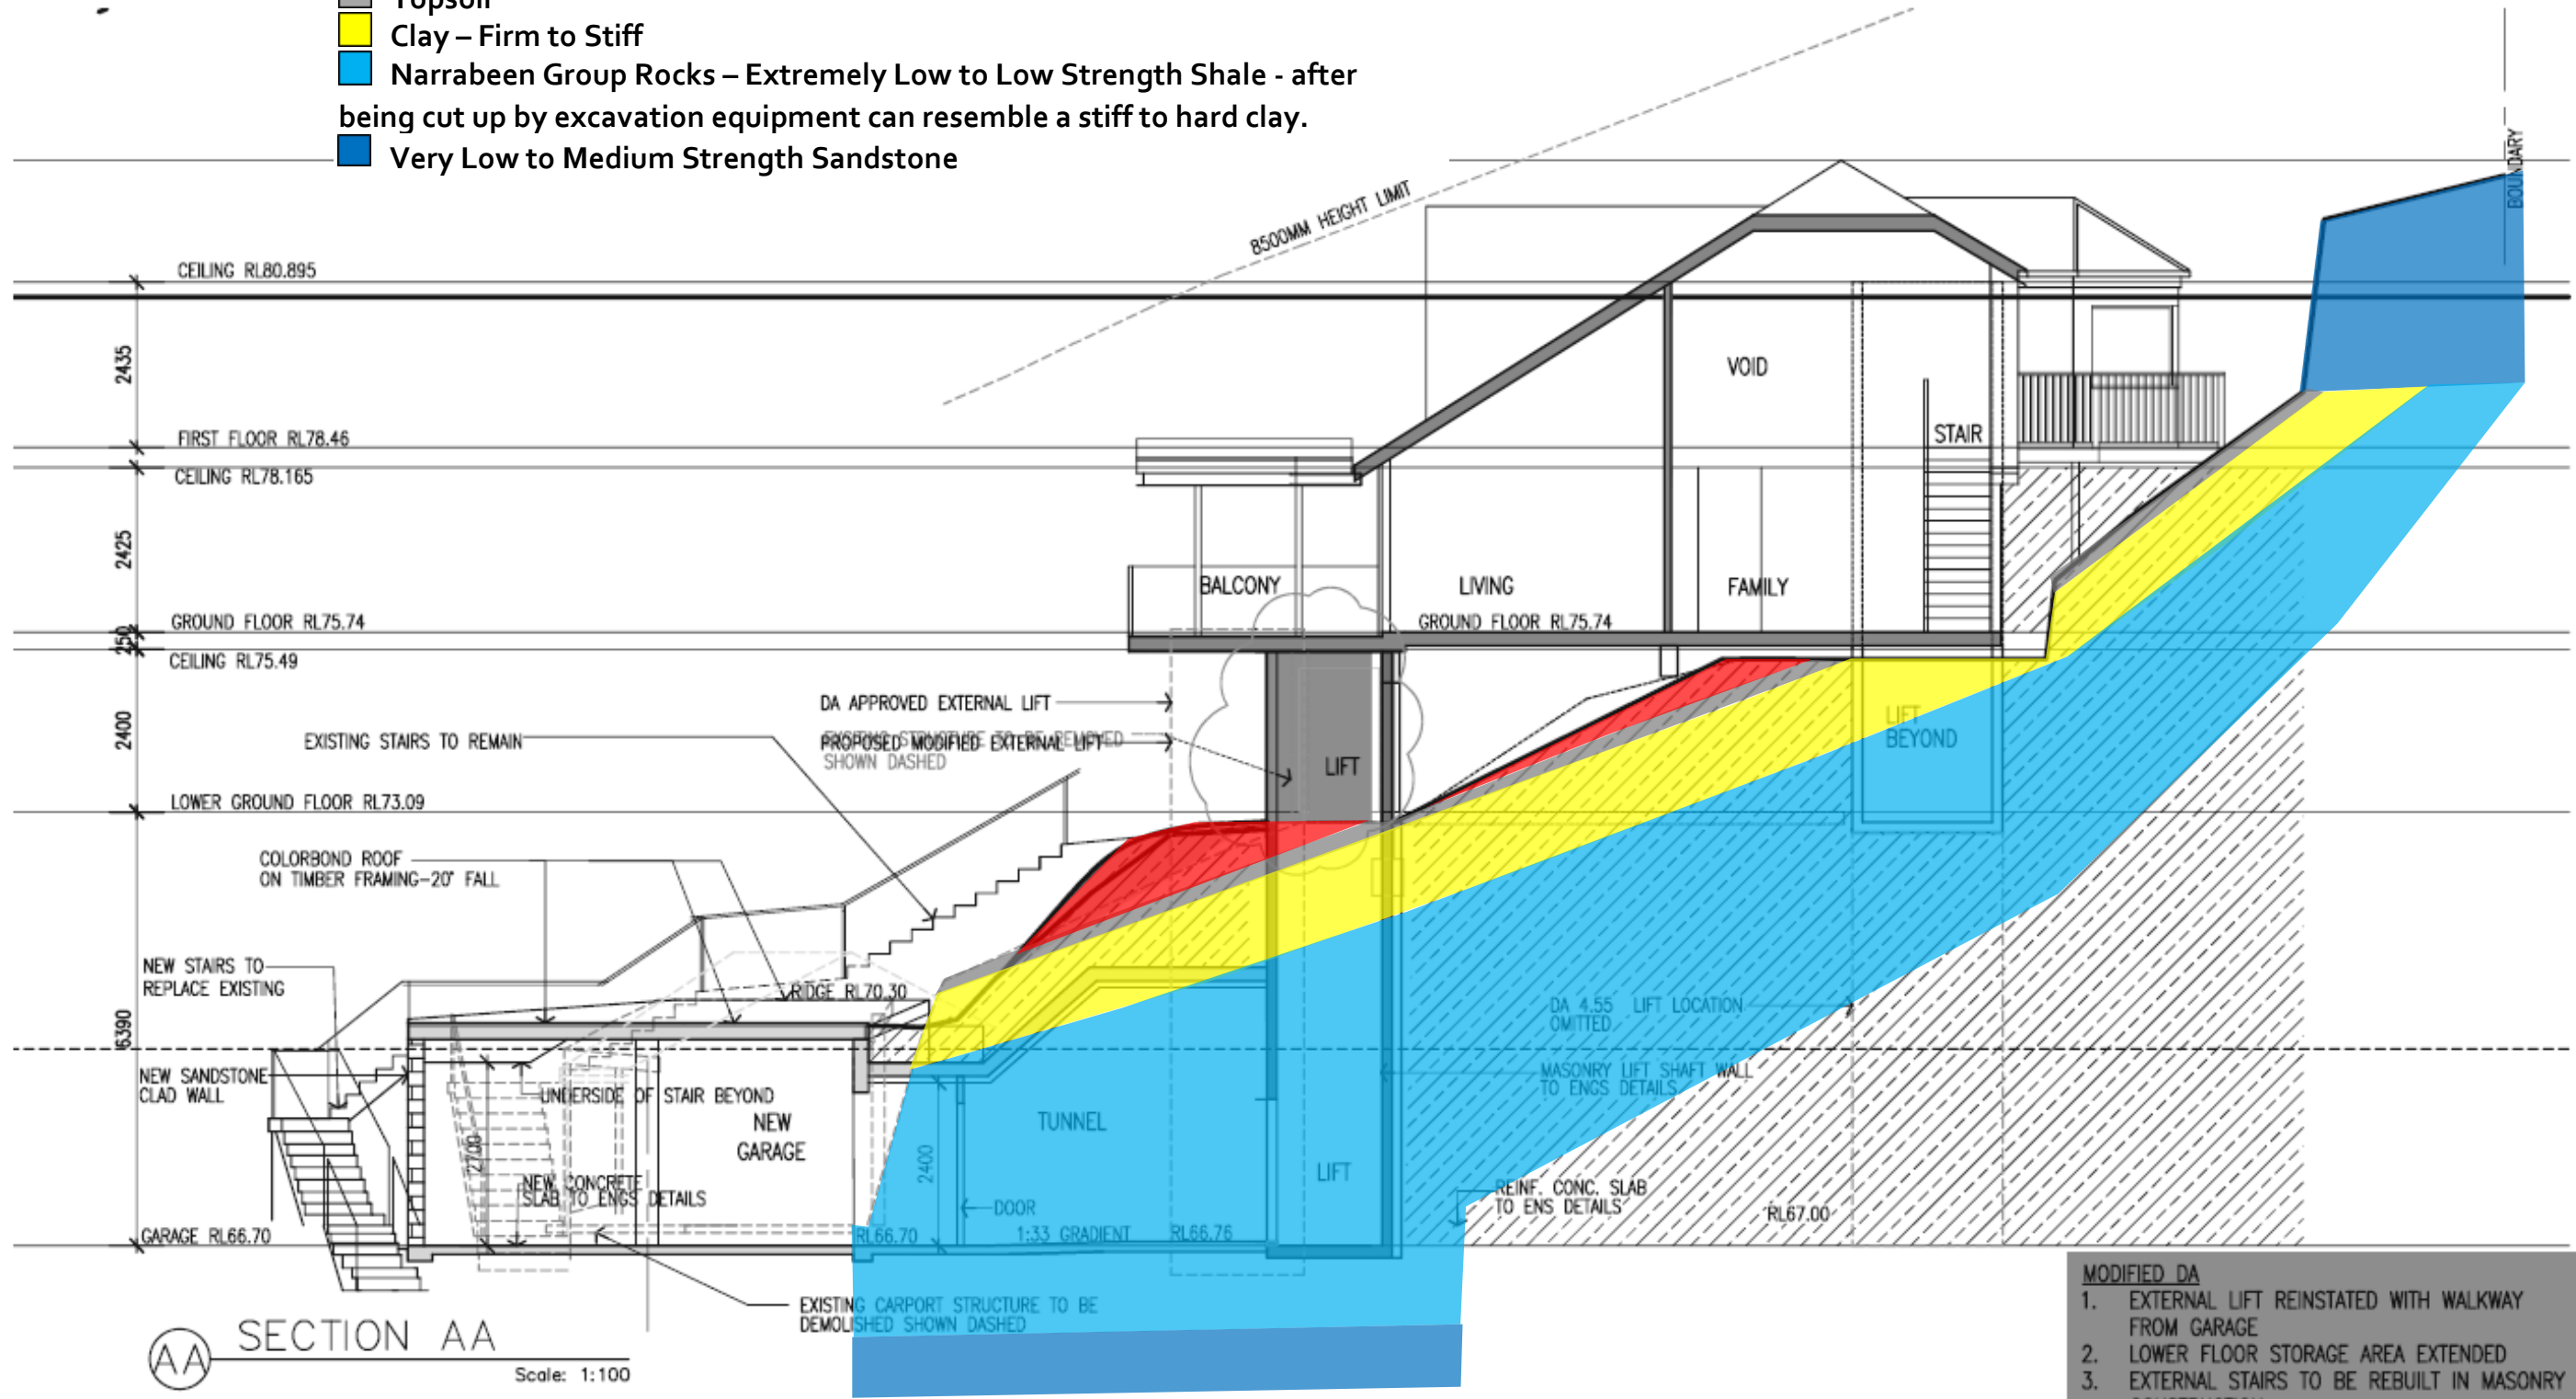
TYPE SECTION – Diagrammatic Interpretation of expected Ground Materials

the weathered zone of the under lying rocks at depths of between ~0.6m to ~2.4m below the current surface. The weathered zone of the underlying rock is interpreted as Extremely Low to Low Strength Shale. It is to be noted that this material is a soft rock and can appear as a mottled stiff clay when it is cut up by excavation equipment.

- Fill
- Topsoil
- Clay – Firm to Stiff
- Narrabeen Group Rocks – Extremely Low to Low Strength Shale - after being cut up by excavation equipment can resemble a stiff to hard clay.
- Very Low to Medium Strength Sandstone
