**re: DA-STAGE GEOTECHNICAL INVESTIGATION / LANDSLIDE RISK APPRAISAL  
PROPOSED HORSE ARENA DEVELOPMENT, POOL & BUILDING ADDITIONS  
NO.113 [LOT 6 DP749791] ORCHARD STREET WARRIEWOOD NSW**

DA-STAGE GEOTECHNICAL INVESTIGATION / LANDSLIDE RISK APPRAISAL  
PROPOSED HORSE ARENA DEVELOPMENT, POOL & BUILDING ADDITIONS  
NO.113 [LOT 6 DP749791] ORCHARD STREET WARRIEWOOD NSW

report ref: R/18-023.A

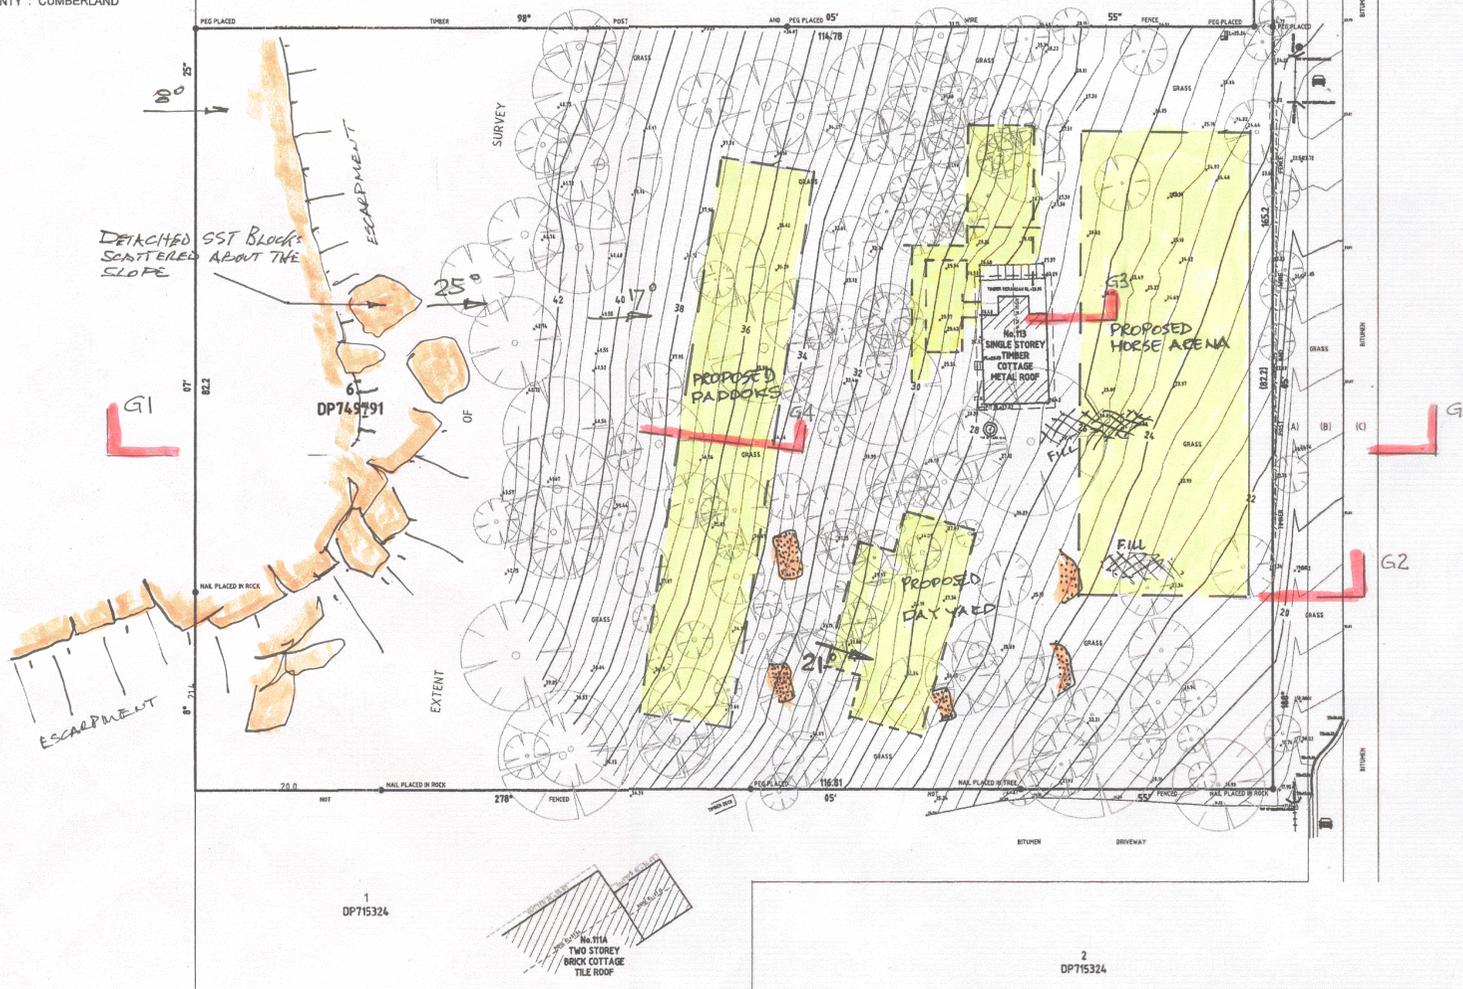
<b>Project No:</b> 18-023	<b>Scale:</b> as shown	GEOTECHNICAL BASE PLAN NO.113 ORCHARD STREET WARRIEWOOD NSW (Jill Hunter)	<b>Figure 2</b>
<b>Drawn:</b> wnd	<b>Date:</b> 20 Aug 18

The features described above from our geotechnical mapping and general observations are marked up on the survey plan presented as Figure 2 and on the geotechnical slope section provided in Figure 3A.
