## **REPORT ON GEOTECHNICAL INVESTIGATION**

### **PROPOSED SWIMMING POOL**

**47 CUTLER ROAD, CLONTARF**

**Project No.: 2020-235**

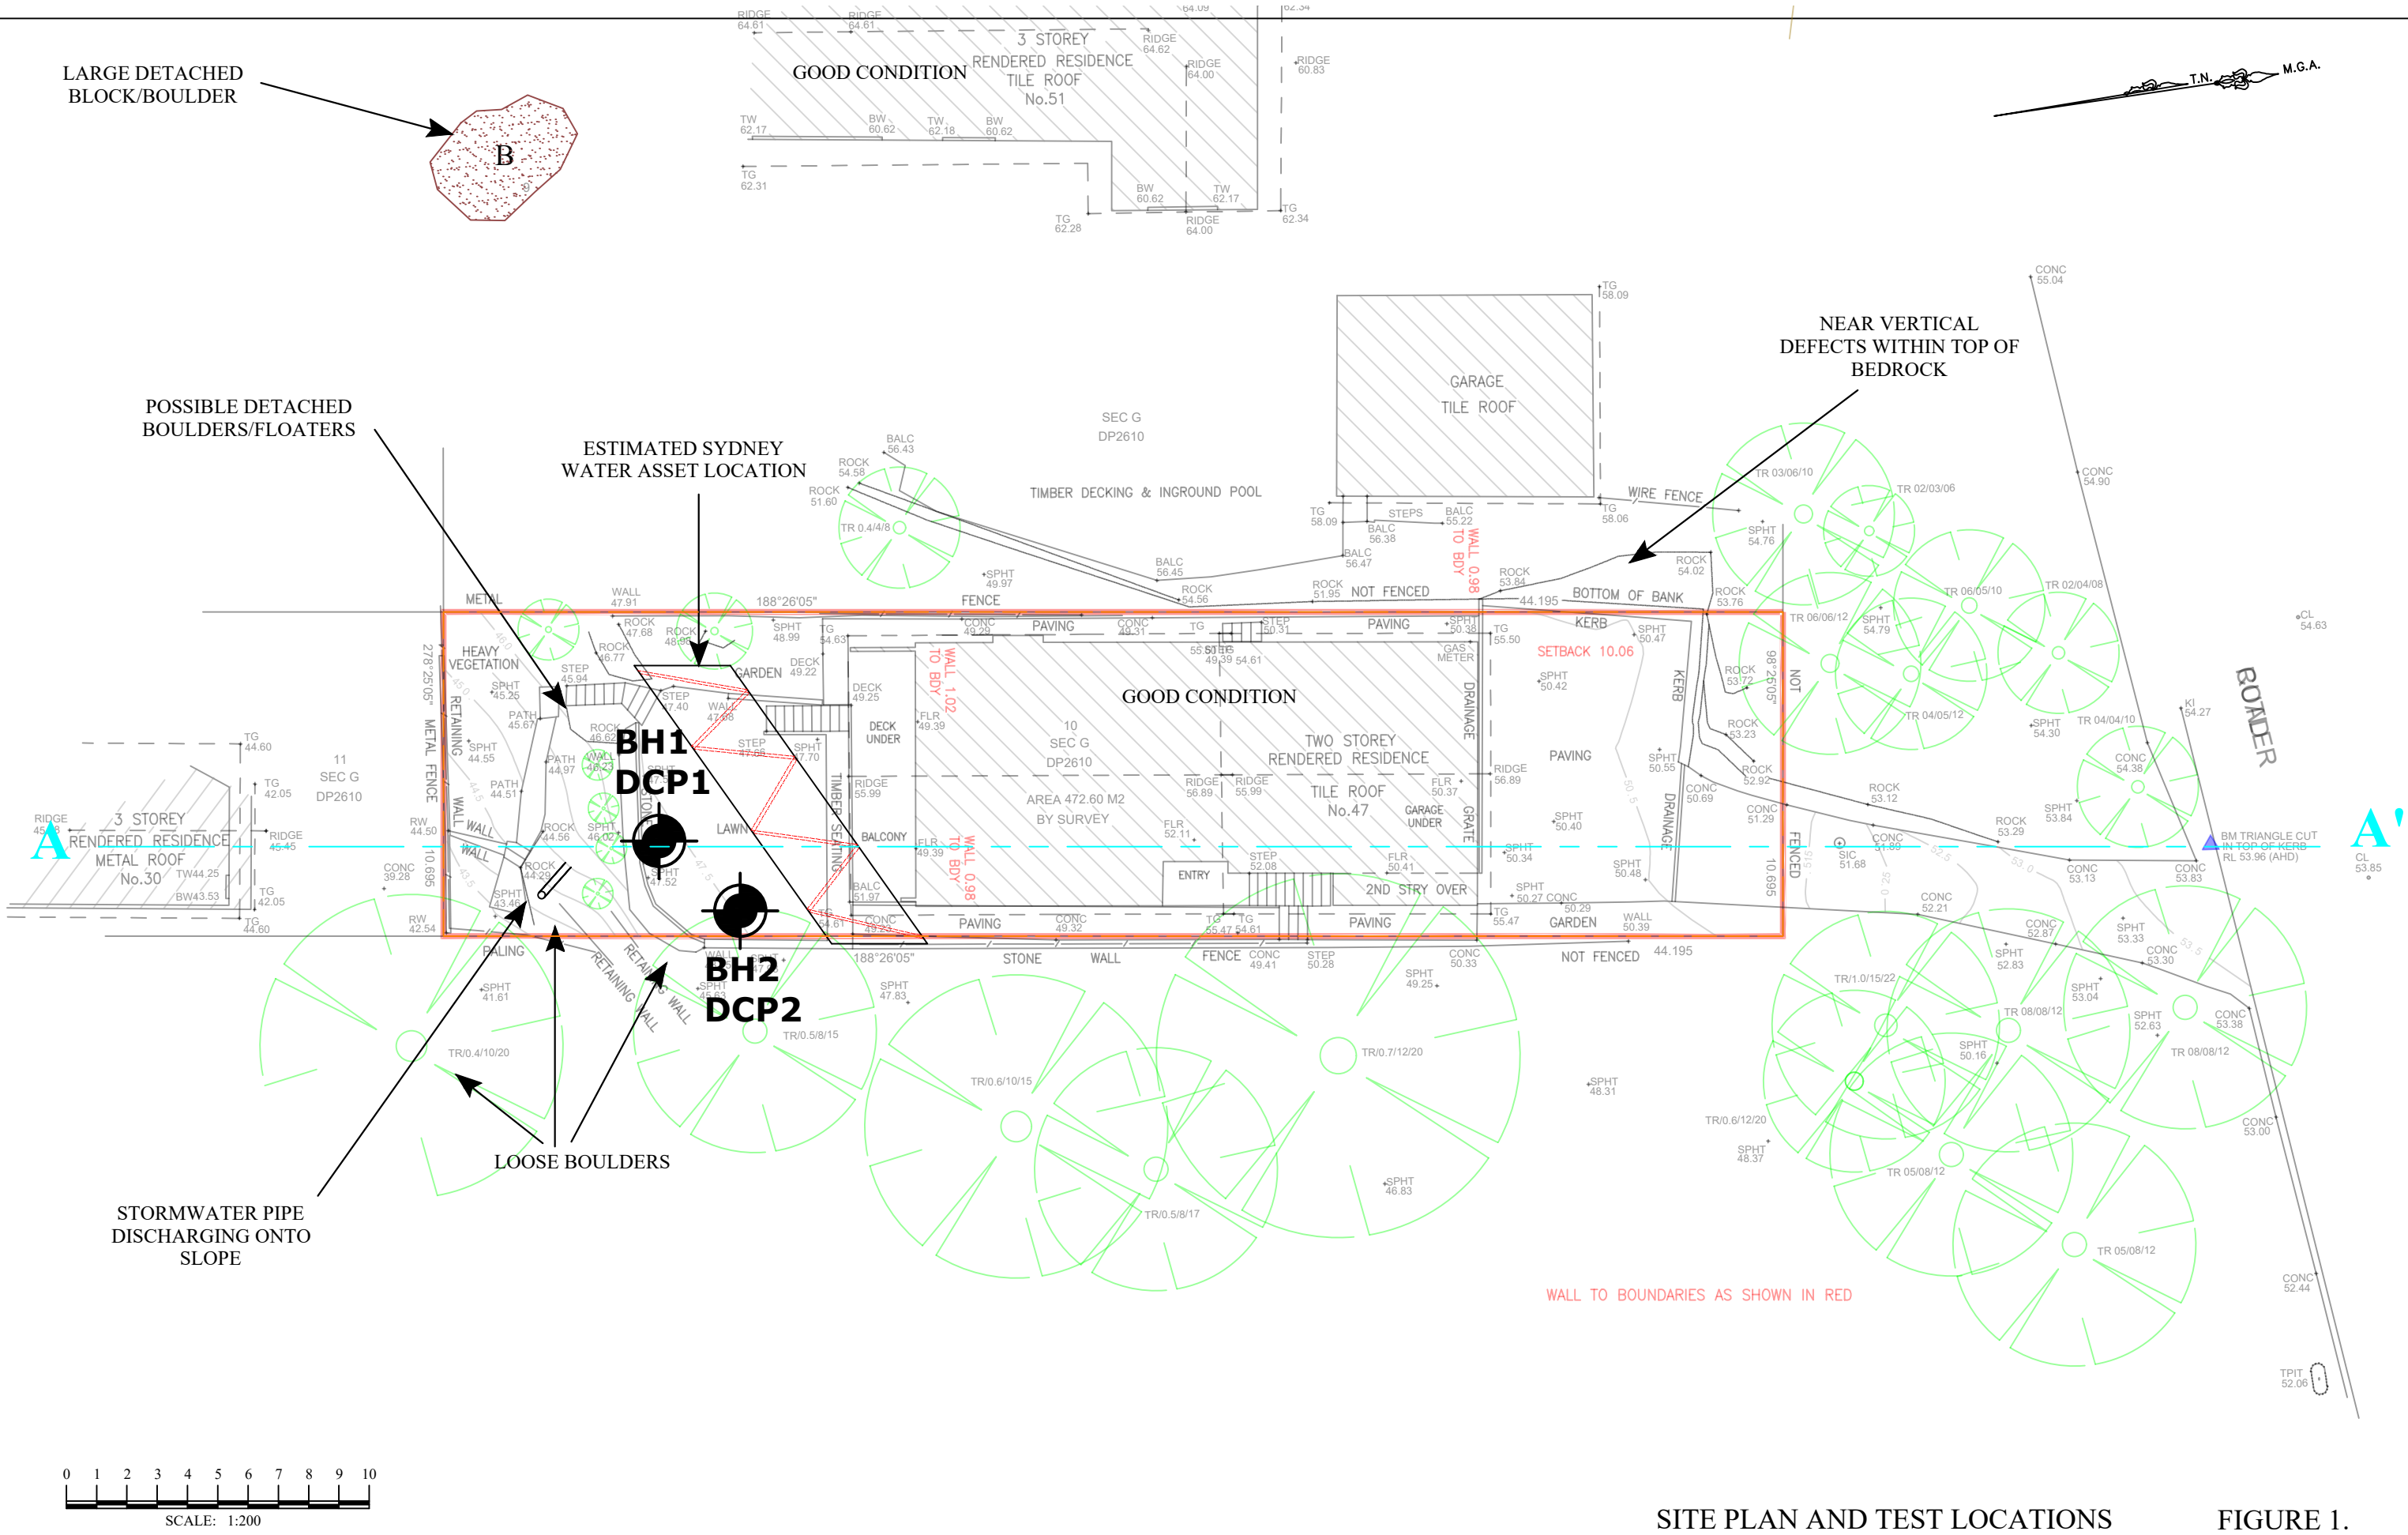
SITE PLAN AND TEST LOCATIONS FIGURE 1.

A Sydney Water (SW) asset is understood to underlie the site at the location indicated approximately on Figure 1. Available information indicates that asset may have been constructed sometime between 1924 and 1987 (based on the 'metropolitan water sewerage drainage board' operational period). It is recommended that Sydney Water be contacted as soon as possible to confirm what asset protection measures may be required as measures required to protect SW assets can have significant impact on project design as well as construction timetables, particularly where older assets are potentially impacted.

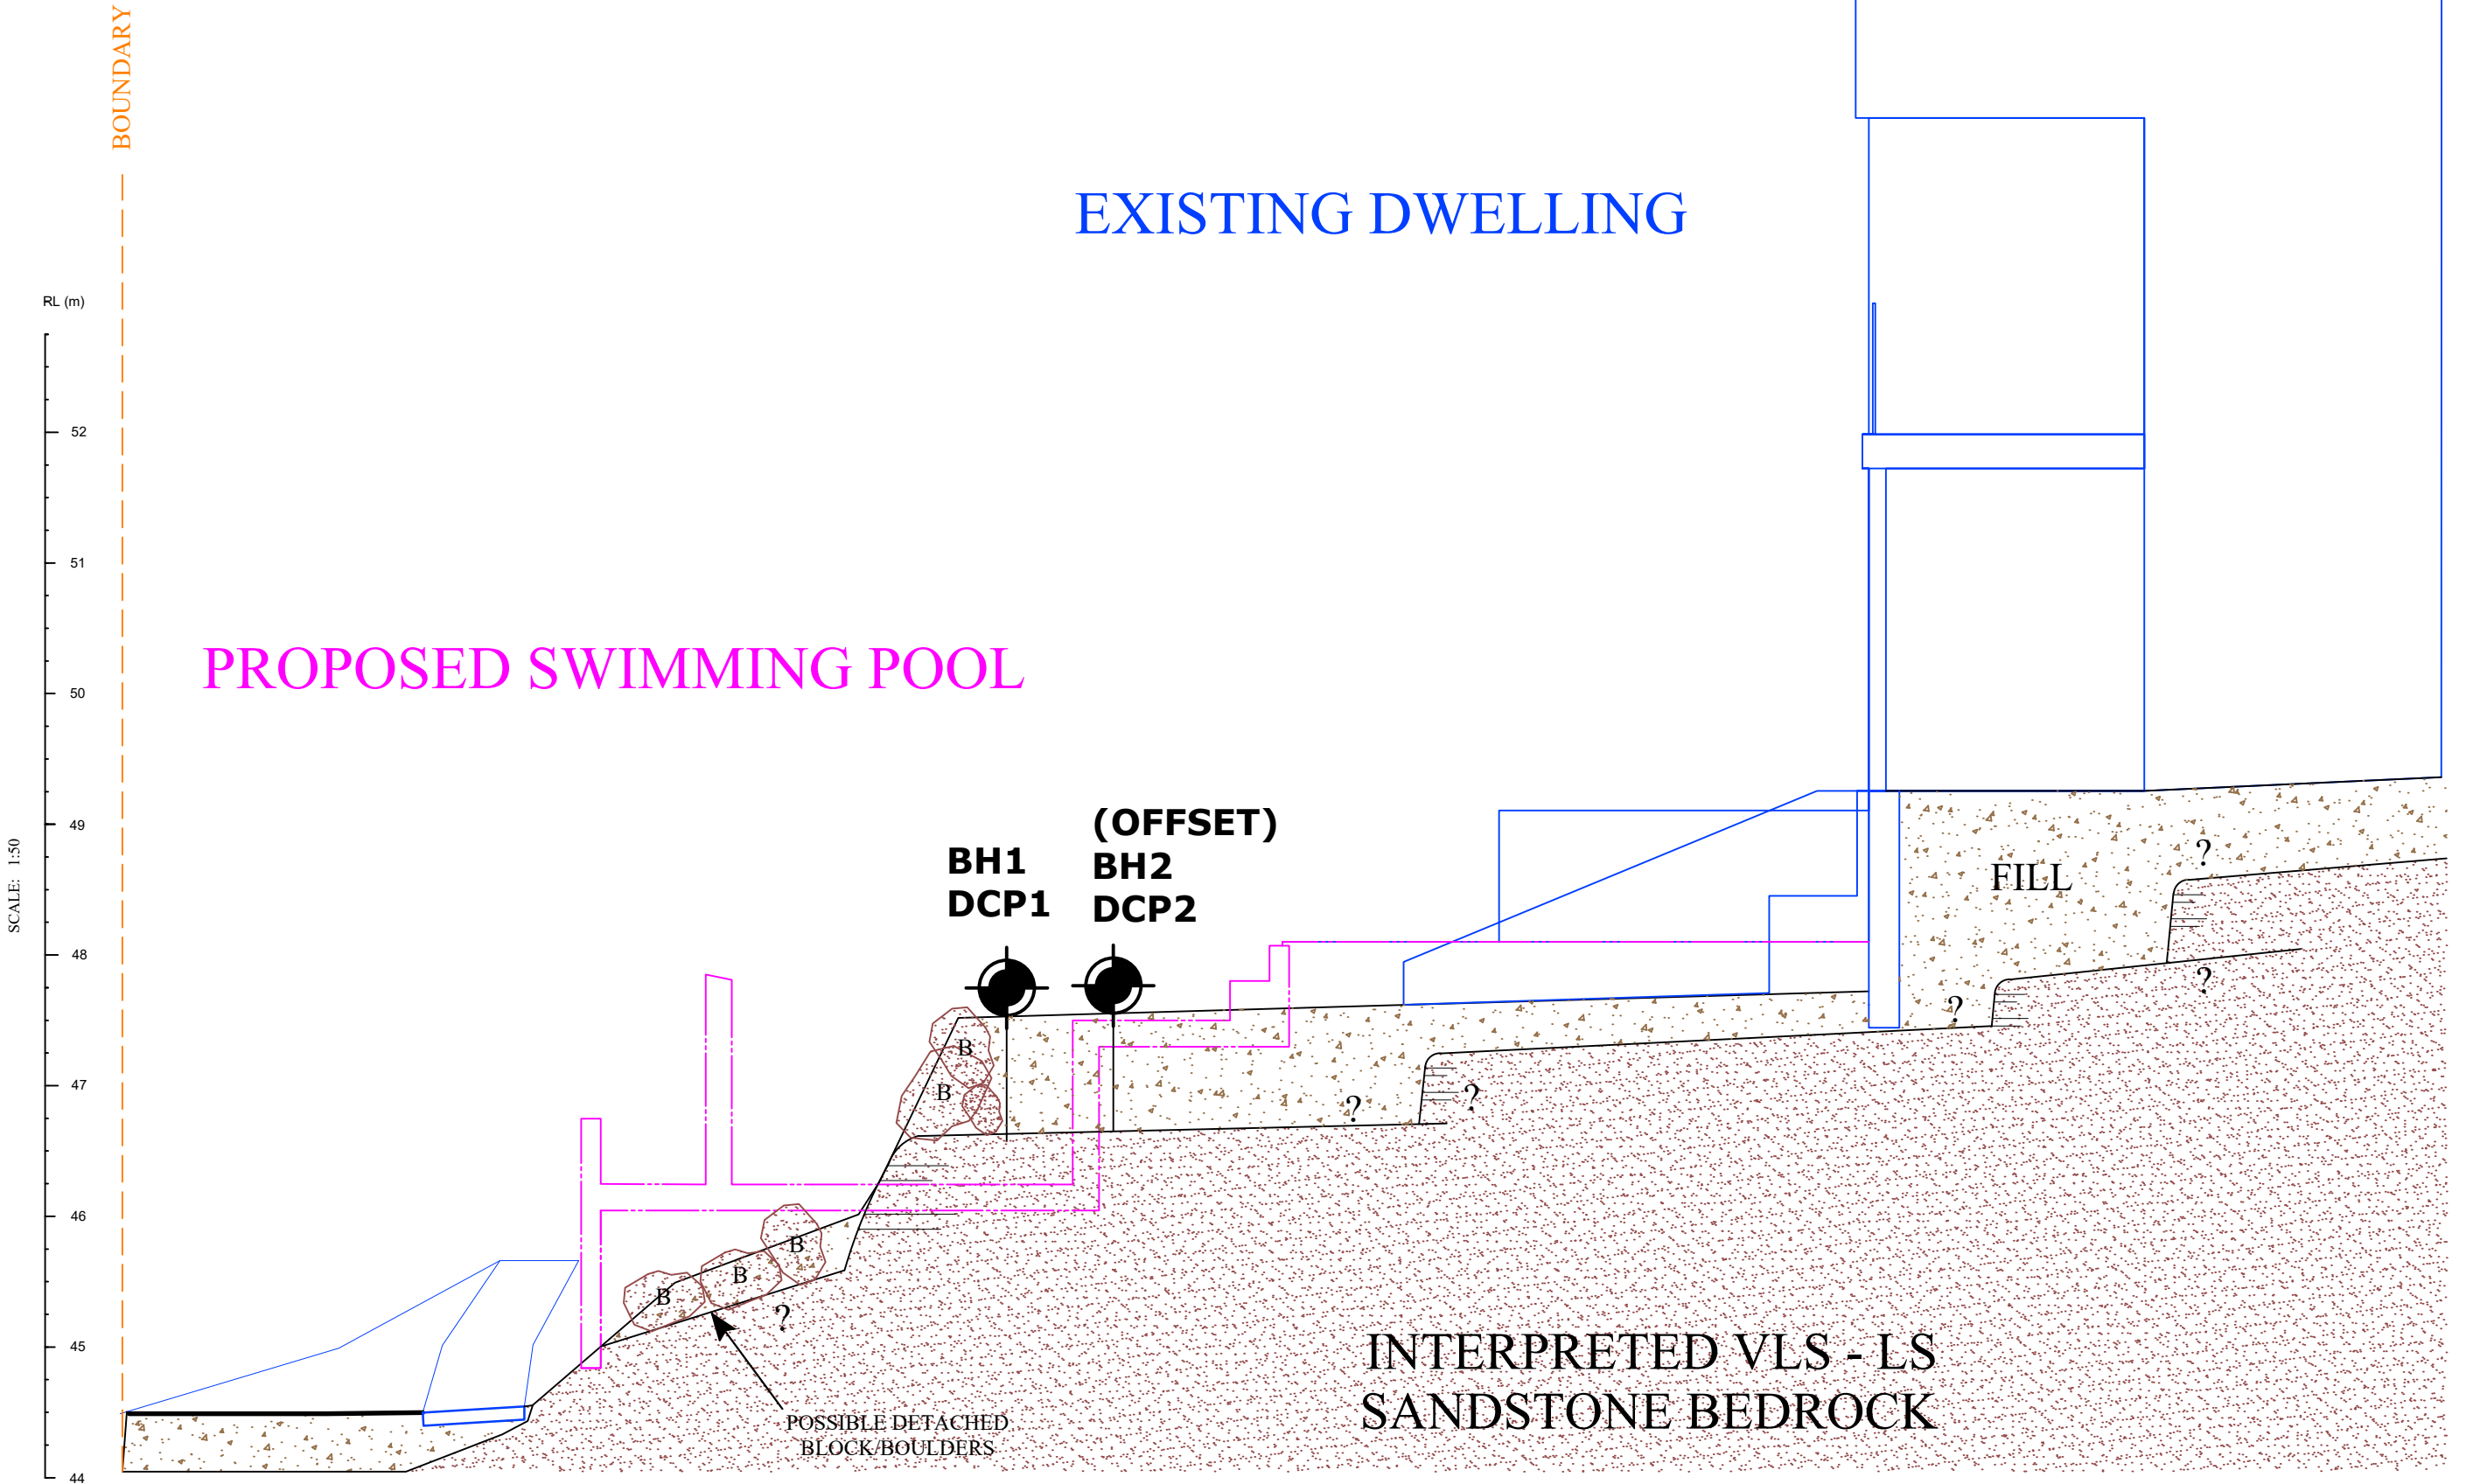
NB. FOR LOCATION OF SECTION  
A-A', PLEASE REFER TO FIGURE 1.  
SITE PLAN AND TEST LOCATIONS

The site investigation identified the presence of a layer of predominately sandy fill to a maximum depth of 0.9m underlain by a layer of jointed/fractured sandstone underlain by better quality sandstone which appeared to be at least very low strength from around 0.9m-1.0m and likely significantly stronger based on adjacent bedrock exposures.
