Report Title: Geotechnical Report 25 Alleyne Avenue, North Narrabeen
Report Date: 15/12/21

GEOTECHNICAL INVESTIGATION:

New House at **25 Alleyne Avenue, North Narrabeen**

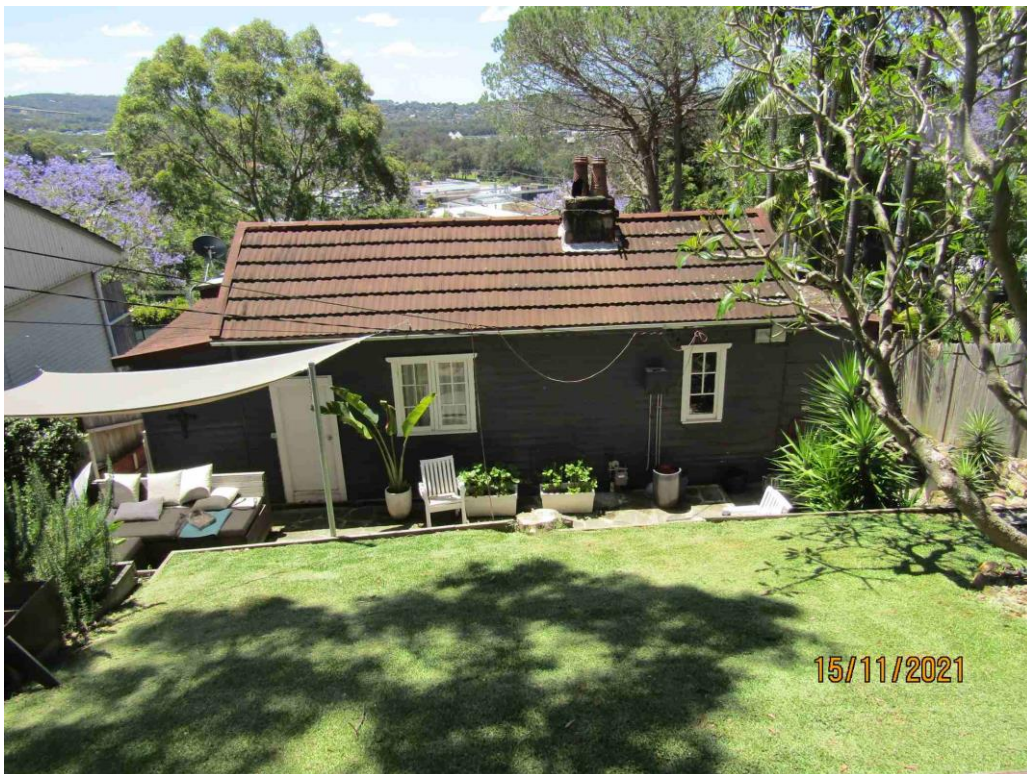
Photo 3

- 2.3** At the road frontage, a gravel driveway runs to a gravel parking area (Photo 1). Fill provides a level platform for the parking area. The fill is supported by a timber retaining wall ~1.5m high (Photo 2). The wall is tilting at up to ~6.3° downslope, but will be demolished as part of the proposed works. A lawn area extends off the downhill side of the retaining wall. A sandstone and timber retaining wall up to ~1.9m high supports the fill for the lawn and a cut for a stone paved area below (Photo 3). The

wall is bulging slightly, but will be demolished as part of the proposed works. The old single storey weatherboard clad house is supported by sandstone block walls, sandstone block piers and timber posts (Photos 4 & 5). The supporting walls and piers stand vertical and show no significant signs of movement (Photo 6). Lawn and garden areas extend off the downhill side of the house (Photos 5 & 7). Fill provides level platforms in the slope for the lawn and garden areas. The upper fills are supported by low sandstone block retaining walls. The lower fill is unsupported but is battered at stable angles. No signs of slope instability were observed on the property. The adjoining neighbouring properties were observed to be in good order as seen from the street and subject property.

The existing ~1.5m high timber retaining wall supporting the fill for the parking area (Photo 2) and existing sandstone block retaining wall (Photo 3) are to be demolished from the top down prior to the excavation commencing. The fill, soil and clay behind the walls is to be battered at 1.0 Vertical to 1.7 Horizontal (30°) as the walls are demolished. The upper ~0.8m of the parking area fill will be excavated for the proposed new driveway. The remainder of the fill is to be removed or battered at 1.0 Vertical to 2.0 Horizontal (26°) prior to the excavation for the house commencing.
