H2O Consulting Group Pty Ltd

Marine Habitat Survey: 23 and 25 – 33 Robertson Road, Scotland Island

February 7, 2018

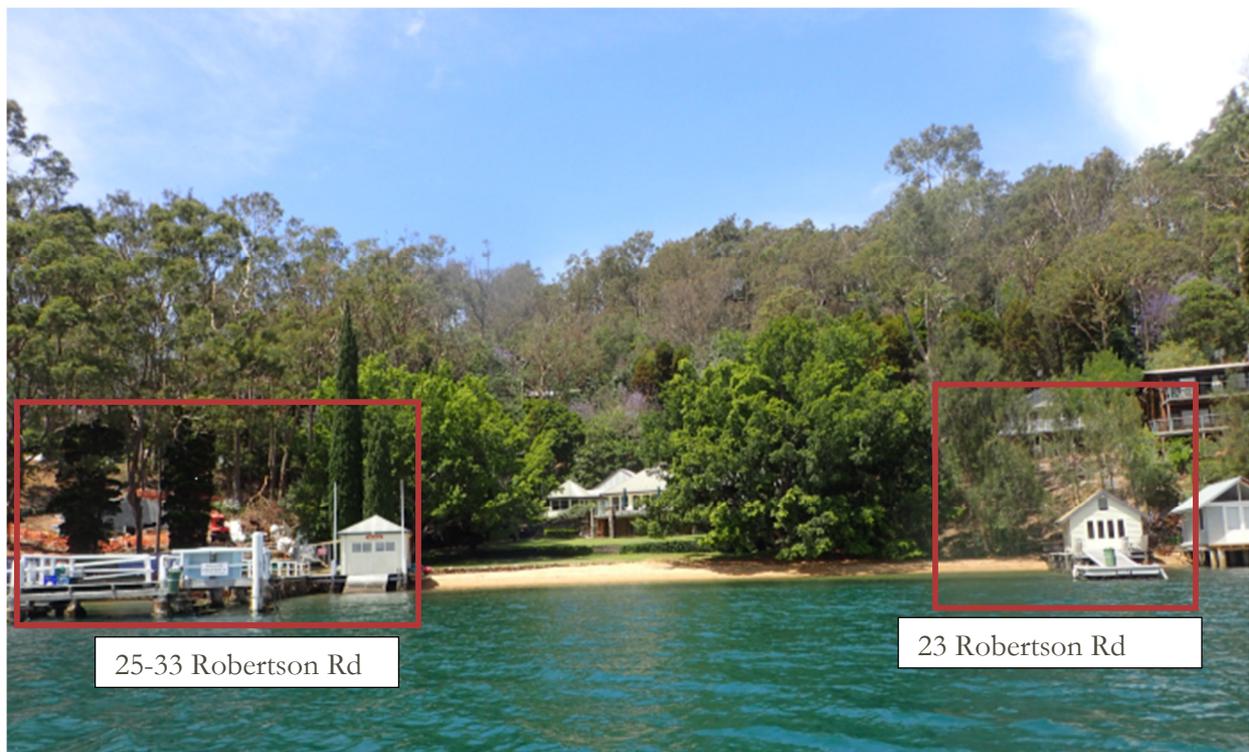
The works are proposed on two adjacent water front land parcels (Figure 2), with individual plans provided for both 23 Robertson Road (Figure 3) and 25-33 Robertson Road (Figure 4).

Figure 2: Photo of the subject site.
