## **GEOTECHNICAL INVESTIGATION:**

### **Alterations and Additions at 37 Daly Street, Bilgola Plateau**

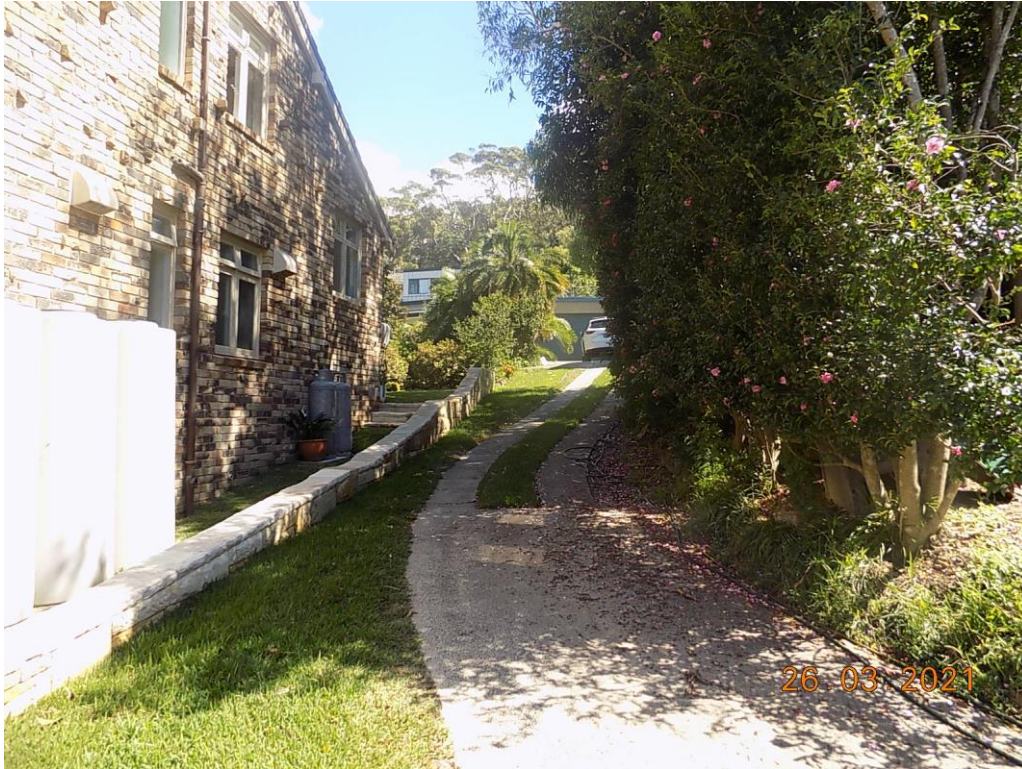
Photo 1

- 2.1** The site was inspected on the 26<sup>th</sup> March, 2021.
- 2.2** This residential property is on the high side of the road and has a E aspect. It is located on the moderate to gently graded upper reaches of a hillslope. The natural slope rises across the property at an average angle of ~10°. The slopes above and below the property continue at moderate angles.
- 2.3** At the road frontage, a concrete driveway runs up the slope to a brick garage at the S side of the house (Photo 1). The garage has been cut into the slope. The cut for the garage is supported by a stable concrete block retaining wall (Photo 2). Along the driveway, between the road frontage and the garage, a ~1.0m high sandstone block retaining wall supports a cut for an additional parking area (Photo 3). A timber deck and pool extend off the downhill side of the house. The deck is supported on
