J5044 6th October, 2023 Page 1.

GEOTECHNICAL INVESTIGATION:

New Inclined Lift at 948 Barrenjoey Road, Palm Beach

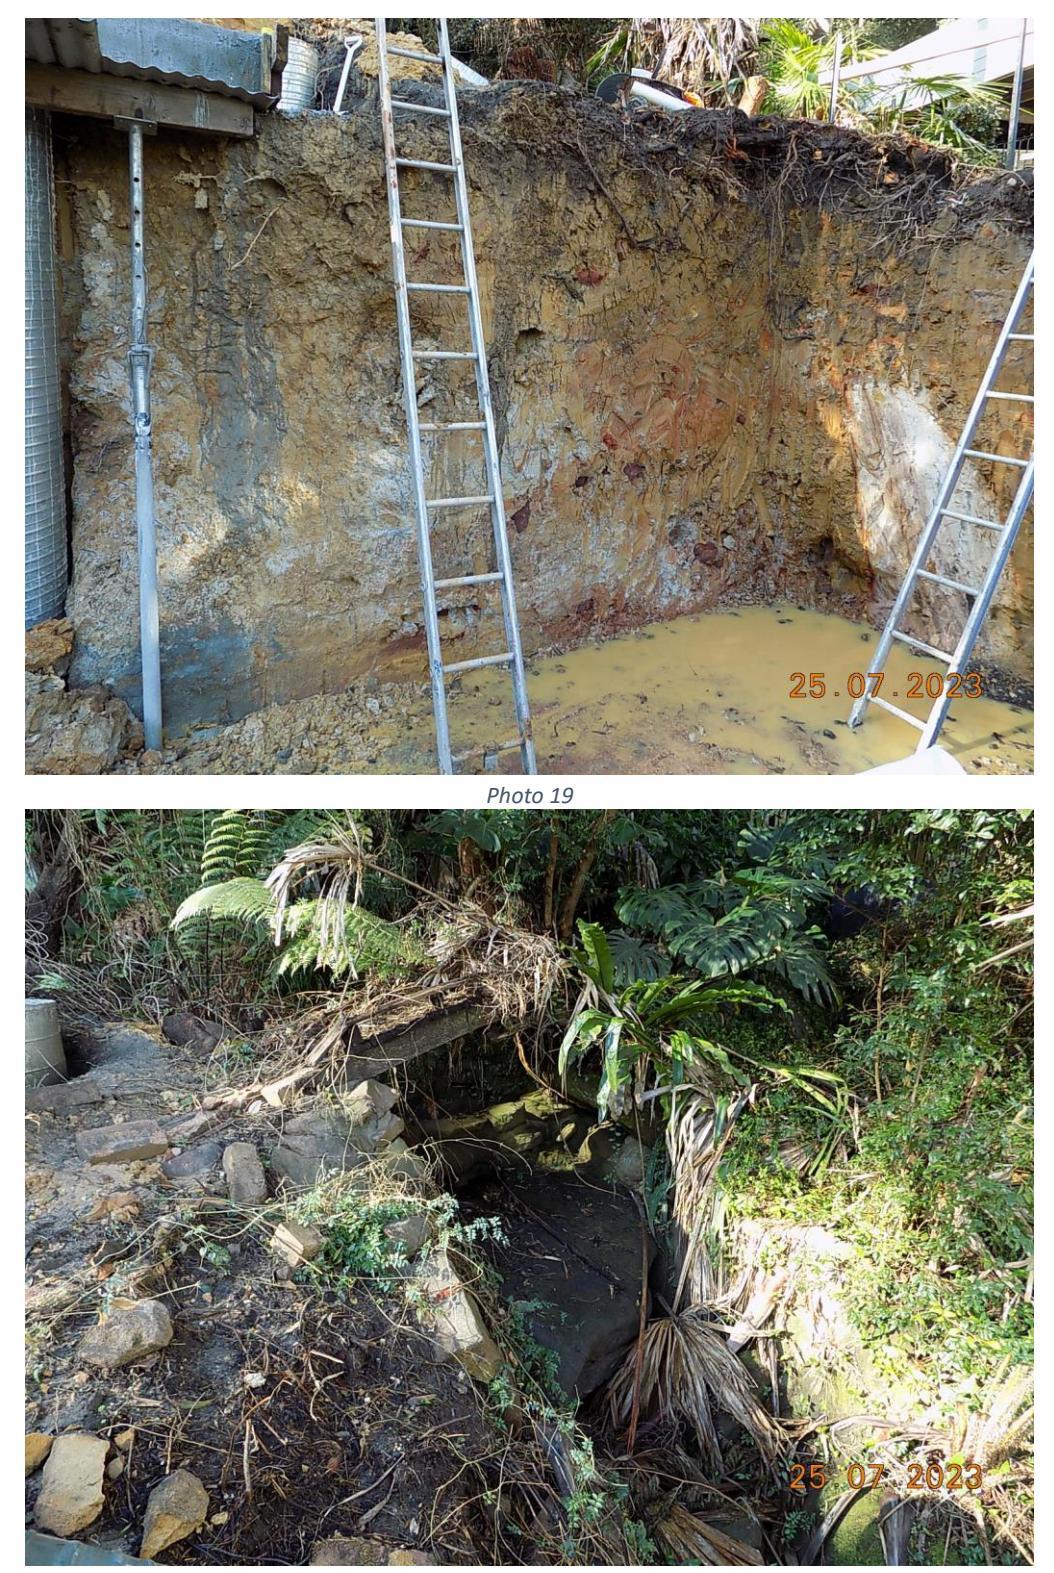
Photo 20

Ground water seepage is expected to move over the denser layers in the profile including the surface of the natural clay buried under the fill/soil and the buried surface of the weathered rock under the clay. As a natural watercourse runs down the slope to the N of the property (Photo 20), we expect groundwater seepage to be higher across the block as slope seepage will move toward the watercourse. Due to the slope and elevation of the block, the water table is expected to be many metres below the base of the proposed excavation.
