Report Title: Geotechnical Report 1164 Barrenjoey Road, Palm Beach
Report Date: 6/11/24

GEOTECHNICAL INVESTIGATION:

New House at **1164 Barrenjoey Road, Palm Beach**

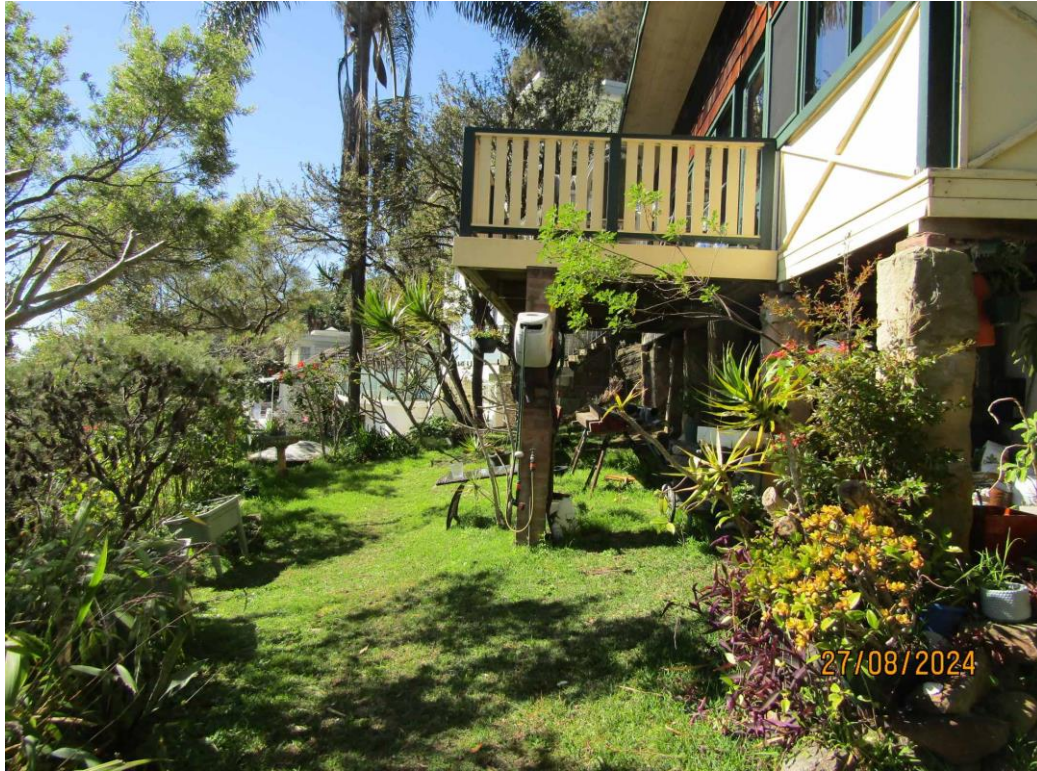
Photo 3

2.3 A steeply graded garden area rises from the road frontage (Photos 1 & 2). Fill to an estimated depth of ~1.0m provides a level platform for a lawn area at the downhill side of the house (Photo 3). The fill batter merges into the natural steep slope below (Photos 1 & 2). The single storey house with balcony is supported on sandstone block walls, sandstone block piers and brick piers (Photos 3 & 4). Some of the supporting piers are tilting downslope slightly (Photo 4), but the house will be demolished as part of the proposed works. Medium Strength Sandstone bedrock outcrops at the uphill side of the house and steps up the steep slope at the uphill side of the property (Photos 5 to 7). Some of the exposed rock faces display some minor jointing and undercutting, but appear to be currently stable. The slope across the uphill side of the property is densely vegetated (Photo 8).
