J2125A. 20th February, 2020 Page 1.

18 Alexander Street, Collaroy

Comments on Updates to Plans

GEOTECHNICAL INVESTIGATION:

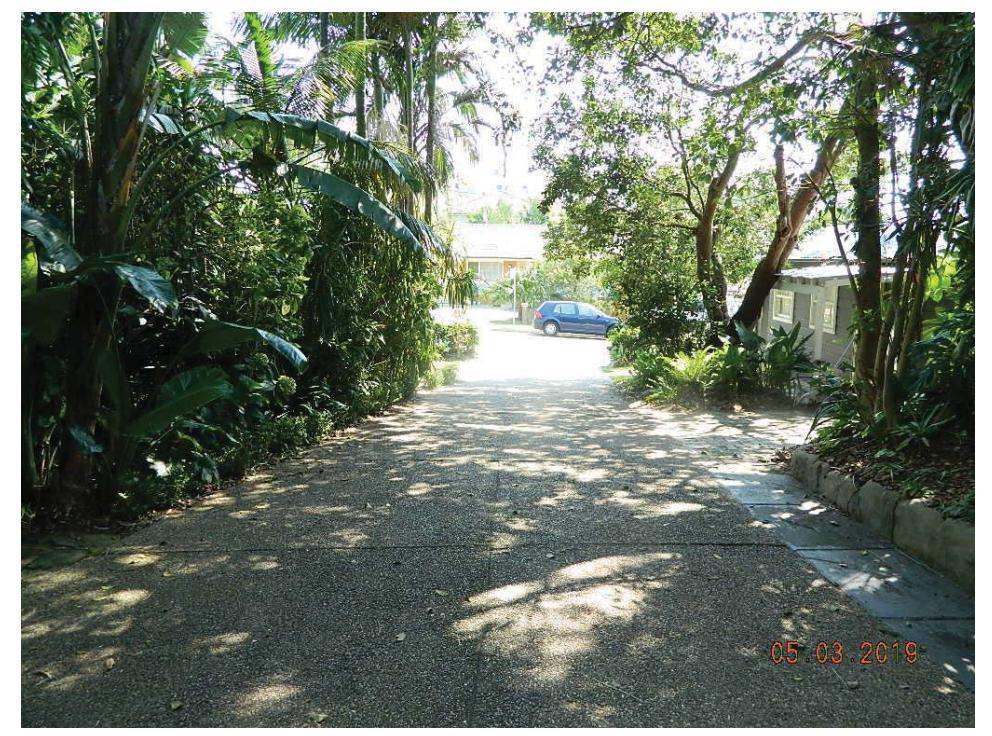
Photo 3

2.3 At the road frontage, a concrete driveway runs to a garage beneath the house (Photo 1). A free standing studio is located beside the driveway (Photo 2). A gravel driveway runs up the slope to a car parking space on the E side of the studio (Photo 3). The area between the road frontage and the house is otherwise densely vegetated (Photo 4). The majority of the part three storey brick house will be demolished as part of the proposed works (Photo 5). A stable timber retaining wall reaching a maximum height of ~1.0m terraces the

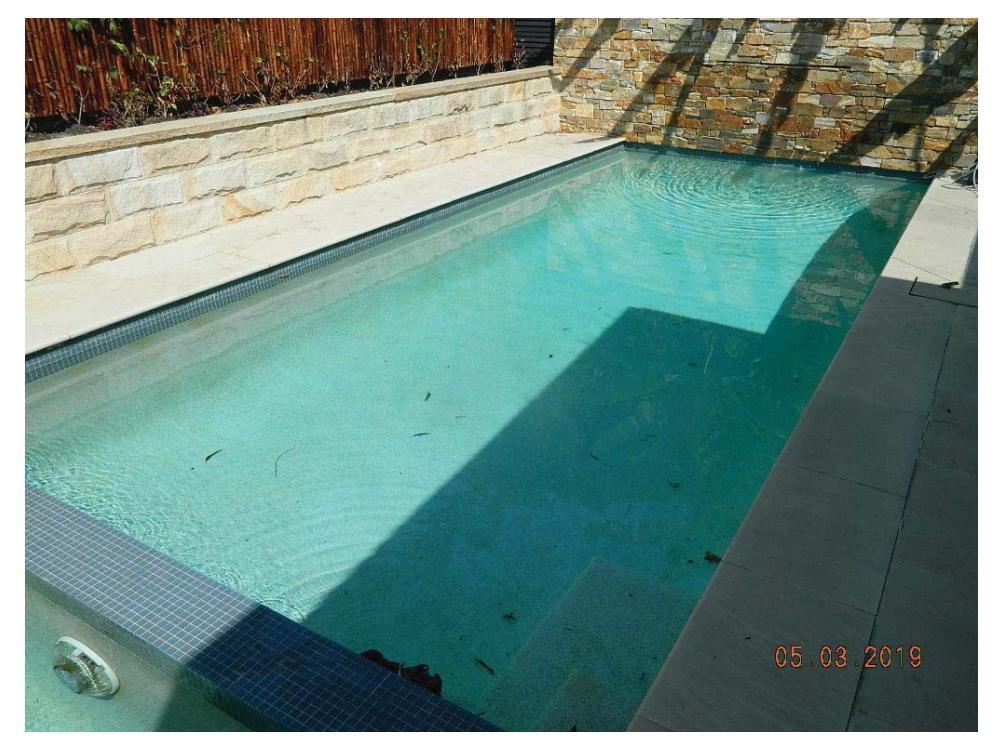
Photo 7

slope on the E side of the house. The wall retains a fill that levels a lawn area above (Photo 6). A near level lawn area rises from the uphill side of the house to a stable ~0.5m high sandstone block retaining wall along the uphill boundary (Photo 7). A recently constructed pool in the SW corner of the property is in good condition with no signs of cracking or movement in the pool shell (Photo 8). No signs of movement were observed on the grounds. The adjoining neighbouring properties were observed to be in good order as seen from the road and the subject property. No geotechnical hazards were observed on these properties that could impact on the subject property.
