54 Bardo Road, Newport

Geotechnical Comments for Section 4.55.

GEOTECHNICAL INVESTIGATION:

New Seniors Housing Complex at 54 Bardo Road, Newport

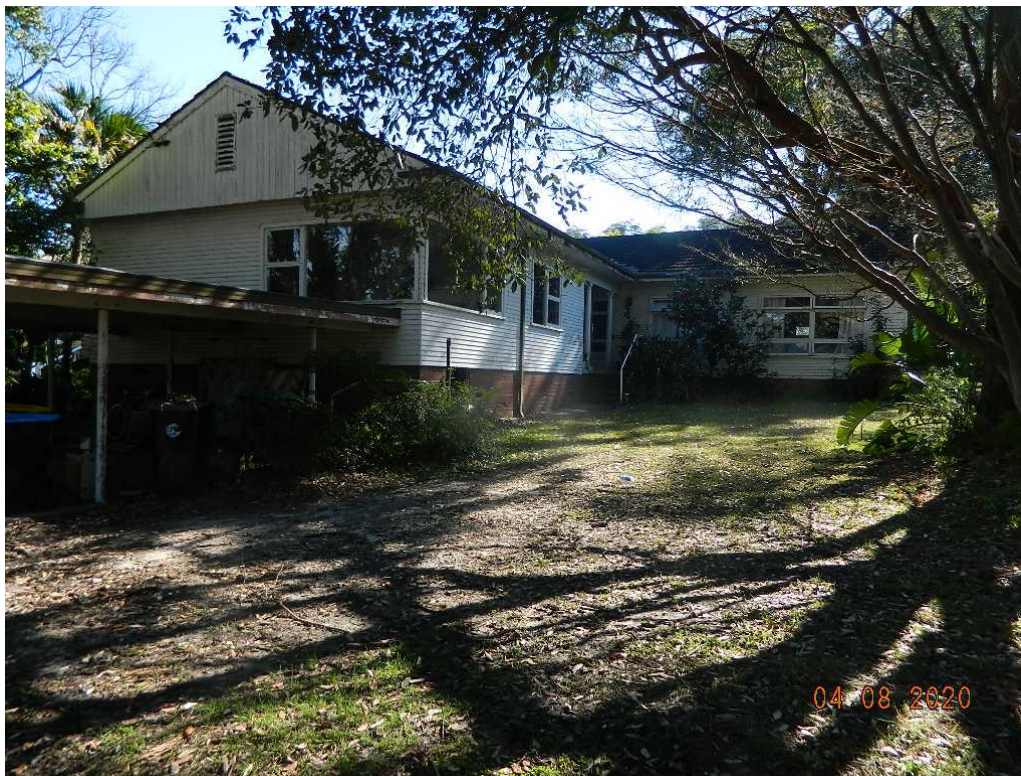
Photo 2

- 2.3** At the road frontage, a concrete driveway runs to a carport on the downhill side of the house (Photos 1 & 2). A gently sloping lawn is located E of the driveway, carport and house (Photo 3). The one storey brick and timber clad house is supported by brick walls and brick piers (Photo 3). The supporting walls and piers stand vertical and show no significant signs of movement (Photo 4). A gently sloping lawn extends from the uphill side of the house to the uphill property boundary (Photo 5). A fibro shed is located near the NW corner of the property. The house and shed will be demolished and the site will be cleared as part of the proposed works. The adjoining
