arboricultural impact assessment report

AIA-01

Revision A, Issued for Authority Approval/DA 15 November, 2019

Allambie Heights Village - Project 2

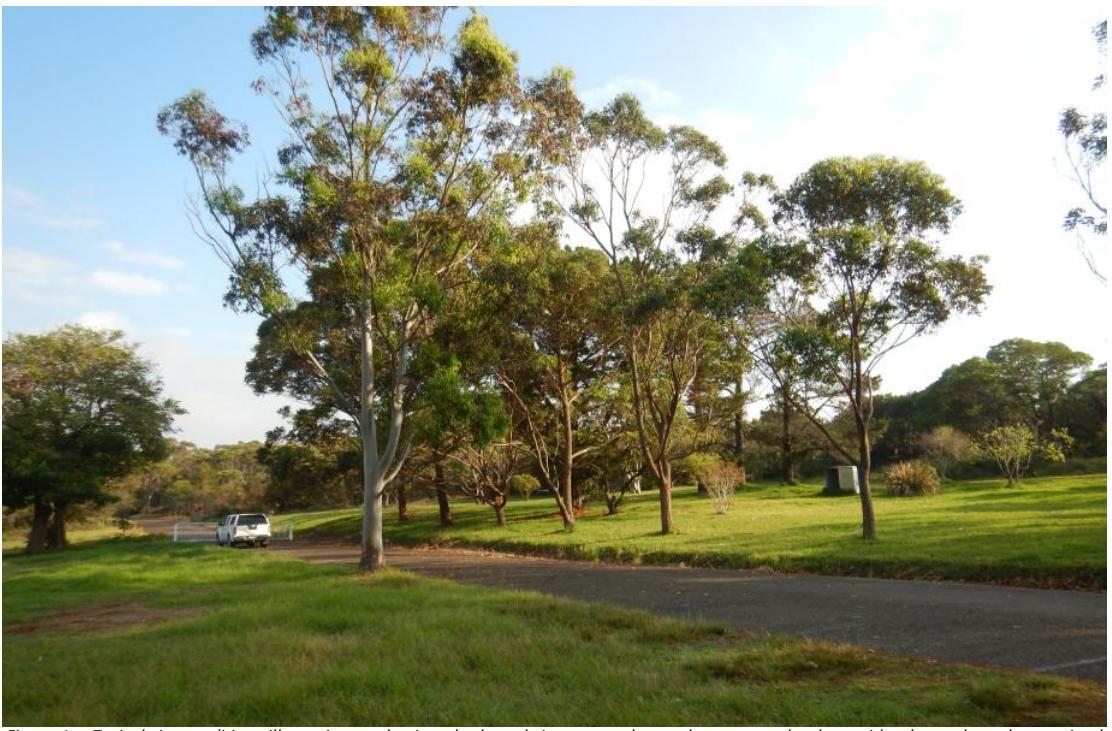
Figure 1 – Typical site conditions illustrating predominantly cleared site area and some larger trees that have either been planted or retained from pre-existing trees as amenity trees. (Photo: Arterra)

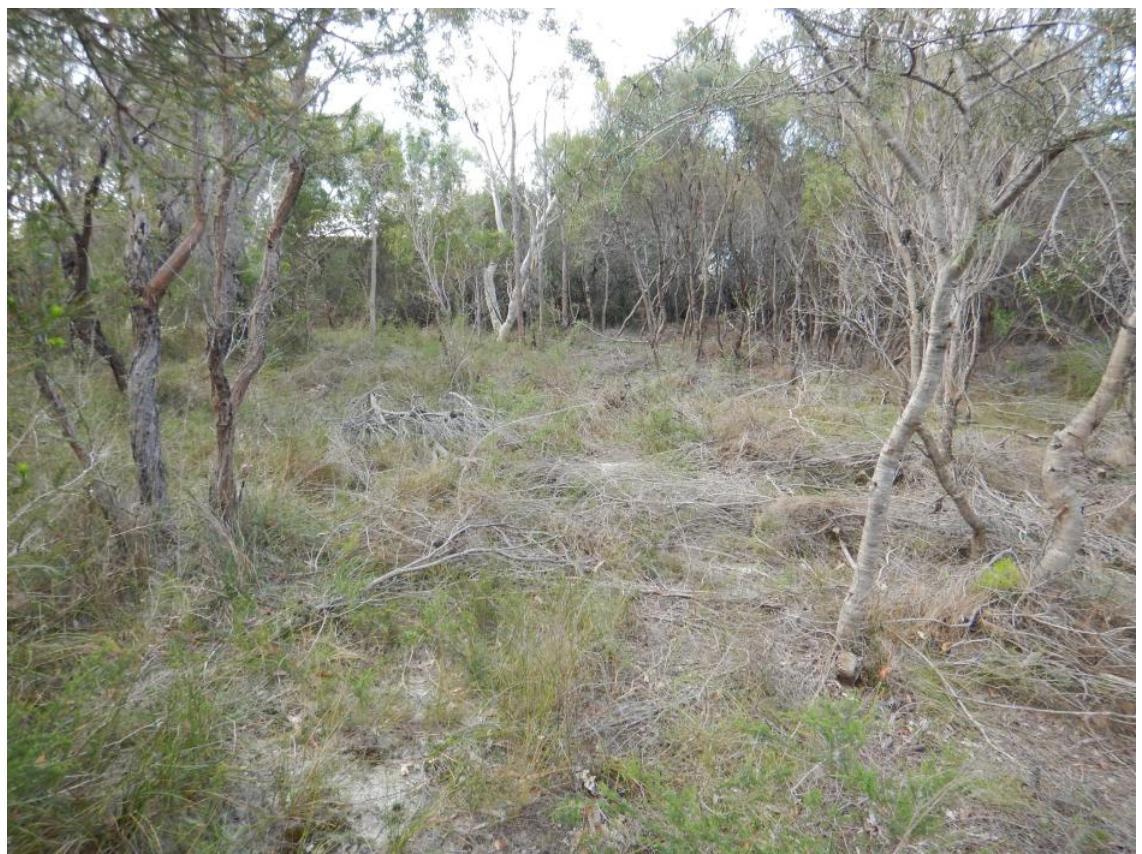
Figure 3 – The site and bushland areas to the west of the proposed development. The trees in this portion of the site are not addressed in this report but are covered in the ecological assessments. (Photo: Arterra 21/4/18)

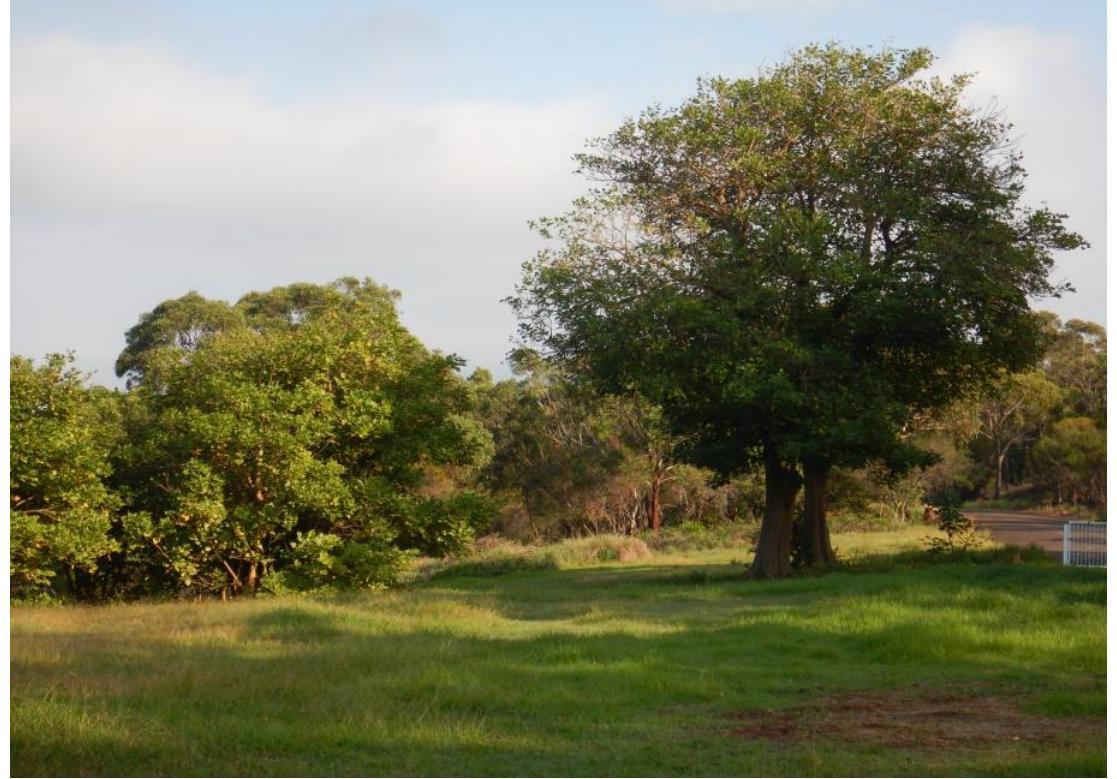
Figure 5 – View to south-west across the southern portion of the site. (Photo: Arterra 21/4/18).
