Development Application for _____ Name of Applicant
Address of site _____ 8 Forest Road, Warriewood, NSW

**REPORT TO
WARRIWOOD VALE PTY LTD**

**ON
GEOTECHNICAL ASSESSMENT
(In Accordance with Pittwater Council Risk
Management Policy)**

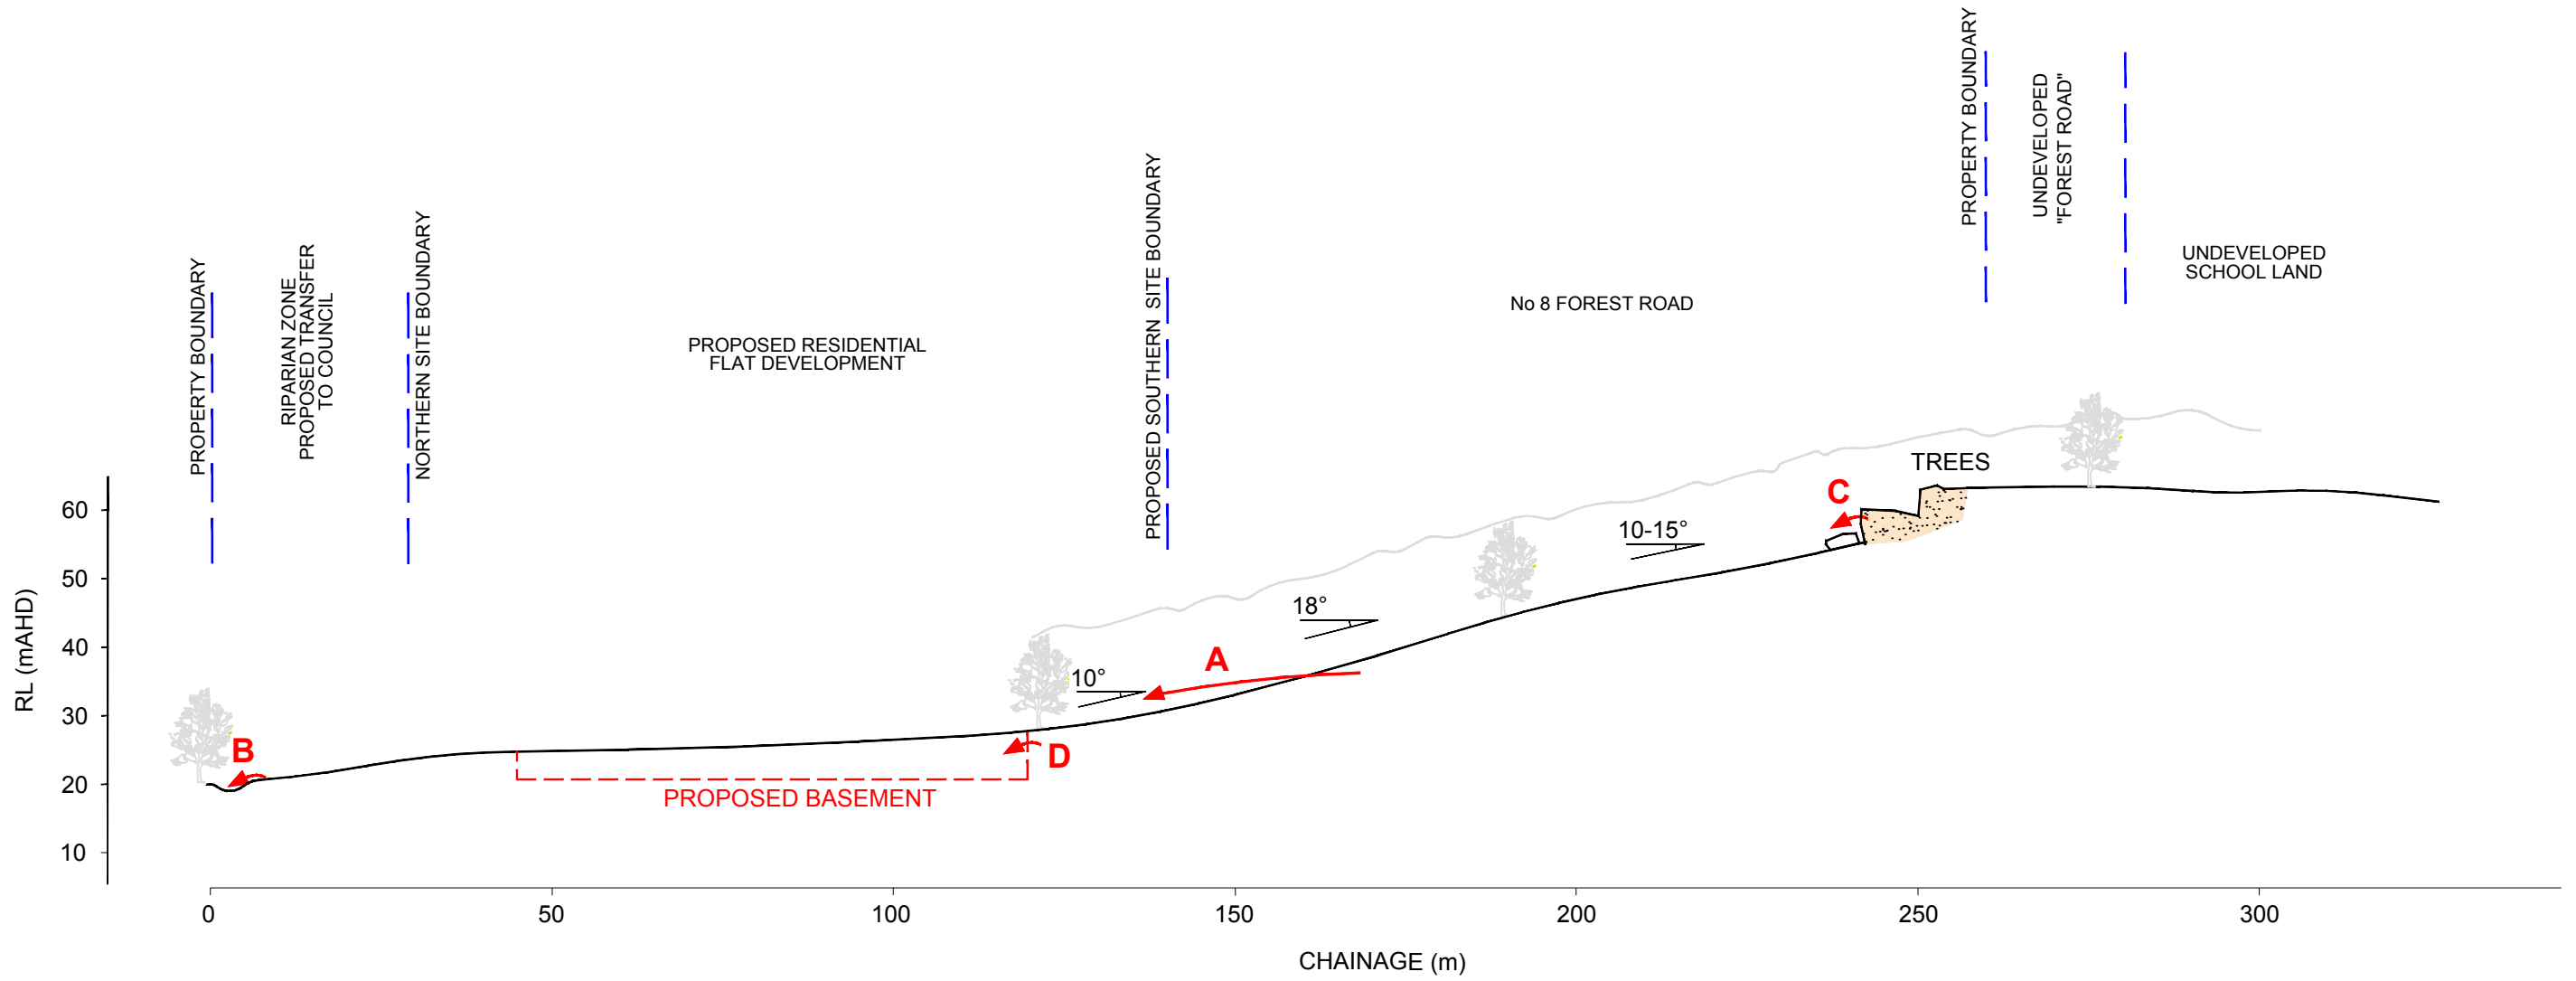
The attached Figure 2 presents a geotechnical sketch plan showing the principal geotechnical features present at the site. Figure 2 is based on the Partial Detail Survey of Lot 1 DP 5055 prepared by Pulver Cooper & Blackley (Ref. 87815, Rev G, dated 9/11/2017). Additional features on Figure 2 have been measured by hand held inclinometer and tape measure techniques and hence are only approximate. Should any of the features be critical to the proposed development, we recommend they be located more accurately using

These potential hazards are indicated in schematic form on the attached Figures 2 and 3.

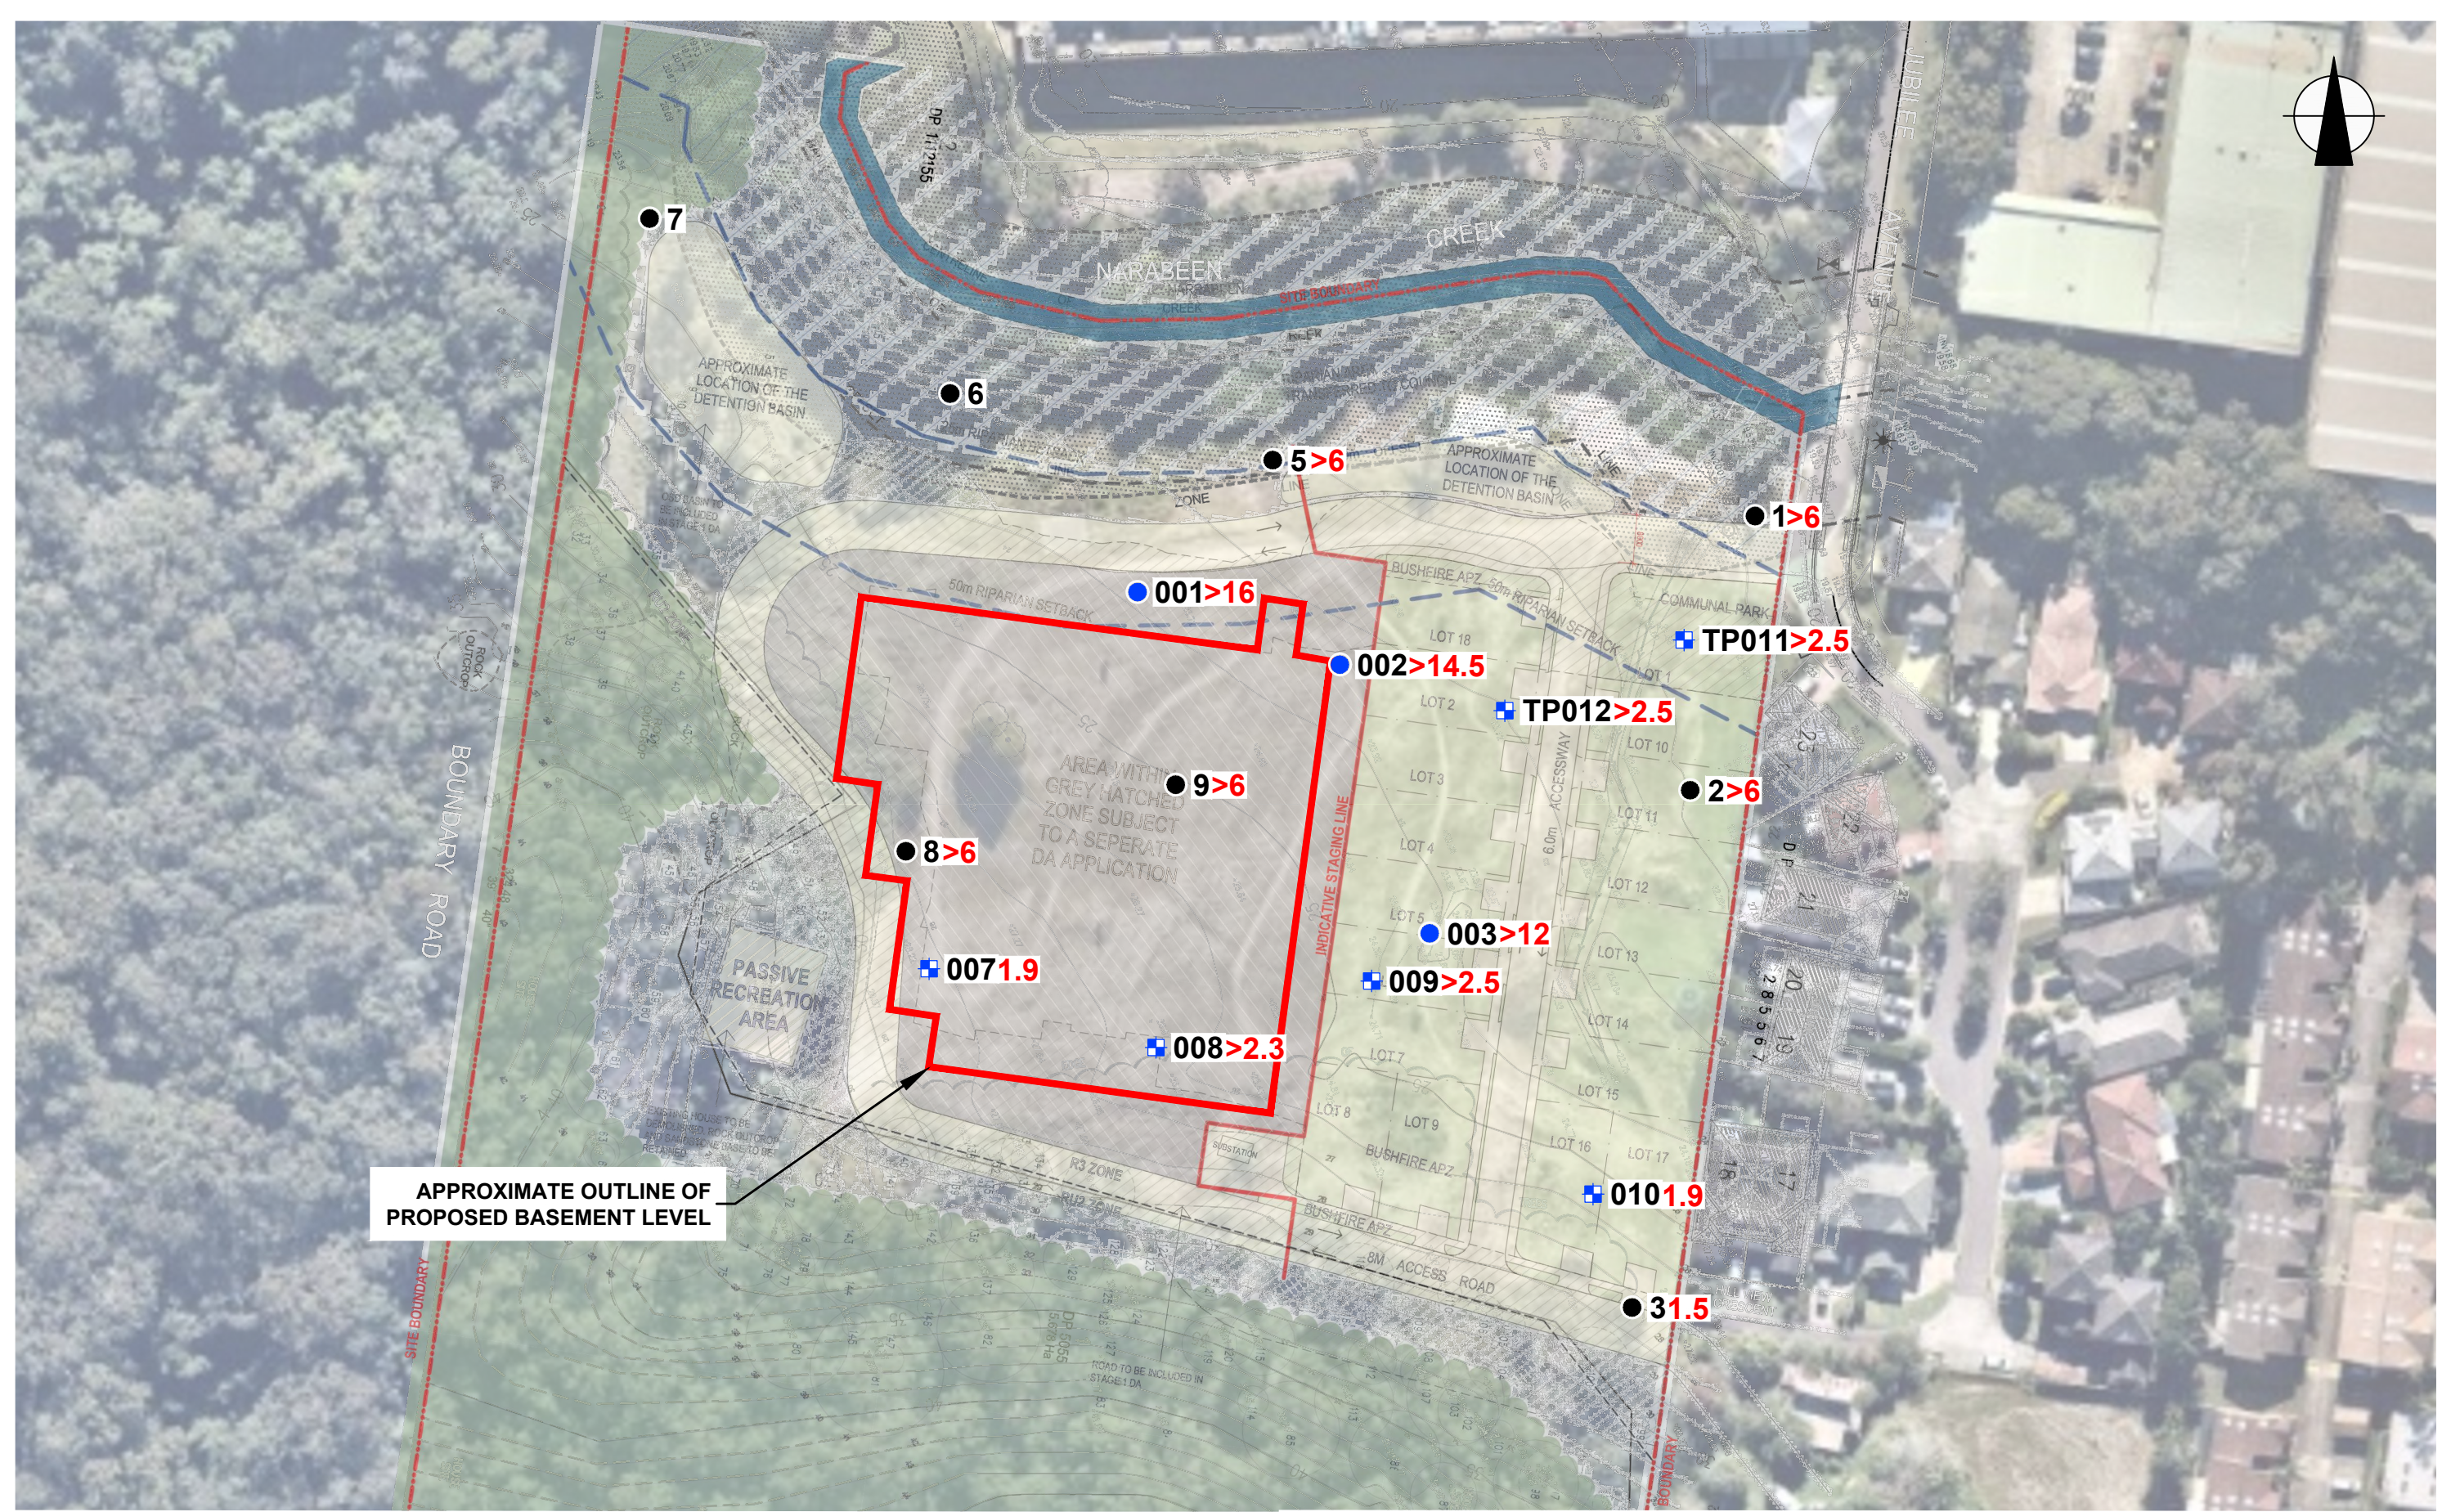
The locations of the relevant boreholes and test pits from the above two previous investigations are shown on Figure 4, which also shows the depths at each location where rock was encountered, or the termination depths if rock was not encountered. The proposed subdivision and basement outline (as per Jackson Teece architectural drawing DA-030 &109) are also shown on Figure 4, overlain on a Nearmap aerial image. It should be noted that the surface RLs of the Cardno test locations are unknown.
