Tree Consultants

ARBORICULTURE IMPACT ASSESSMENT *re Development Application (DA2018/0569) Submission* **JUNE 2018**

Site: Lot 20 in DP 22275
60 Binburra Avenue
AVALON BEACH, NSW 2107

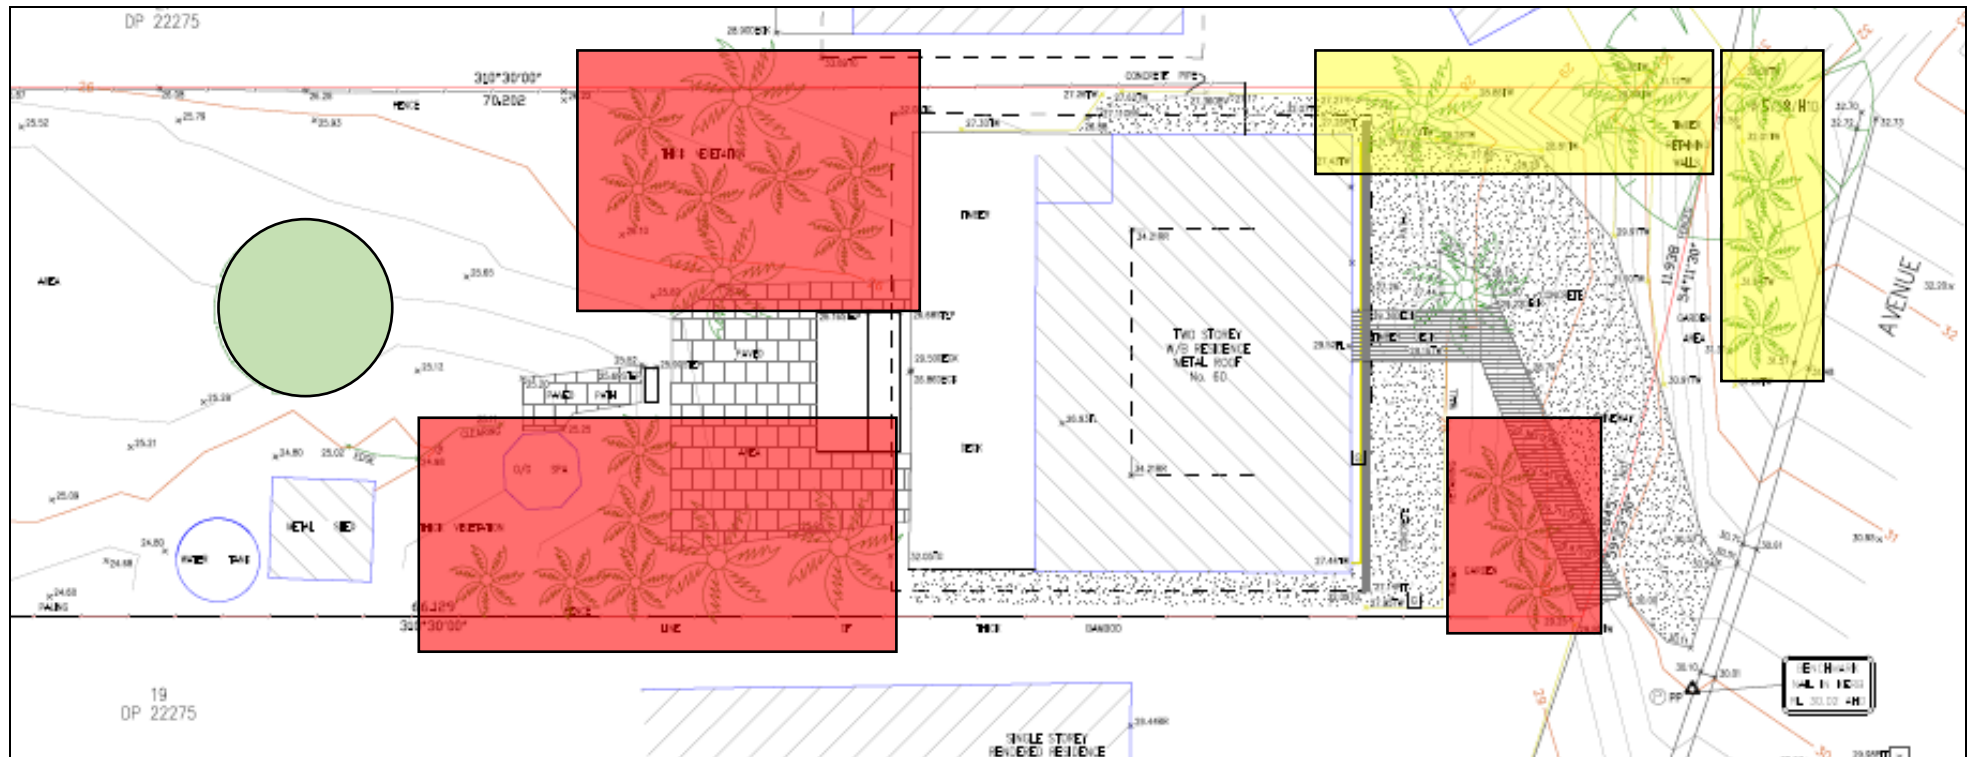
Figure 3: Illustrates portion of Site Survey with discussed tree is marked with a “green circle”. Trees marked within Yellow Boxes are not impacted upon by the DA proposal. Trees within Red Boxes are largely proposed to be removed/replaced.

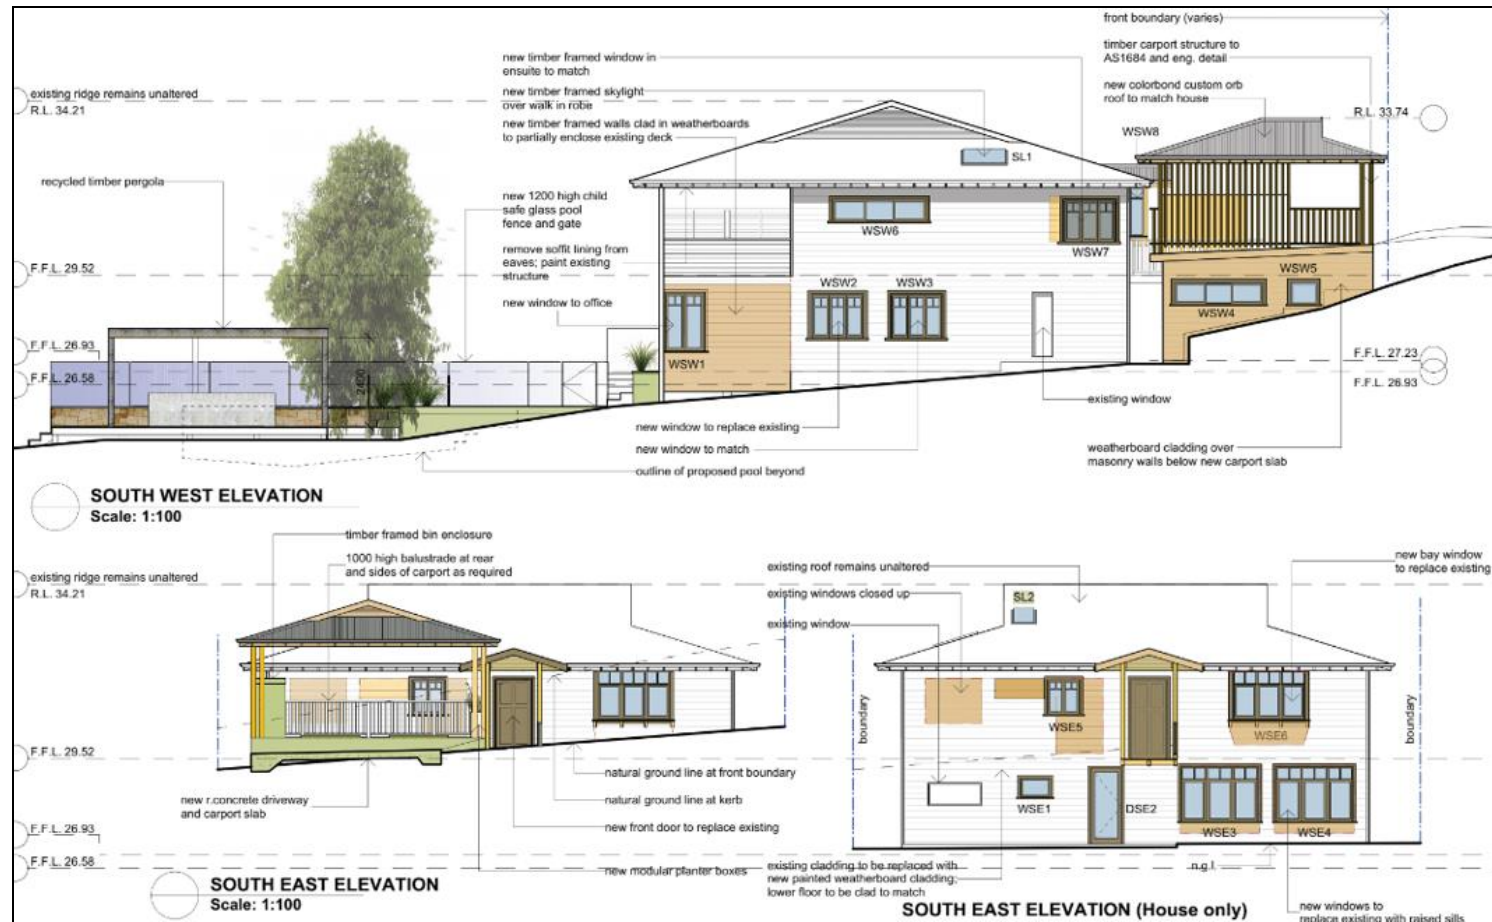
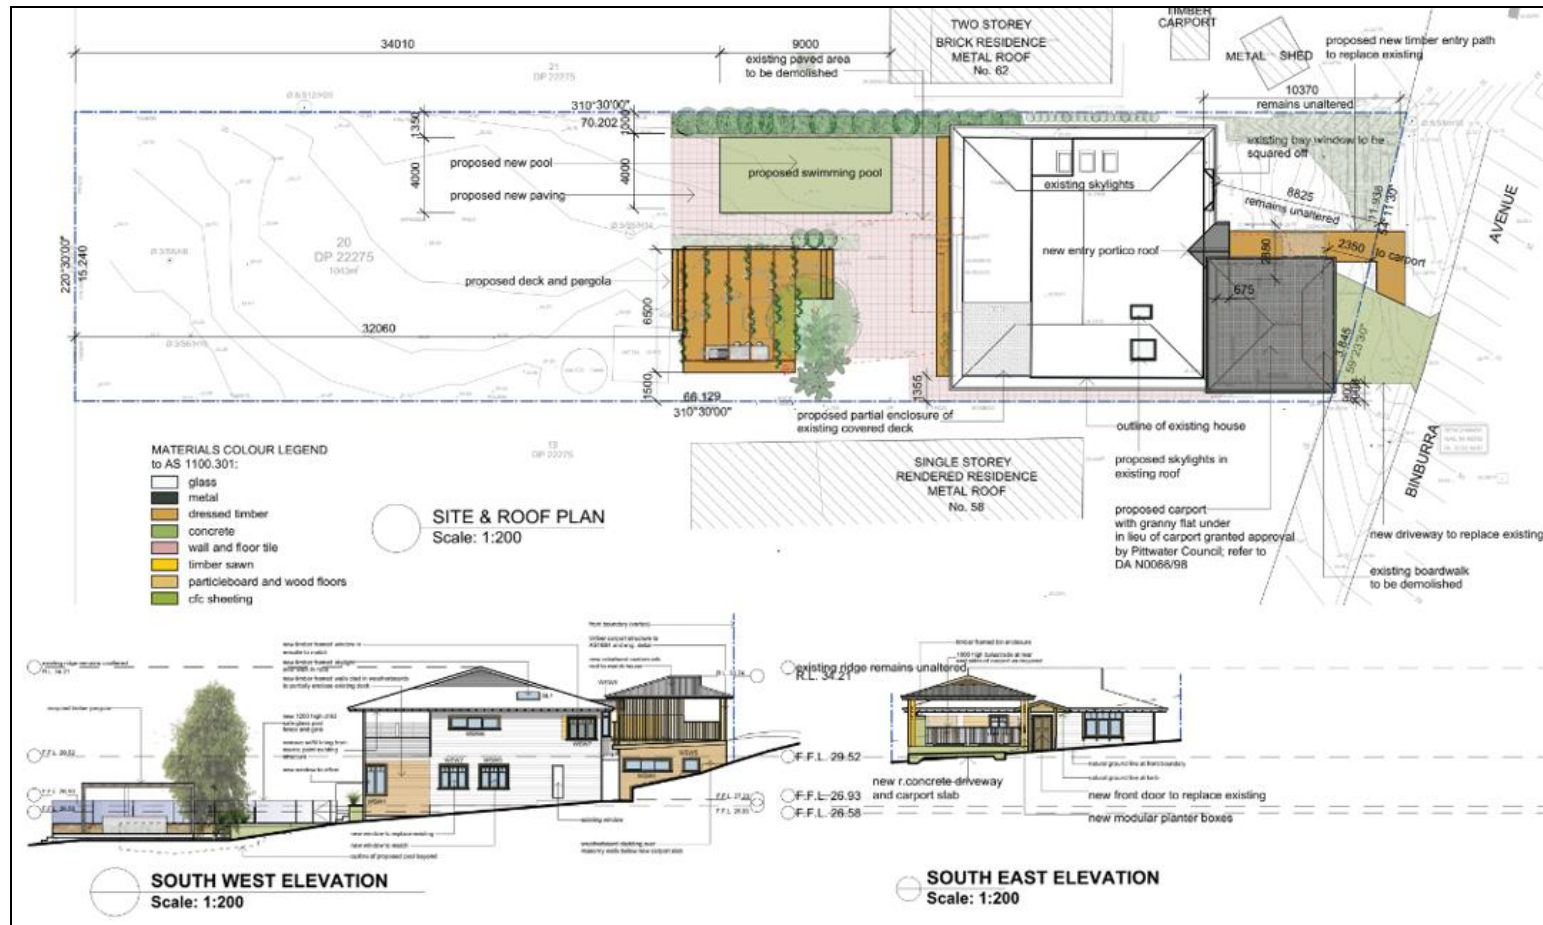
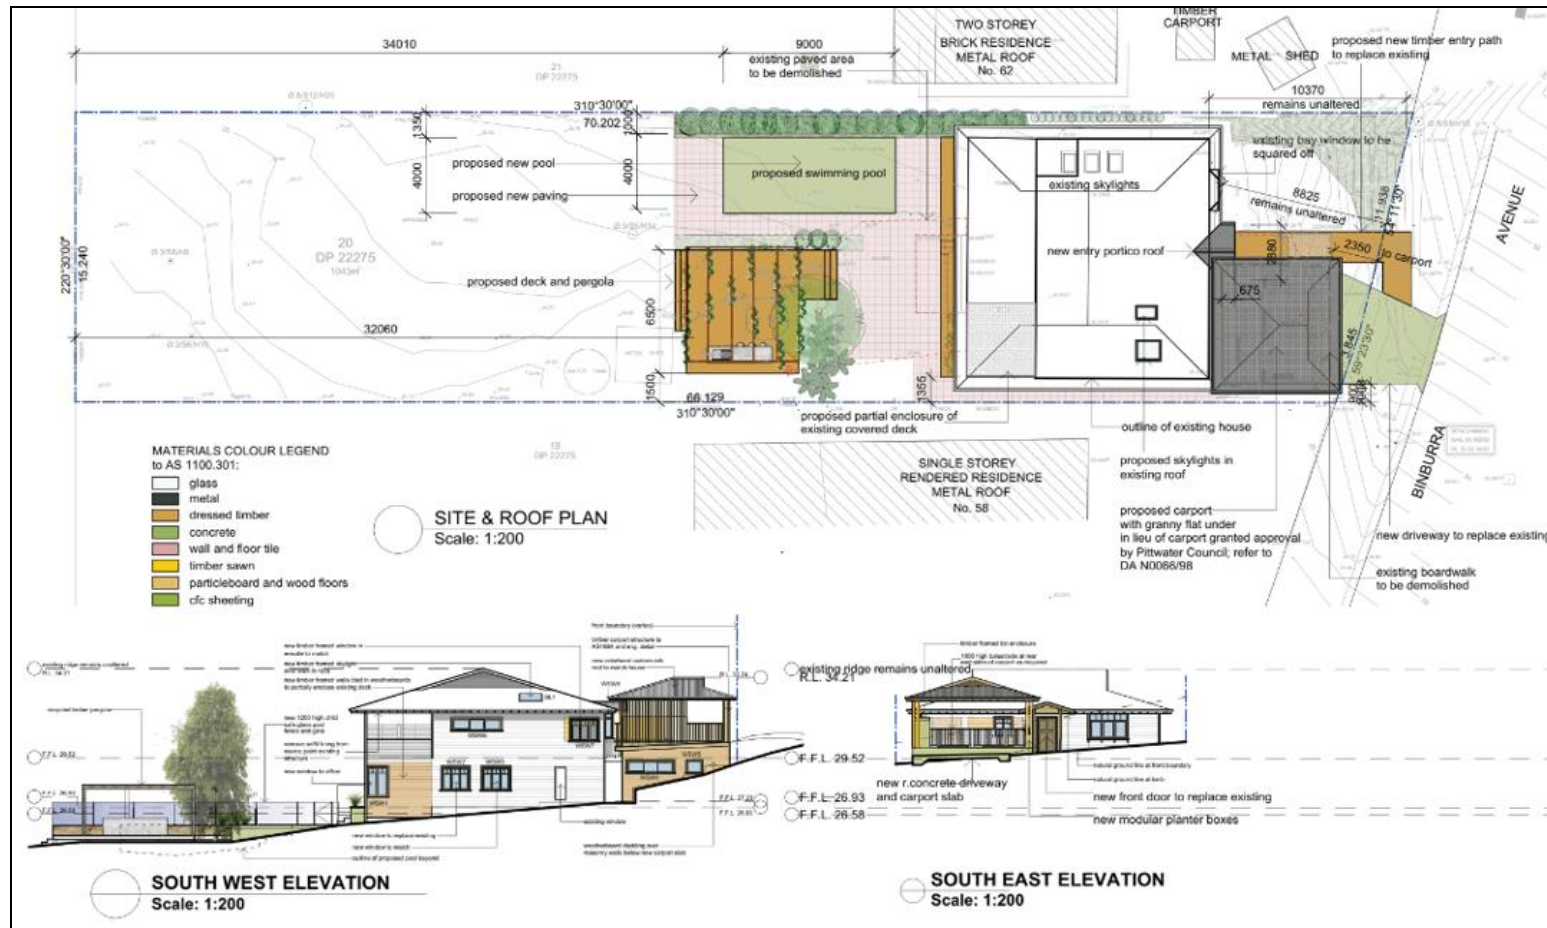
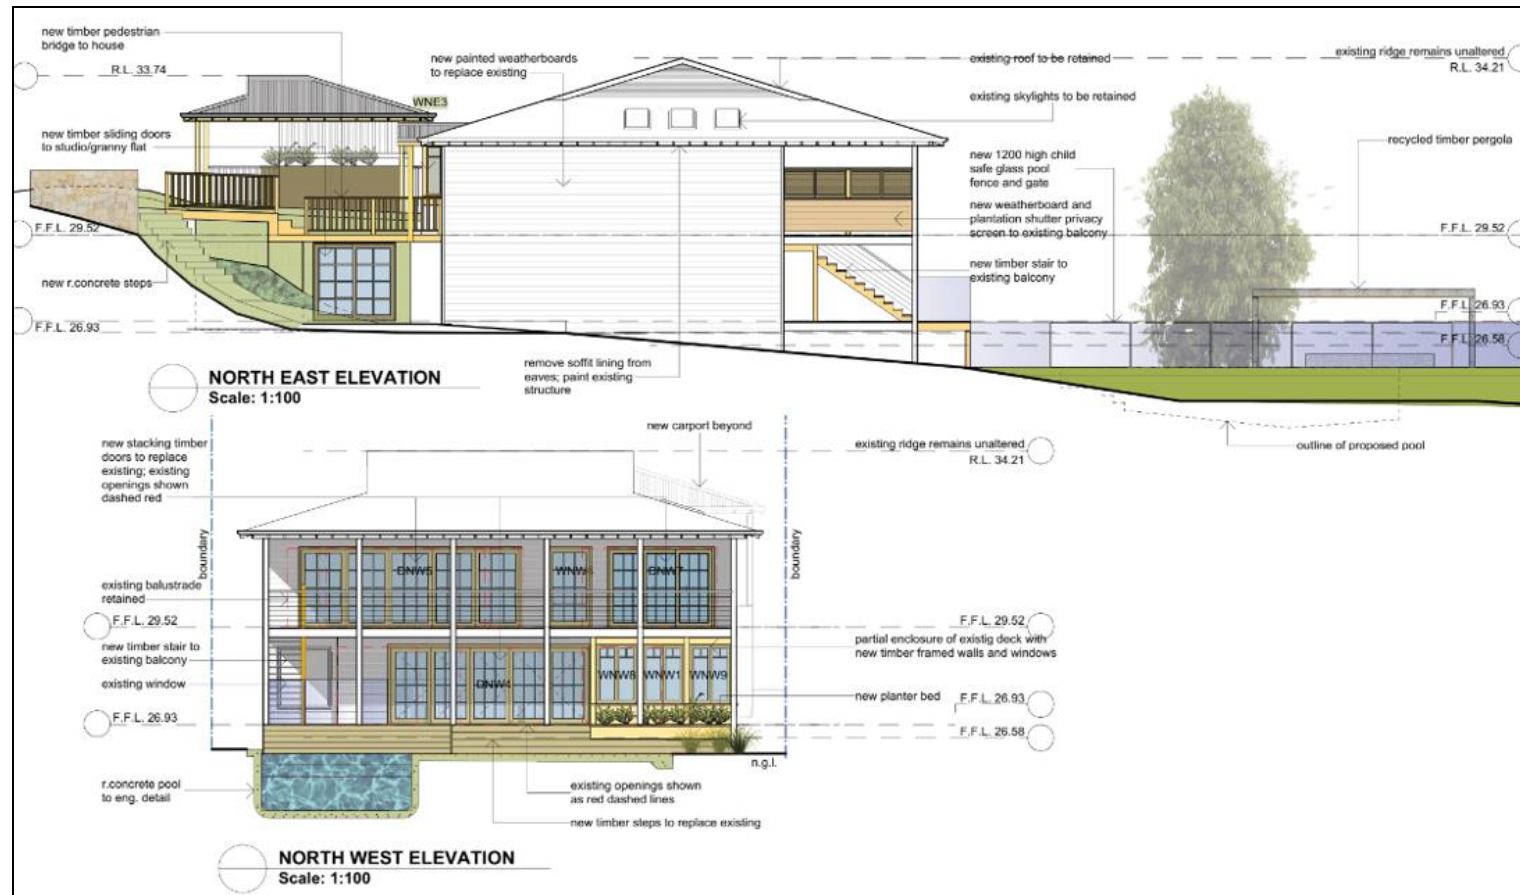
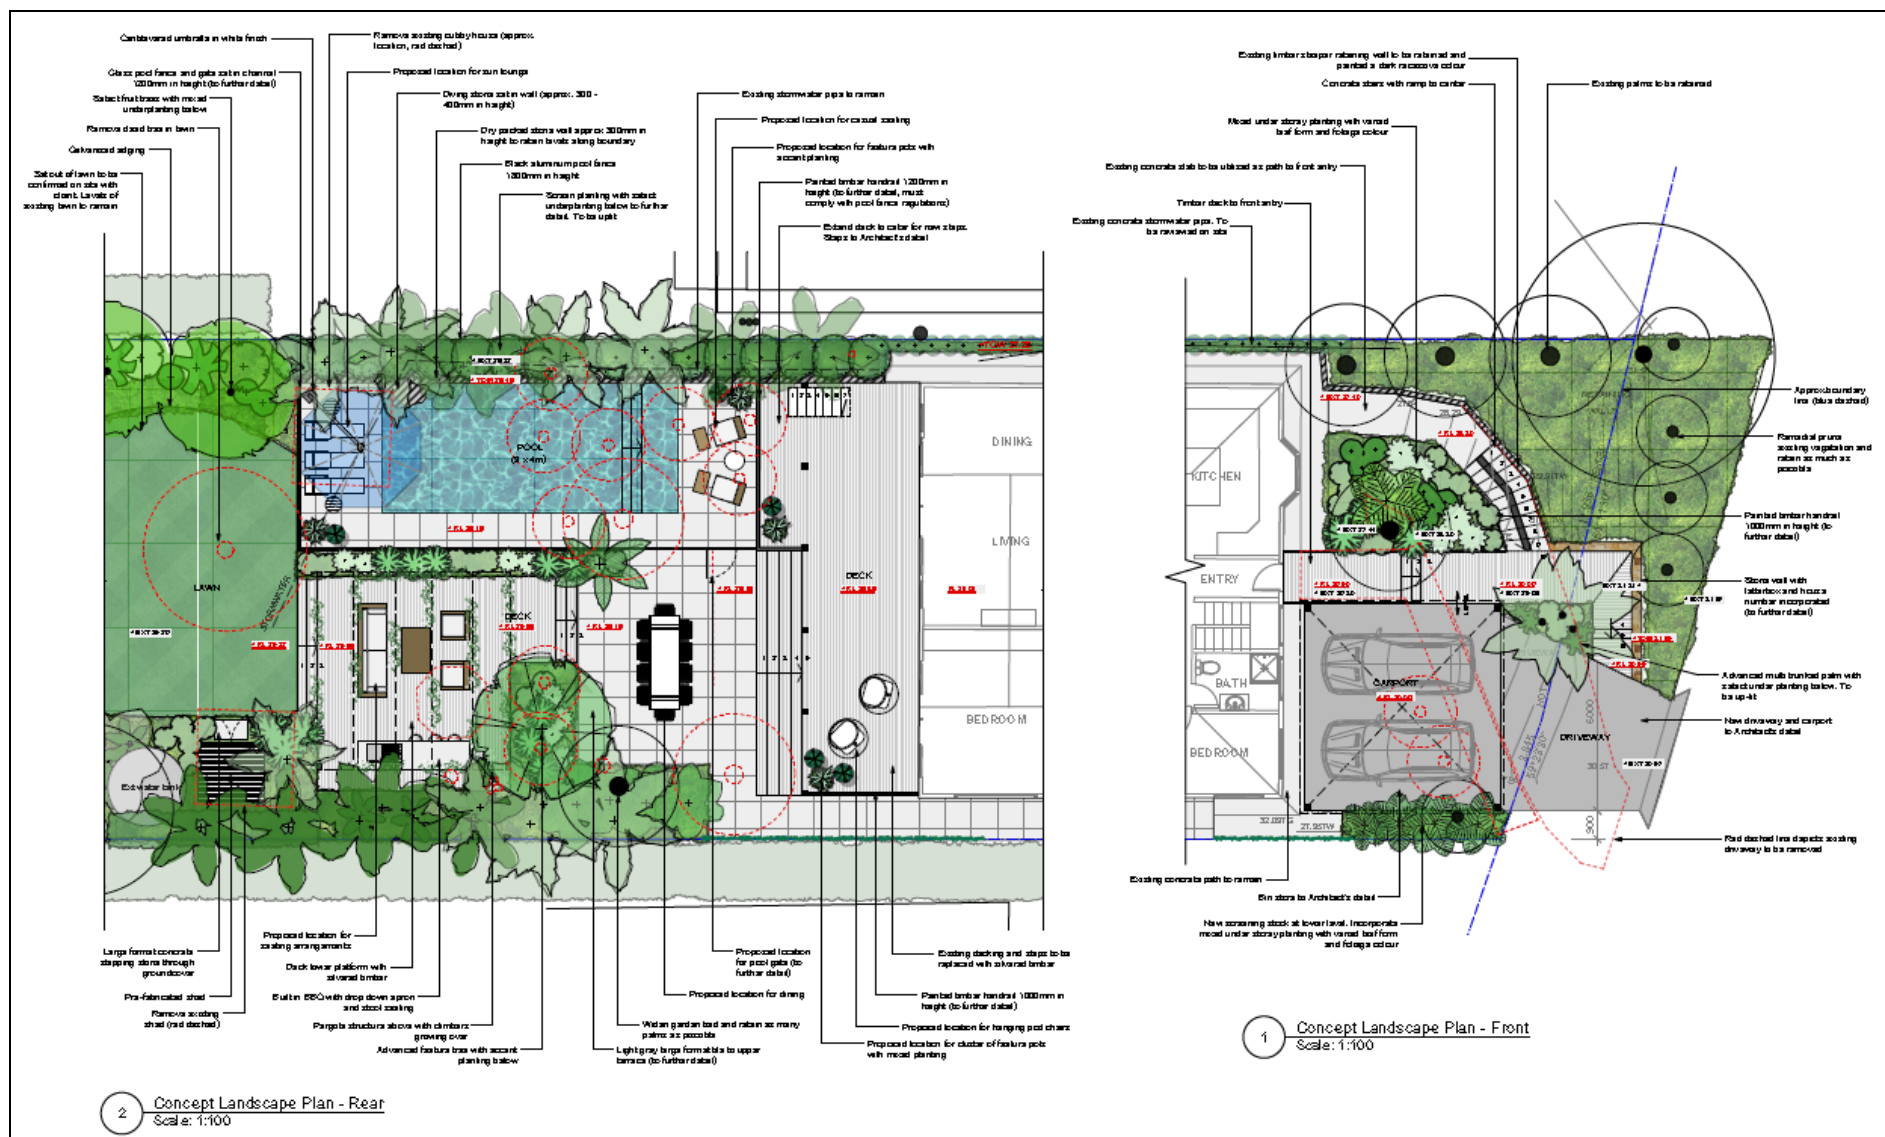
Figure 4: Illustrates proposed Landscape Concept for Rear Yard (Left Side of Plan) & Front Yard (Right Side of Plan).
