## **STAGE 1 (PRELIMINARY) ENVIRONMENTAL SITE ASSESSMENT (ESA)**

**Development Property  
74 Willandra Road  
Narraweena NSW 2100**

**Lot 810 DP 752038**

*(Report ID : EBG-02323.Stage1.ESA)*

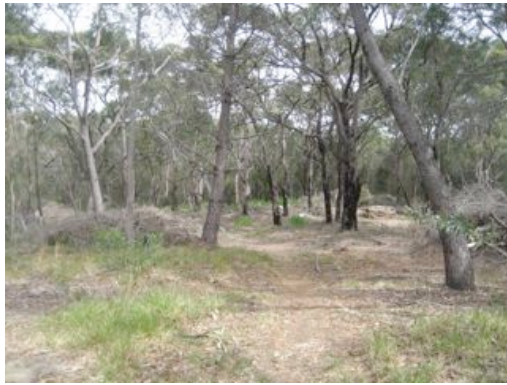
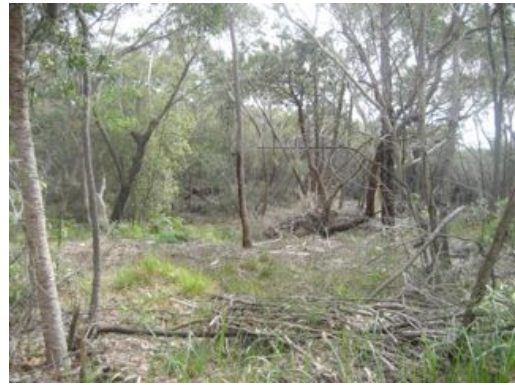
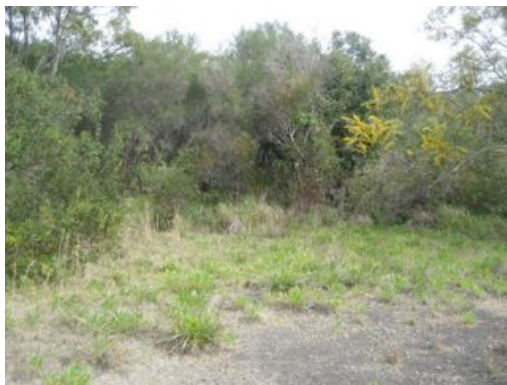
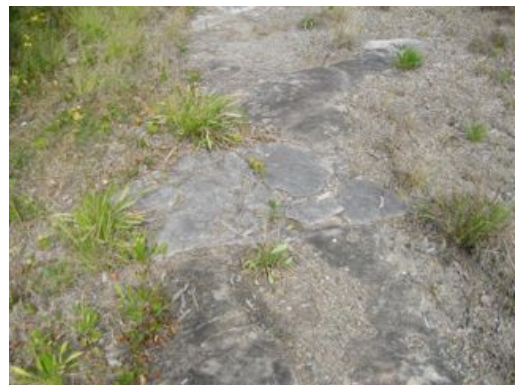
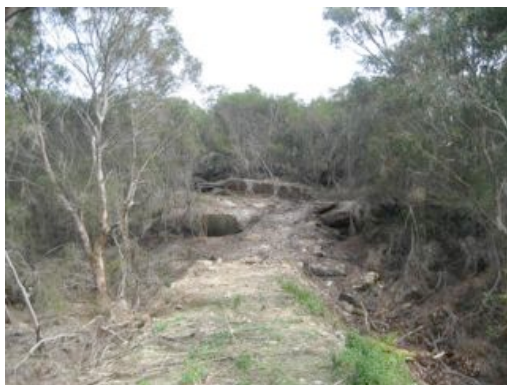
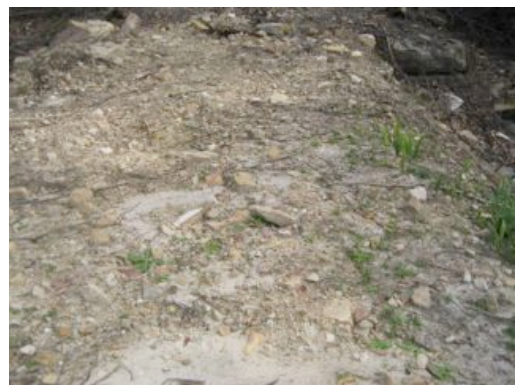
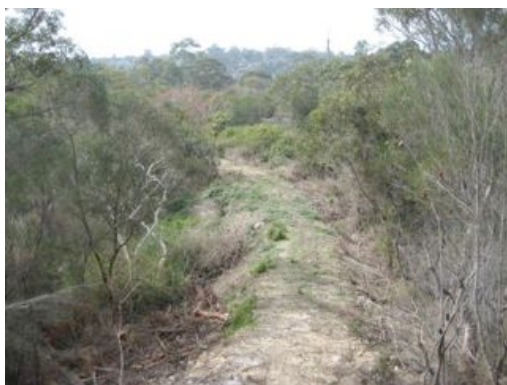
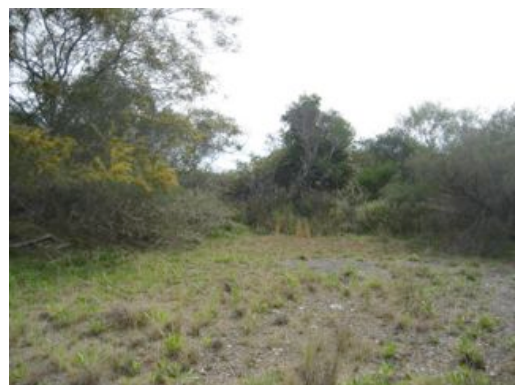
*Appendix A - PHOTOGRAPHS : Stage 1 ESA : 74 Willandra Rd, Narraweena NSW  
(EBG-02323.Stage1.ESA)*

Isolated areas of illegal dumping were located on the property. Small pieces of asbestos cement were located in four areas on the property (or near the properties' boundaries). Three are of concern and relevant to this investigation. The locations are shown on the aerial photo in 3.9.4 and recommendations concerning these areas are given in *Section 6.2 Recommendations*. Three areas need remediation prior to development. No underground tanks were located during the inspection.

- R1 – Location No. 1: Cleared area on side of road behind barrier and within the bounds of the property. Located approximately 150 metres east of the Rural Fire Brigade building. Broken sheet lying on ground. This can be seen from the road. Suspected dumped from road traffic. The broken asbestos cement sheeting shall be removed as bonded asbestos prior to development as per *Appendix B: Specification for the Removal of Bonded Asbestos*.

- R2 - Location No. 2: The adjacent property to the north has been cleared and a suspected development is being undertaken to accommodate a house or similar. Soil has been bulldozed to create raised track/embankment trending NE/SW and then E/W up to a small sandstone bluff to the rear of the properties. Isolated pieces of asbestos cement sheeting and other building debris were found within the soil of this embankment. It is difficult to ascertain from the ground, however this embankment may impinge onto the property or within the property's northern boundary. Whether this is the case should be checked by a surveyor. If the embankment or part thereof is located within the property boundaries, the pieces of asbestos cement sheeting located within the subject property shall be removed as bonded asbestos prior to development as per *Appendix B: Specification for the Removal of Bonded Asbestos* or alternatively the soil may be removed back into the adjacent property (its suspected origin).

- R3 - Location No. 4: Small pile of rubbish behind Rural Fire Building. Small pieces asbestos cement sheeting on ground (Located approx. 50m west of building within bush). The pile consists of typical household waste (plastic, bottles etc) and has been placed there some time ago. Isolated pieces of asbestos cement sheeting were found within the pile. The broken asbestos cement sheeting shall be removed as bonded asbestos prior to development as per *Appendix B: Specification for the Removal of Bonded Asbestos*).
