Arboricultural Impact Assessment

**Pittwater House
c/- Neeson Murcutt Architects
70 South Creek Road
Collaroy NSW**

23 October 2019

C91571 Rev 2

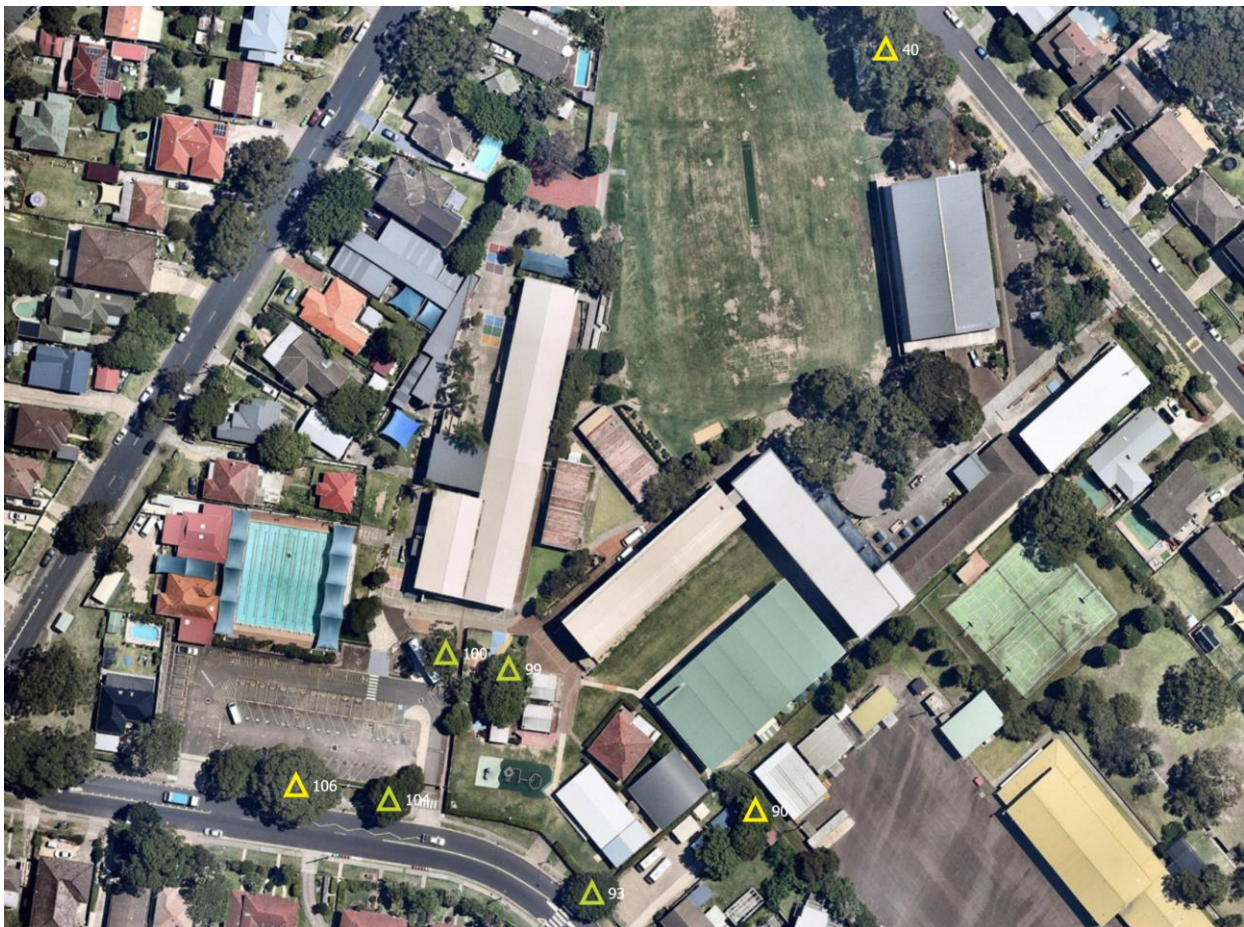
Figure 4. Aerial image showing location of High Retention Value Trees. Note that icon colour indicates trees current risk rating (not Retention Value). Tree attributes are to be obtained from Appendix C – Tree Assessment Data. (ArborPlan, 2019).

- 6.2.3 Tree 93 was a Magenta Brush Cherry (*Syzygium paniculatum*). The tree was located within the minibus depot on the southern side of the site and contributes significantly to the streetscape screening value and forms a significant feature within the landscape.
- 6.2.4 Tree 93 was of good health and fair structure and has a life expectancy of 25–50 years.
- 6.2.5 The TPZ for Tree 93 was 8.2m measured at a radial distance from the centre of the trunk.

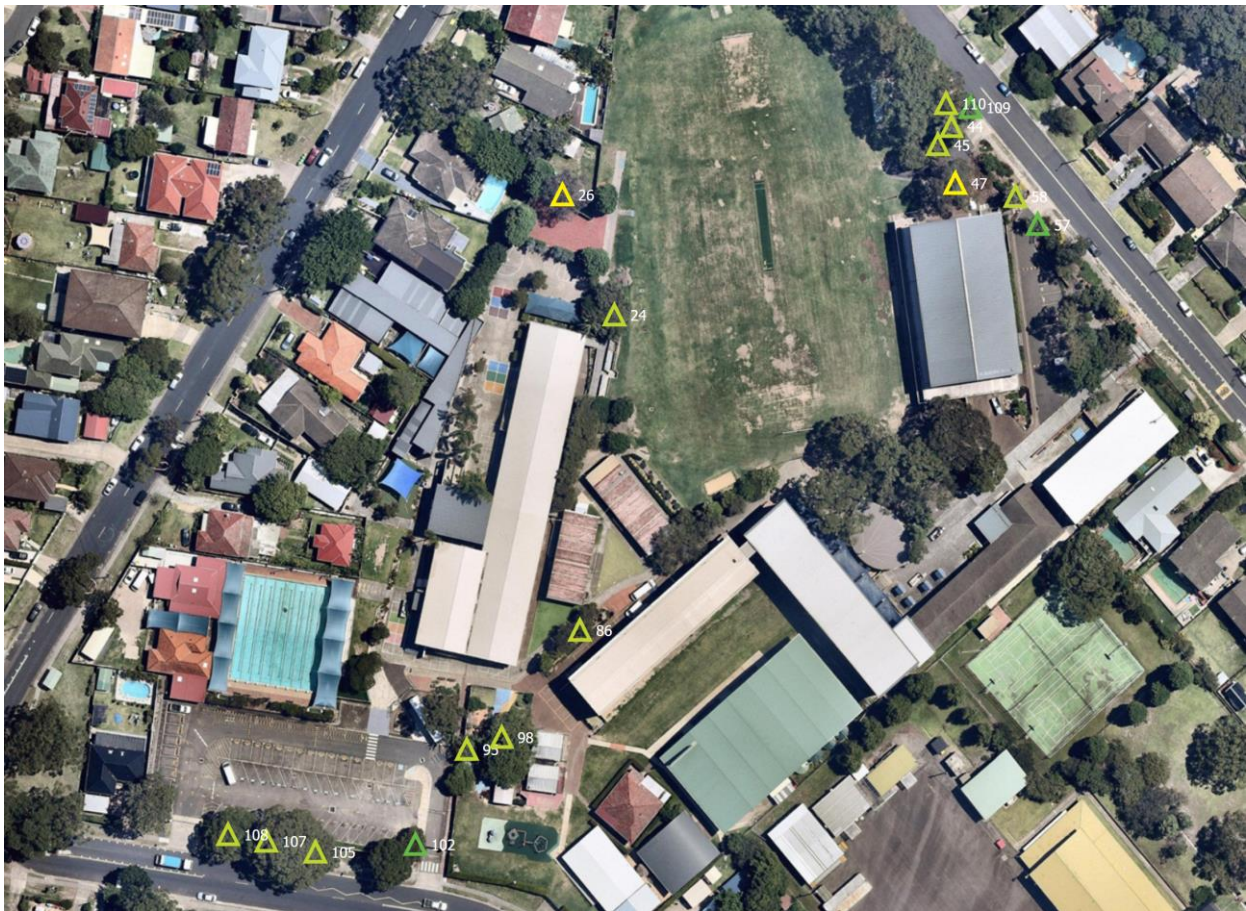
Figure 10. Aerial image showing location of Moderate Retention Value Trees. Note that icon colour indicates trees current risk rating (not Retention. Value). Tree attributes are to be obtained from Appendix C – Tree Assessment Data. (ArborPlan, 2019).

- 6.3.3 Tree 47 was a Narrow-leaved Black Peppermint (*Eucalyptus nicholii*). This relatively shorted lived Eucalyptus species is endemic to the New England area of NSW. This tree was of mature size and in good health and fair structure. Active termites were observed as well as a large trunk wound that potentially harbours decay. The tree has a ULE of 10–15 years only.
- 6.3.4 The TPZ for Tree 47 was 9.4m measured at a radial distance from the centre trunk.

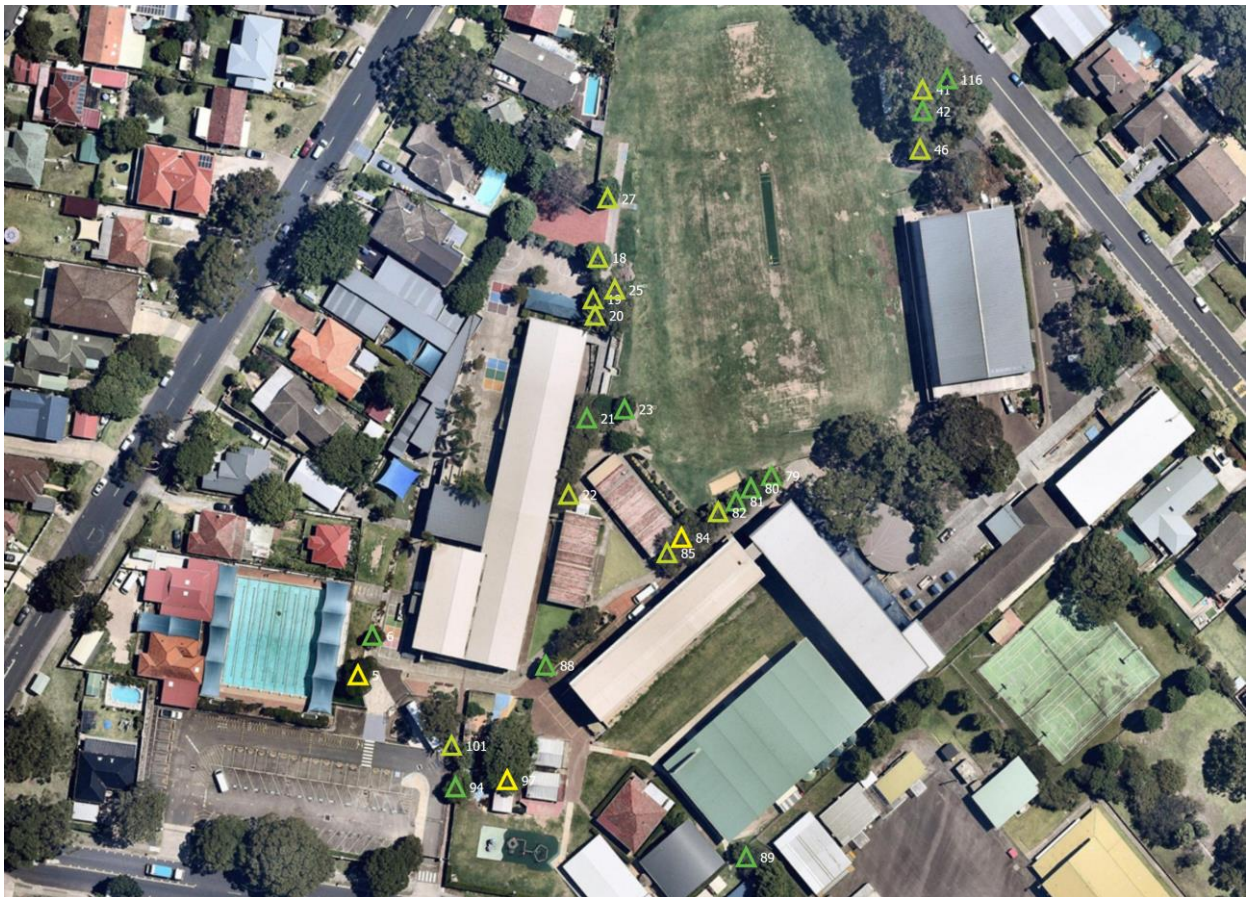
Figure 12. Aerial image showing location of Low Retention Value Trees. Note that icon colour indicates trees current risk rating (not Retention Value). Tree attributes are to be obtained from Appendix C – Tree Assessment Data. (ArborPlan, 2019).

- 6.4.3 Trees 79, 80, 81, 82, 84 and 85 are all examples of Category C trees. Species include Weeping Bottlebrush (*Callistemon viminalis*), Willow Myrtle (*Agonis flexuosa*) and Kanooka (*Tristaniopsis laurina*). These species' have a relatively small mature size potential. Whilst they offer some screening and amenity value, they are easily replaceable, hence their Low Retention Value.
- 6.4.4 As an example, the TPZ for Tree 82 was 2.5m measured at a radial distance from the centre trunk.

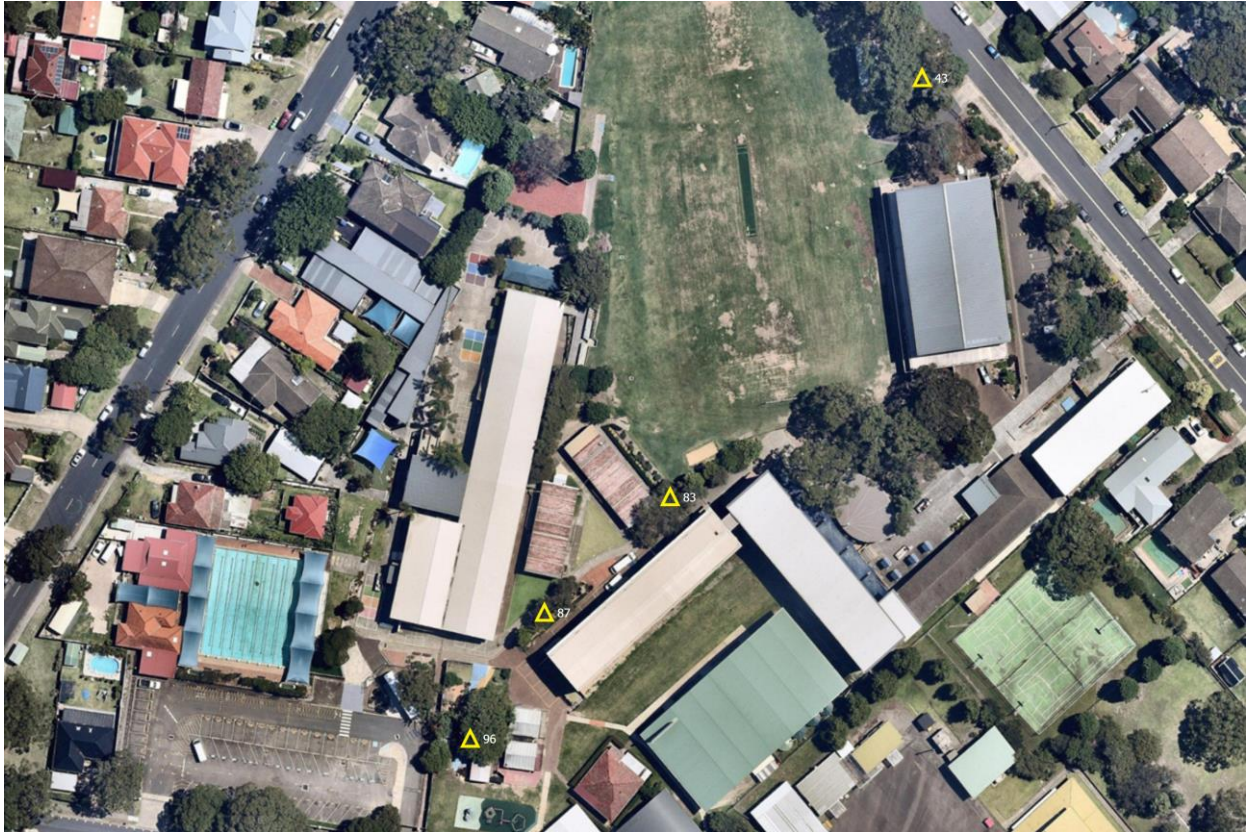
Figure 14. Aerial image showing location of Remove Retention Value Trees (Nil/No Retention Value). Note icon colour indicates trees current risk rating (not Retention Value). Tree attributes are to be obtained from Appendix C – Tree Assessment Data. (ArborPlan, 2019).

6.5.3 Tree 96 was a Cheese Tree (*Glochidion ferdinandi*) tree located within the garden area on the southern side of the site. The tree has experienced multiple stem failures resulting in poor structure and a low ULE. This tree is recommended for removal irrespective of any further development.

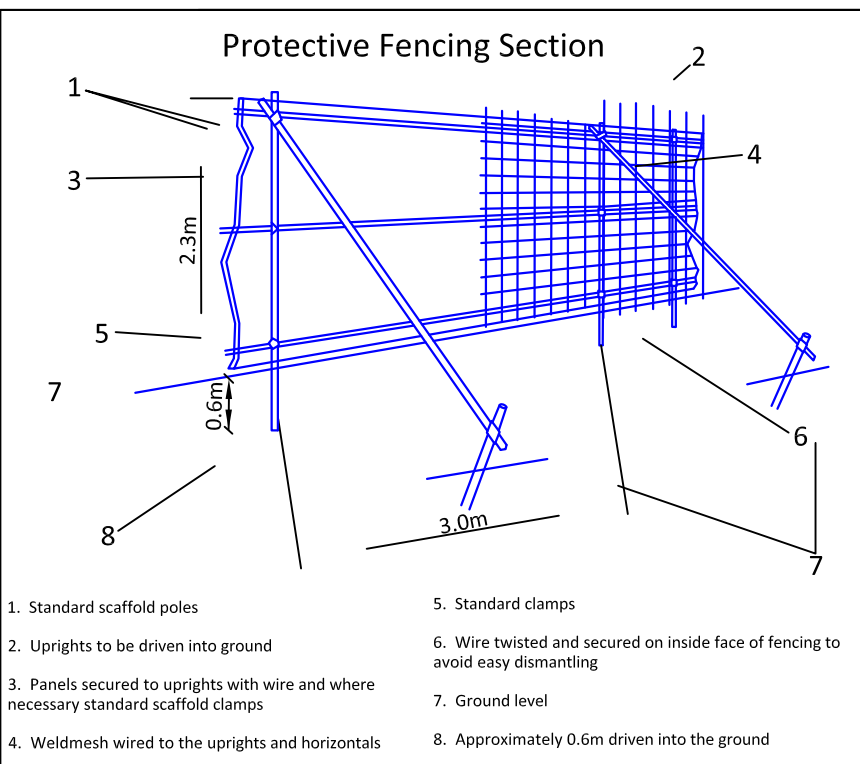
PROJECT:	Arboricultural Impact Assessment Pittwater House School
CLIENT:	C.M.S Surveyors Pty Ltd.
DRAWING:	Tree Protection Plan
DRAWING NO.:	ASTPP01 Rev.2 23.10.2019
BASED ON:	Survey Plan 4883G C.M.S Surveyors Pty Ltd.
SCALE:	Do not scale
DRAWN BY:	NA

Demolition of existing structures and new car park proposed in TPZs. Proposed parking to be outside TPZs or above grade and installed in a manner not to impact tree roots. Any excavation or below grade works within TPZs must be supervised by Project Arborist.

To be erected prior to the commencement of all works on site, and retained in place throughout construction. To comprise either 2.4m wooden site hoarding; or a 2.1m high scaffolding framework, with uprights at maximum 3.5m spacings, every other one braced to the ground with 45 degree struts; supporting standard anti-climb 'Heras' welded mesh fence panels secured with anti-lift devices to concrete or plastic bases pinned to the ground by scaffold uprights sunk to a minimum depth of 500mm; individual panels fixed to each other with at least 2 clamps and to scaffolding with heavy-duty cable ties. "TREE PROTECTION ZONE - KEEP OUT" or similar notices to be attached to every fifth panel.
