Report Title: Geotechnical Report 102 Wakehurst Parkway, Elanora Heights

Report Date: 13/9/18

GEOTECHNICAL INVESTIGATION:

Subdivision and Alterations and Additions at **102 Wakehurst Parkway, Elanora Heights.**

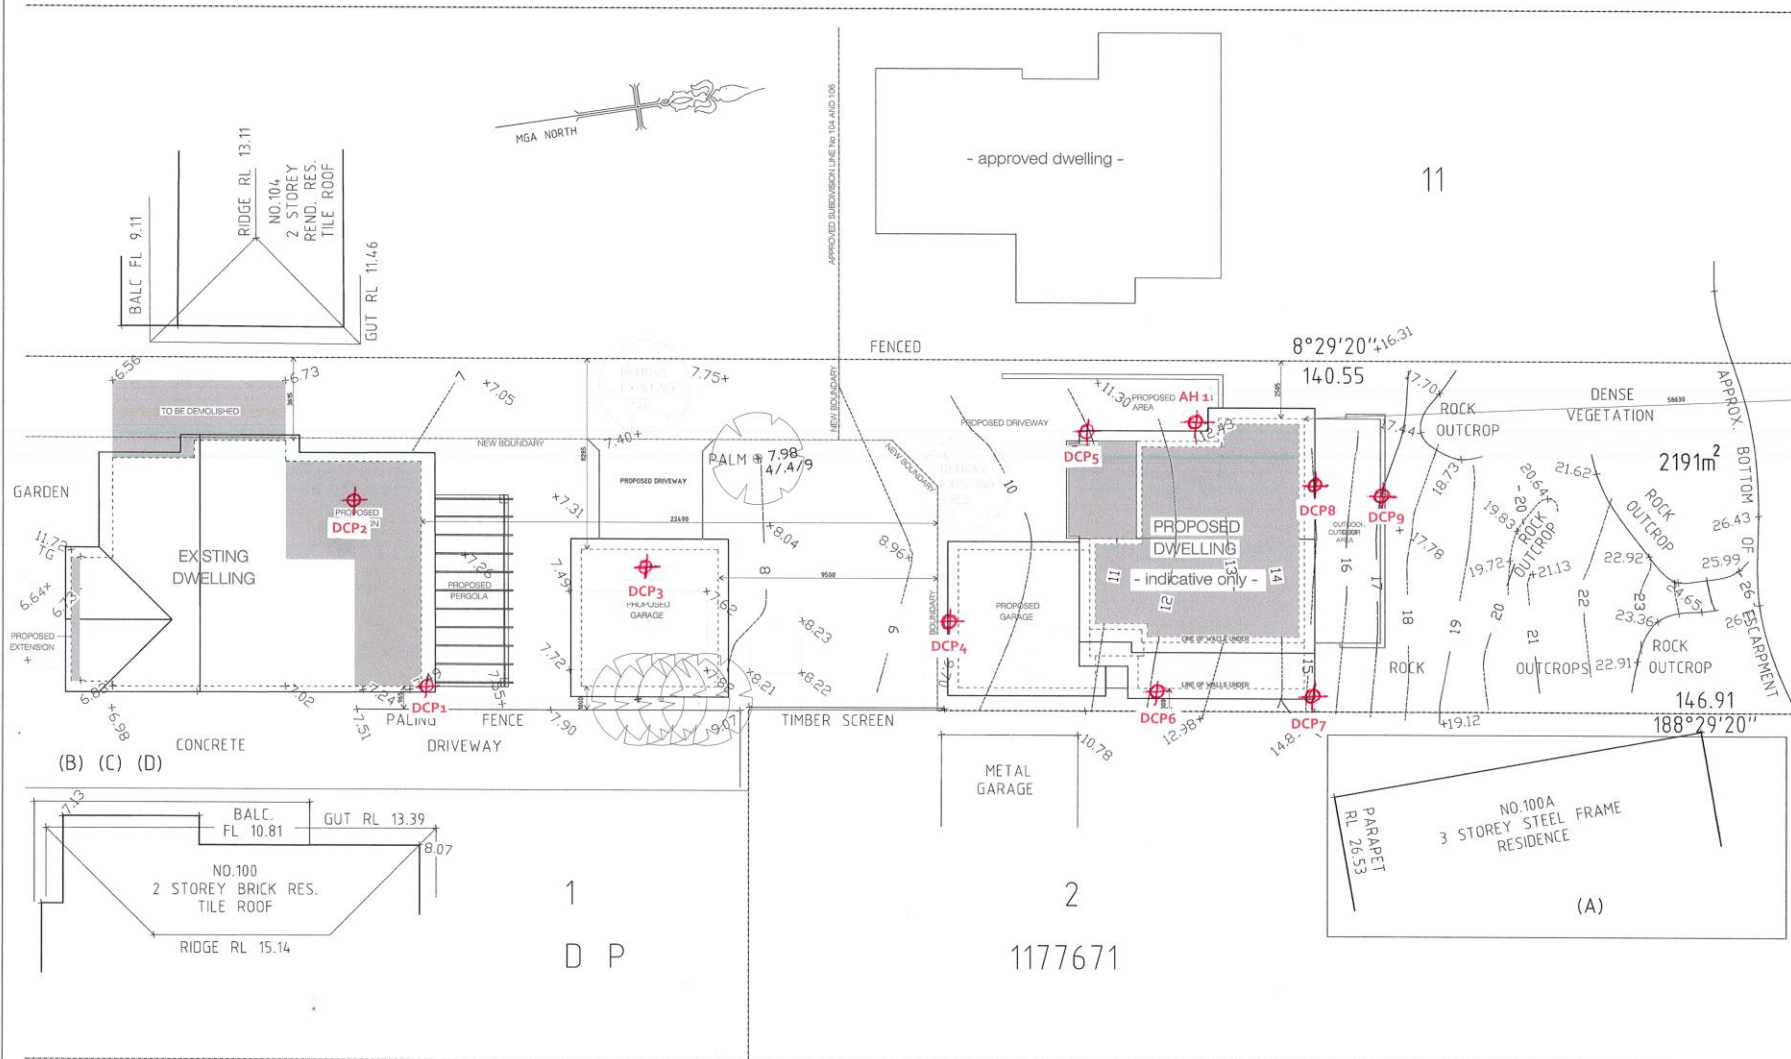
SITE PLAN – showing test locations

One auger hole was put down to identify the soil materials. Nine Dynamic Cone Penetrometer (DCP) tests were put down to determine the relative density of the overlying soil and the depth to bedrock. The locations of the tests are shown on the site plan. It should be noted that a level of caution should be applied when interpreting DCP test results. The test will not pass through hard buried objects so in some instances it can be difficult to determine whether

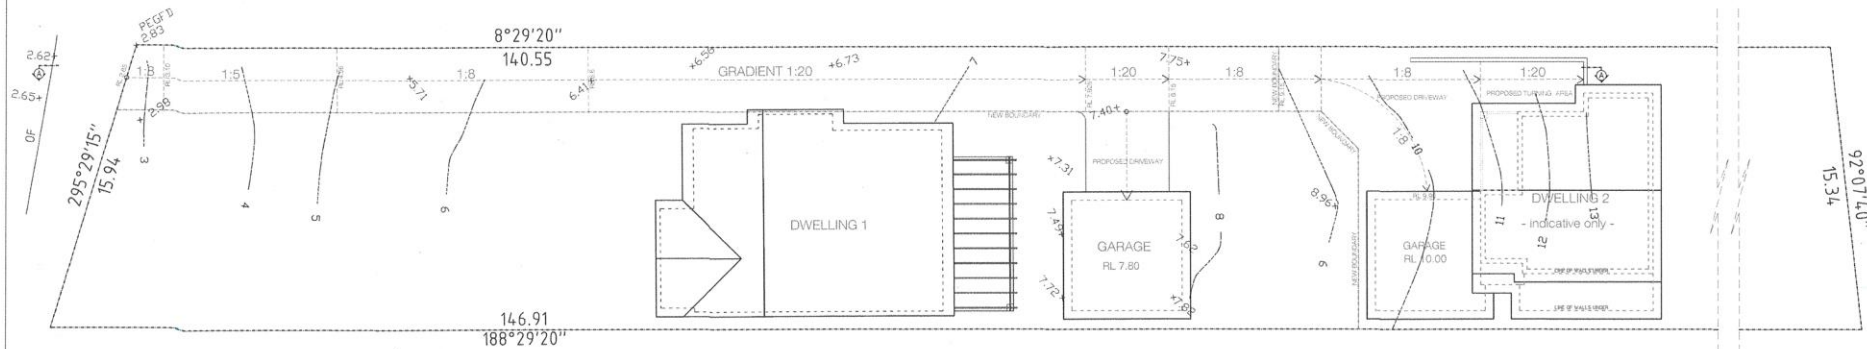
TYPE SECTION – Diagrammatical Interpretation of expected Ground Materials

The contact between the Newport Formation and the Hawkesbury Sandstone is interpreted to be at the base of the Hawkesbury Sandstone cliff face. Below the contact, in the location of the proposed works, the slope materials are colluvial at the near surface and residual at depth. They consist of a thick sand over silty clays. In the test locations, the clays merge into the weathered zone of the underlying shale at depths of between ~1.8 to ~2.4m below the current surface. The weathered zone is interpreted to be Extremely Low to Very Low Strength Shale. It is to be noted that this material can appear as a mottled stiff clay when it is cut up by excavation equipment. See Type Section attached for a diagrammatical representation of the
