Arboricultural Impact Statement.

**Location: 4 Bellara Avenue NORTH
NARRABEEN NSW 2101**

For: Sydney Water Corporation Pty Ltd
C/- RJK Architects
On. 22/9/2023

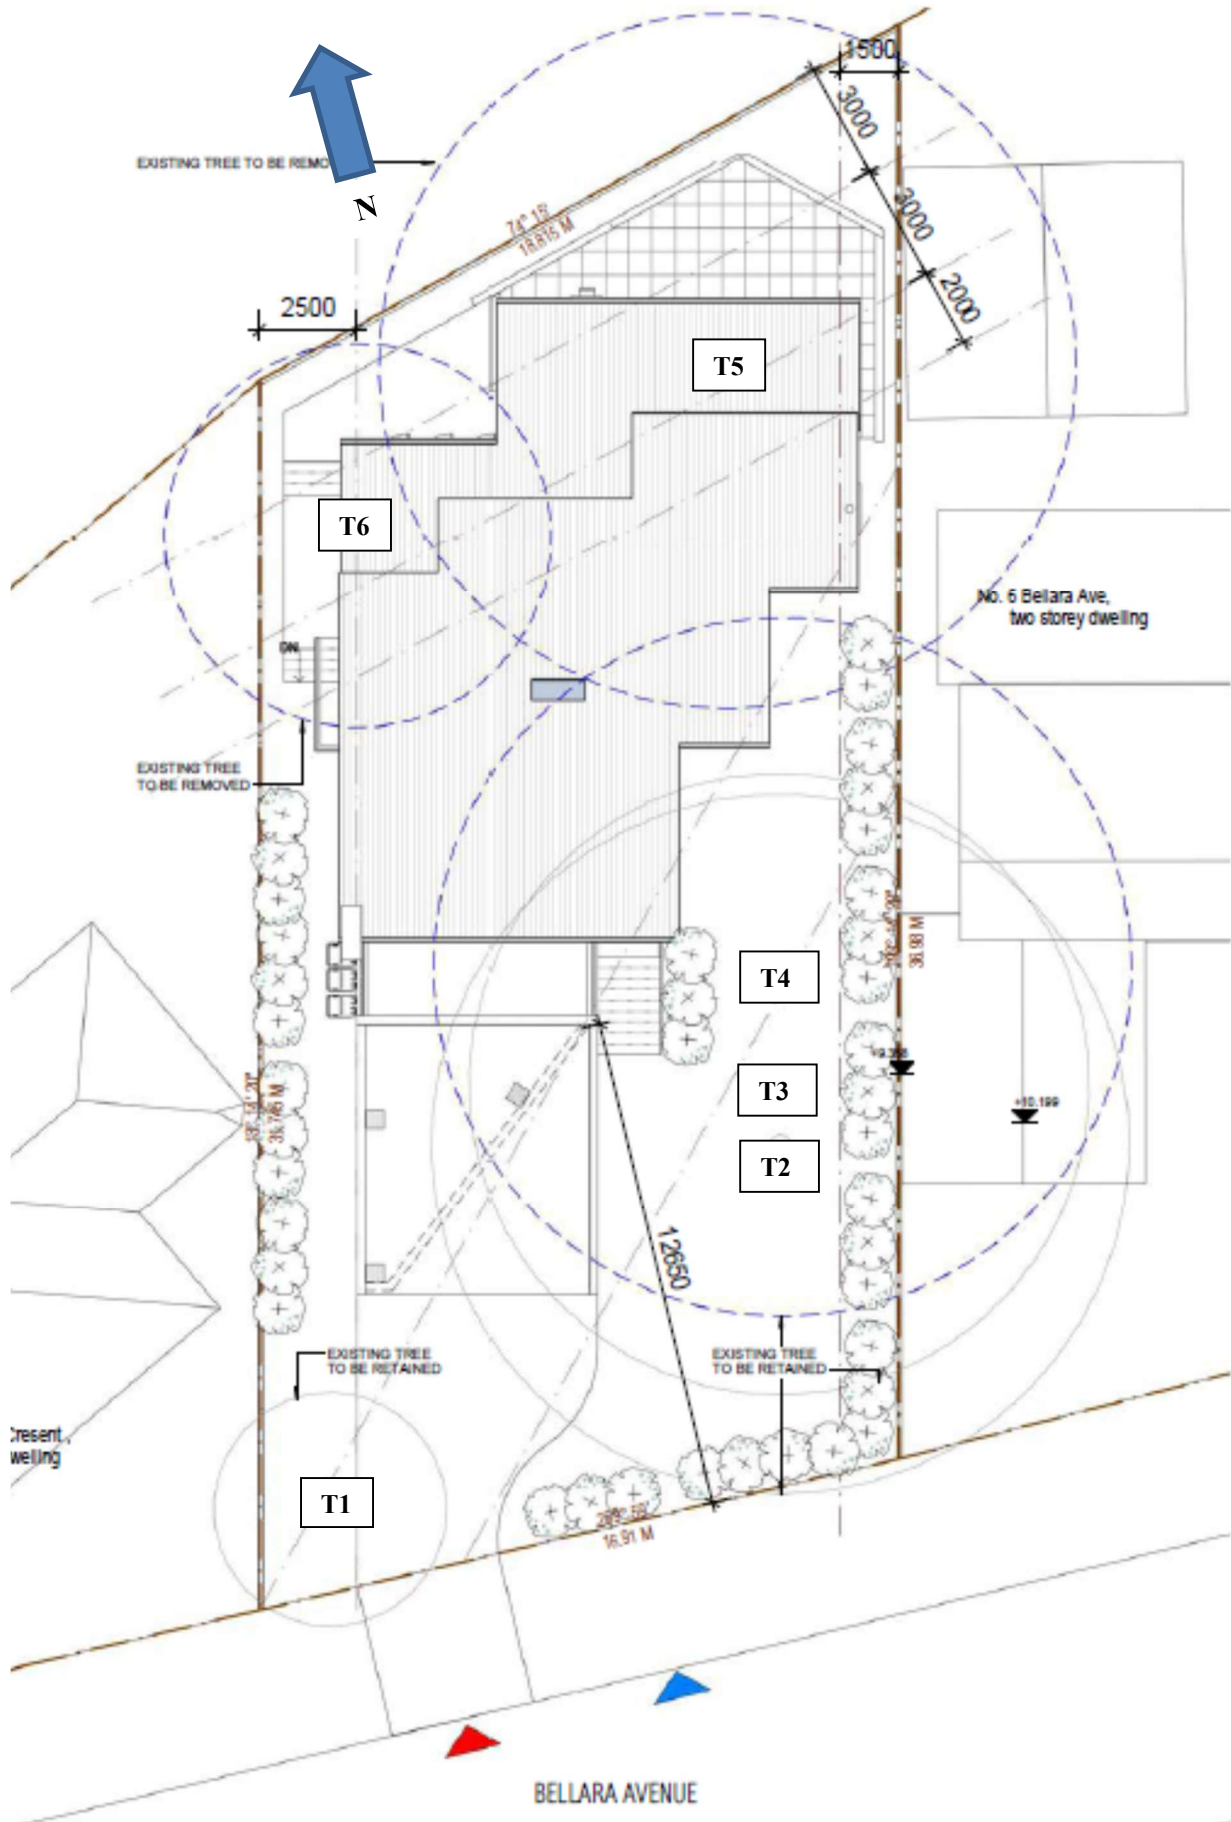
APPENDIX 2 Excerpt from site plans showing the location of trees on the Site in relation to the proposed new building footprints.

- 5.3** Trees **T2 & T3** will suffer Minor Encroachment into their relative TPZs and SRZs from the new driveway and I concur with the findings in the previous report that these specimens be retained (See Appendix 2). Nonetheless these trees can be inadvertently damaged by deliveries, trades vehicles and the passage of plant equipment and so a protective fence and signage is recommended for these trees (See Appendix 4a & 4b).
