**STANDFAST TREE SERVICES**  
ESTABLISHED 1979

Re Modification DA – 135 Seaforth Crescent, Seaforth

Re Arboricultural Impact Assessment (AIA) for 135 Seaforth Cres, Seaforth

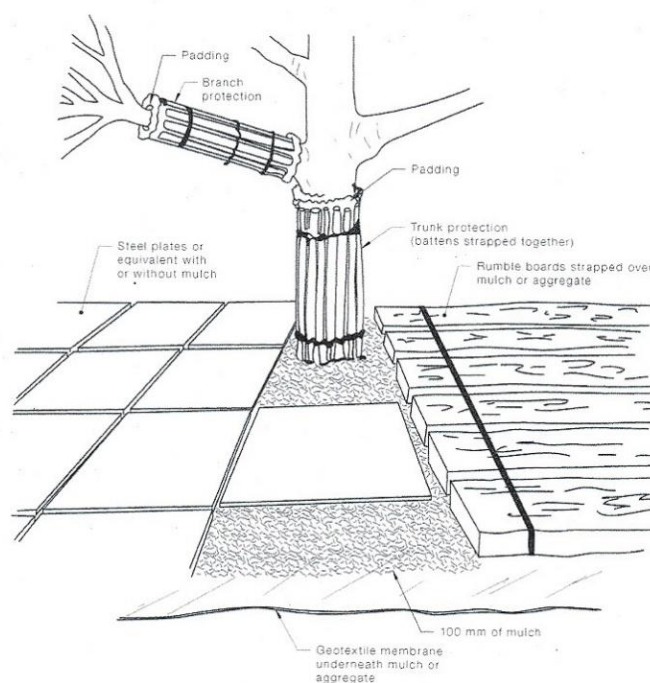
If temporary access for machinery is required within the TPZ ground protection measures will be required. The purpose of ground protection is to prevent root damage and soil compaction within the TPZ. Measures may include a permeable membrane such as geotextile fabric beneath a layer of mulch or crushed rock below rumble boards as per Figure 4.

Where necessary, install protection to the trunk and branches of trees as shown in Figure 4. The materials and positioning of protection are to be specified by the project arborist. A minimum height of 2 m is recommended.

- 1 For trunk and branch protection use boards and padding that will prevent damage to bark. Boards are to be strapped to trees, not nailed or screwed.
- 2 Rumble boards should be of a suitable thickness to prevent soil compaction and root damage.
