Report Title: Geotechnical Report 60-62 Chisholm Avenue, Avalon Beach
Report Date: 4/3/21

GEOTECHNICAL INVESTIGATION:

New Driveway and Garage at **60-62 Chisholm Avenue, Avalon Beach**

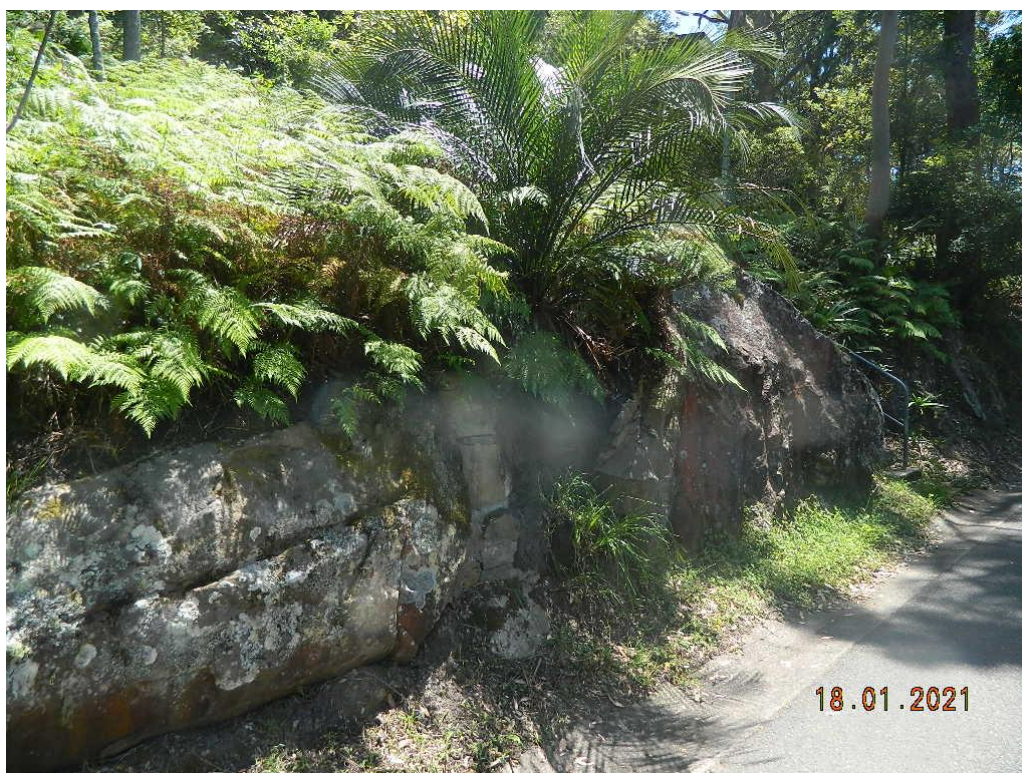
Photo 3

- 2.3** A turning circle is located at the road frontage (Photo 1). The cut for the road and turning circle is supported by a sandstone block retaining wall up to ~1.5m high. The wall displays bulging in places (Photos 2 & 3). See 'Section 16 Ongoing Maintenance'. Medium Strength Hawkesbury Sandstone Bedrock is outcropping at the road frontage (Photo 4). Sandstone bedrock is exposed at the surface and dislodged joint blocks are embedded in stable positions in the steep vegetated slope between the road frontage and the houses (Photos 5 to 7).

Part of the bulging sandstone block retaining wall (Photos 1 to 3) will be demolished as part of the proposed works. The remaining portion is in poor condition. It is recommended it be repointed/rebuilt to meet current engineering standards as part of the works, if this is not already planned.

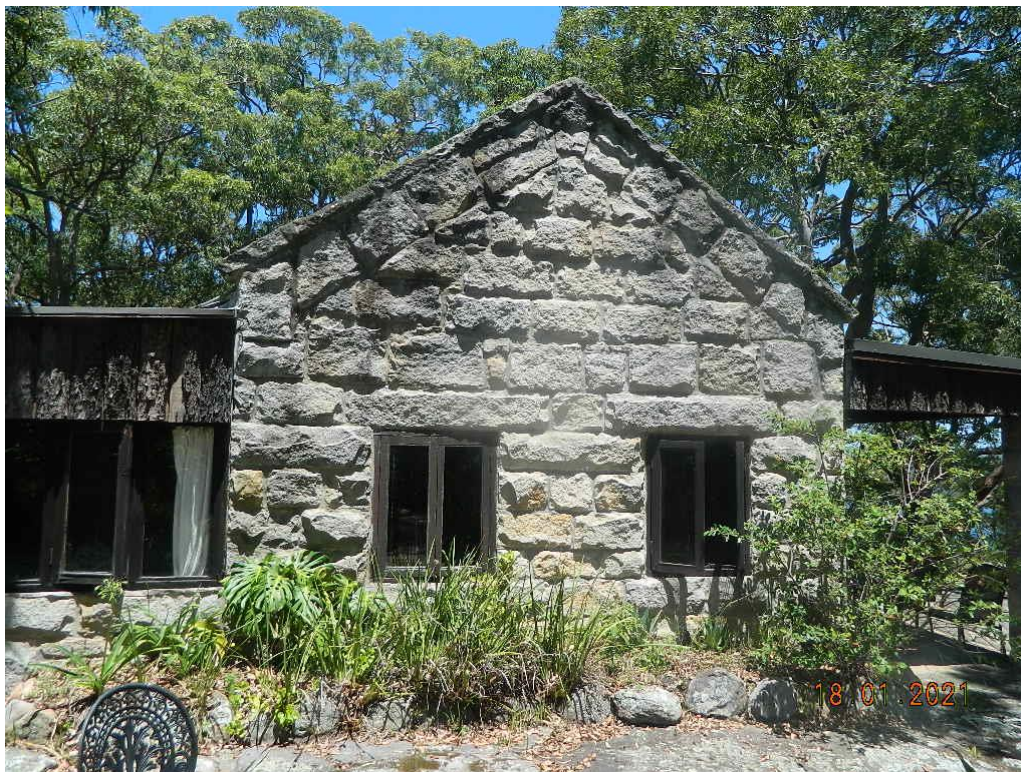
Photo 10

The house at 62 Chisholm Ave is accessed by a bitumen right of carriageway (ROW) and sandstone driveway (Photos 8 & 9). A sandstone dressed concrete block garage in good condition is located on the W side of the house (Photo 10). The old single storey sandstone block house is supported by sandstone block walls and sandstone piers (Photo 11). The supporting walls and piers stand vertical and display no significant signs of movement (Photo 12). The house is supported on exposed sandstone bedrock on the crest of the slope. A moderately sloping lawn on the NW side of the house is terraced by stable sandstone block retaining walls up to ~1.5m high. Sandstone bedrock is outcropping on the steep slope on the NW side of the property. A portion of the rock is undercut by up to ~3.5m (Photos 13 & 14). The undercut has a relatively thin cantilever arm in relation to its overhang length however has stood in its present state for at least hundreds of years. In the unlikely event that the undercut fails, it will fall onto the area immediately below. Given the location of the undercut and provided no one spends time under it, it is not considered a significant threat to life or property.

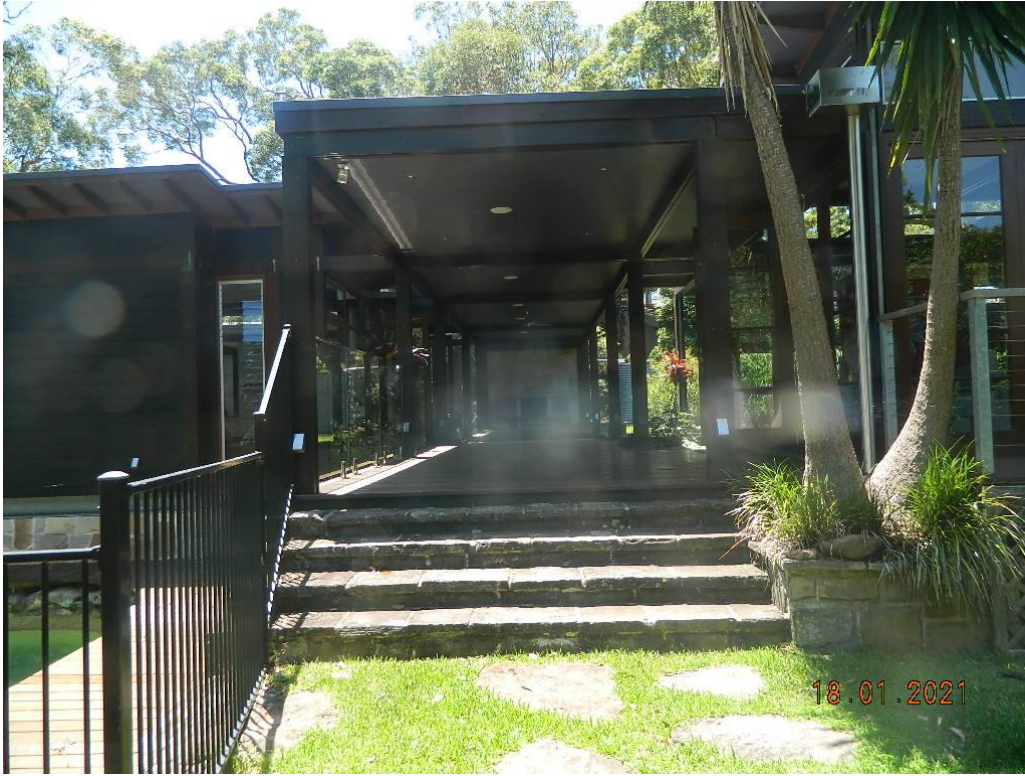
Photo 16

The ROW extends to the house at 60 Chisholm Ave (Photo 15). A pool in good condition is located on the W side of the house (Photo 16). A stable sandstone block retaining wall up to ~2.2m high supports fill on the downhill side of the pool. The part two storey timber clad house is supported by steel posts and concrete block walls (Photos 17 & 18). The supporting posts and walls stand vertical and show no significant signs of movement.
